GLOBAL SAFETY FIELD INVESTIGATIONS
DCS5098
URGENT - DISTRIBUTE IMMEDIATELY

Subject: N192210220 - Special Coverage
Supercharger Replacement

Models: 2014 Cadillac CTS-V

Special Coverage Adjustment

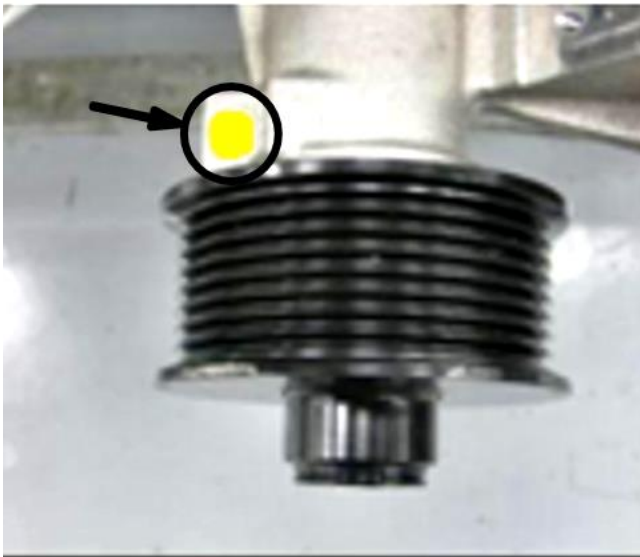
- A CTS-V may come in with a complaint of a rattling noise at idle from the supercharger. This noise will typically go away above 1400 RPM.
- Verify the vehicle does have a noticeable rattling noise coming from the supercharger that goes away over 1400 RPM.
 - If the vehicle does **not** have a noise coming from the supercharger, no further action is required. Claim diagnostic time and inform the customer that no further diagnosis or repairs will be covered under this special coverage. Any further work will need to be customer pay, warranty, or good will.
 - If you can verify the noise, inspect the supercharger behind the pulley as shown.

- If the supercharger has a yellow or white dot, proceed to step 3.
 - If the supercharger has a black dot, proceed to step 4.
- Inspect the belt part number.
 - If the belt part number is 12676726, proceed to step 4.
 - If the belt part number is illegible, or is **not** 12676726, replace the supercharger belt. Refer to *Supercharger Belt Replacement* in SI.
 - If supercharger belt replacement **did not** fix the noise issue, proceed to step 4.

- If supercharger belt replacement **did** fix the noise issue, no further action is required.
4. Replace the supercharger and supercharger belt (if the belt was not already replaced). Refer to *Supercharger and Gasket Replacement* in SI.
