HYUNDAI Technical Service Bulletin	GROUP AUTOMATIC TRANSMISSION	NUMBER 19-AT-013H
	DATE JULY 2019	MODEL SANTA FE (TMa)
SUBJECT: AUTOMATIC TRANSAXLE HARSH UPSHIFT WHEN COLD

Description: If you are servicing a 2019 Santa Fe (2.0T) with a harsh 2-3 or 3-4 upshift when cold, follow the Service Procedure below.

Applicable Vehicles: 2019 Santa Fe (TMa) 2.0T produced from 6/26/2018~1/9/2019

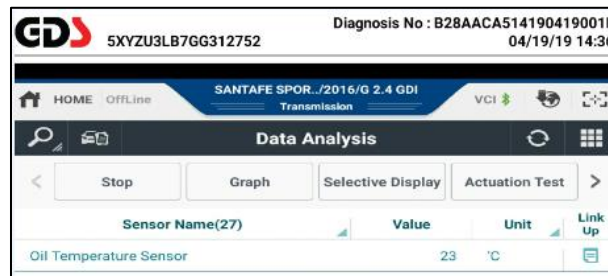
1. Attach a GDS and select **DTC Analysis** and **A/T** menu. Refer to the Santa Fe 2.0T shop manual and repair any DTC found.
2. Attach a GDS and select Data Analysis, A/T menu and Oil Temperature Sensor. Drive the vehicle when the ATF is cold (below 70°F or 21°C).

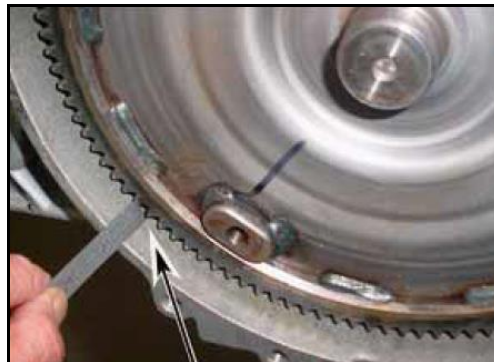
Specification: 0.39~0.51 in. (10~13 mm)

3. If the transmission has a harsh 2-3 or 3-4 upshift at small accelerator pedal input (15~30% APS), but the issue does not occur after the ATF is warmed to normal operating temperatures (above 180°F or 80°C), refer to the 2019 Santa Fe Shop Manual and replace the torque converter.
4. Measure the depth of the torque converter in the converter housing. If the measurement is less than the specification, rotate the torque converter in either direction and push inward until the measurement is at specification.

Do not use an impact gun to force the transmission installation.
