Title Mack Chassis - LEU, MRU, LR - Frequent Requests For Regeneration, (Hourly To Daily); Possible High Soot Load Warnings And Fault Codes Or Accelerated Soot Accumulation - Previously Tech Tip TT-020-2015 - US10 And Newer (Includes GHG17 /US17, Common Rail) Emissions, Common Model Years 2011 And Newer

Mack Model LEU , LR , MRU - TerraPro

Emission Standard US10 , US10+OBD13 , US14 , US14+OBD15 , US14+OBD16 , US14 CNG , US17 , US17+OBD16 , US17+OBD18

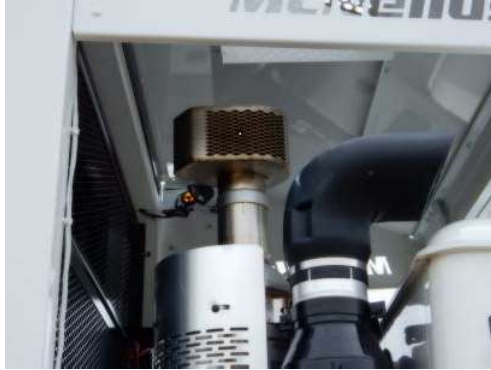
Correct

- One of the common causes of frequent regen requests is exhaust mixing with fresh intake air.
- The exhaust stack screen should be pointed outward, away from the vehicle. A screen that is turned to the front, the

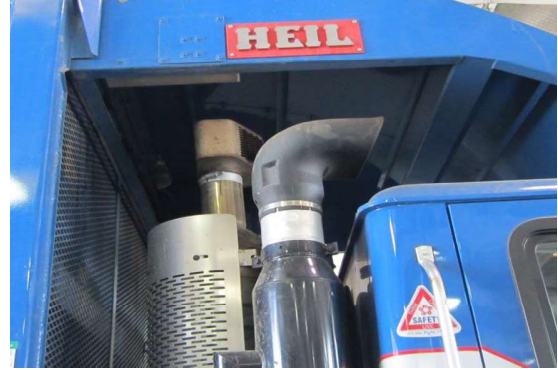
inward can cause a buildup of exhaust gases near the intake that can be pulled in with fresh air. The photos below provide examples of properly and improperly oriented exhaust screens:

Incorrect
