GLOBAL SAFETY FIELD INVESTIGATIONS  
DCS5101  
URGENT - DISTRIBUTE IMMEDIATELY

Subject: N192263740 - Customer Satisfaction Program  
Loose Fuse Box Bolt – US Only

Models: 2018-2019 Chevrolet Low Cab Forward 3500/4500/6500XD MD

## N192263740 Loose Fuse Box Bolt – US Only

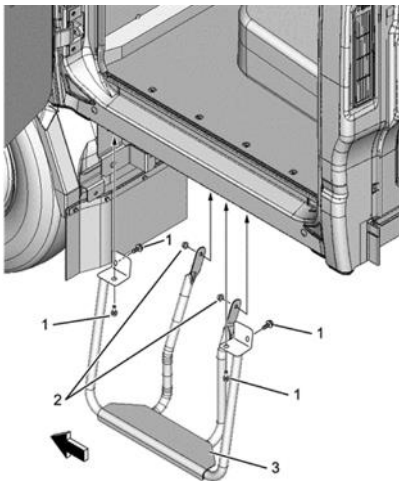
5374426

- (1) Bolt
- (2) Nut
- (3) Rear Step

- If equipped, remove the driver side rear step. See picture above. Refer to *Step Replacement* in SI. If not proceed to the next step.

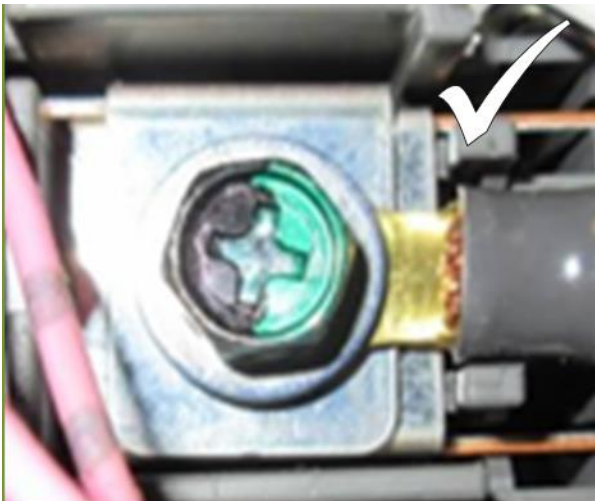
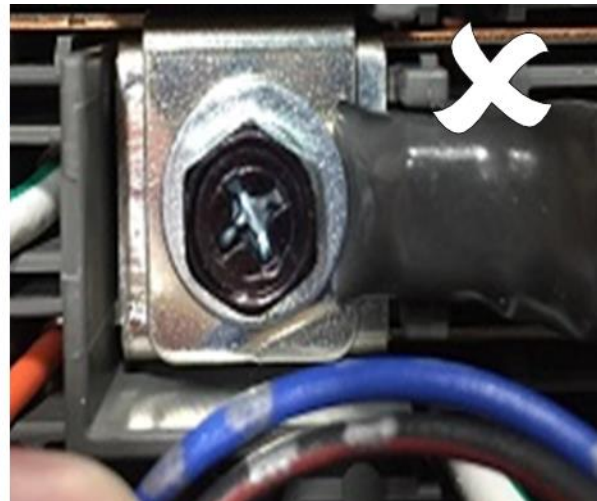
5374440

9. Inspect the wire terminal insulation for excess insulation. See picture above.

- If the insulation is not ok, proceed to step 10.
  - If the insulation is ok, proceed to step 11.
10. Remove the terminal bolt and lift the terminal away from the fuse box. Using a razor blade, carefully trim away any excess insulation as necessary. Then reinstall the bolt.
  11. Torque the power supply terminal bolt to 3.4 Nm (30.1 lb in.).
  12. Install the white inner fuse box cover.
  13. Install the rubber grommet and tape as necessary.
  14. Install the fuse box lower cover.
  15. Mount the fuse box onto the vehicle using the three 12mm bolts removed from step 5 and torque to 7.1 Nm (5.3 lb ft.).
  16. Install the fuse box cover.
  17. Install the driver side rear step if equipped. Torque to 18 Nm (13 lb ft.). See picture above. Refer to Step Replacement in SI.
  18. Install the negative battery cable. Torque to 6 Nm (53 lb in.).
