Service Bulletin

Bulletin No.: 18-NA-050

Subject: Information on Back Up Camera Display Does Not Cover Entire Screen

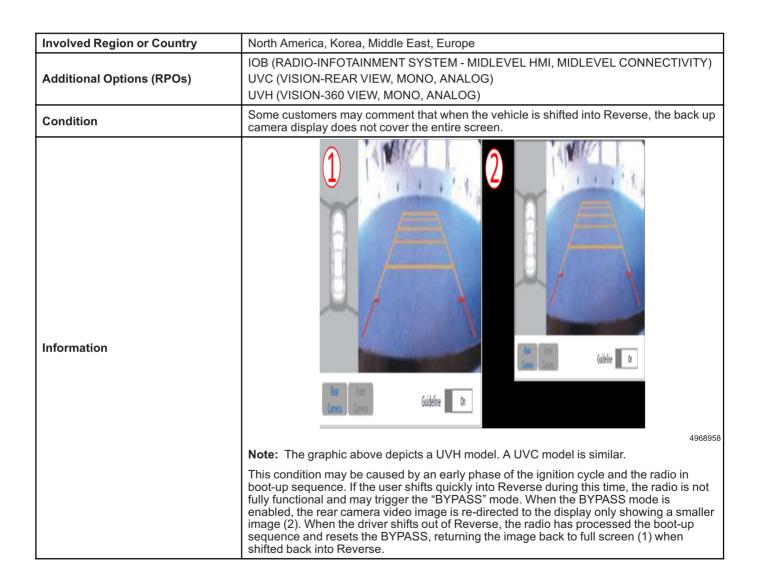
1060135

Note: The graphic above depicts a UVC model. A UVH model depicts an image of a car.

During full screen operation, some screens may display a blank area on the left side of the image. This design is intended to prevent any obstructed viewing past the steering wheel.

Do Not replace the radio for these concerns. Please communicate to the customer this condition is a normal operating characteristic of their vehicle. It will not impact the designed performance or reliability of the vehicle. Please share this information with the customer, including a copy of this message.
