Service Bulletin

Bulletin No.: 19-NA-167

Subject: Water Leak into Interior, and/or Various Electrical Concerns, Liftgate Actuator Noisy or Inoperative

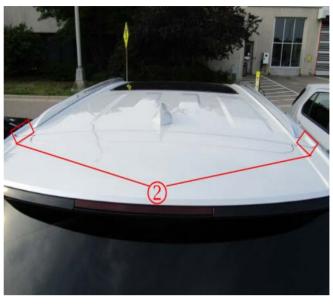
Possible Rear Laser Braze Water Leak Areas (2)

Involved Region or Country	North America, Russia, Israel, Palestine, Japan, South Korea, Europe, Middle East, Australia and New Zealand.		
Additional Options (RPOs)			
Condition	Some customers may comment on seeing water leak into the interior, or wet carpet. This condition could occur at either the front and/or rear, and on the right and/or left side. Some electrical concerns or issues may occur, such as power locks cycle or are inoperative after a car wash or rain in the XT5 and Acadia, or the liftgate actuator may be noisy or inoperative in an XT6.		
	The cause of the condition may be possible "pin hole" voids in the roof panel to outer ring laser braze and seam sealer. The pin holes are most commonly found near the top of the windshield at the A - pillars, or the top of liftgate near the D - pillars. Examples of the leak areas are shown below.		
	Possible Front Laser Braze Water Leak Areas (1)

Following the Service Procedure below, inspect the forward and rear laser braze corners of the roof ditch, at the upper windshield and rear liftgate areas.

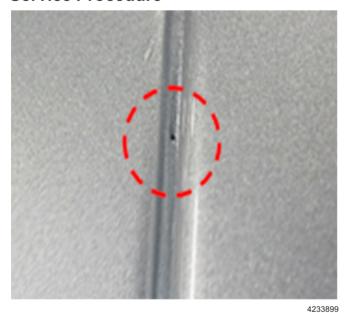
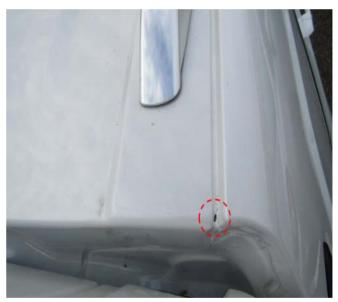
Note: The pin holes/cracks may be more difficult to see on darker color finishes. A front and rear example of a visible pin hole are shown in the graphics above.

- Visually inspect the front right and left roof laser braze, then the rear right and left roof laser braze, for pin holes or a crack.
- 2. Seal the holes/crack in any laser braze area following the steps below:
 - 2.1. Mix a small amount of *Kent Automotive High-Tech Clear Seam Sealer, P/N 10200 (5 oz tube), or equivalent, WITH the proper touch up paint color.
 - 2.2. Avoiding excess sealer build up within the ditch, work a small amount of the sealer into the hole with a gloved finger.
 - 2.3. Wipe away any excess sealer with a light amount of solvent on a rag or paper towel. The solvent will help the sealer flow into the hole/crack.
- 3. Clean and dry any wet trim. Refer to Floor Carpet Drying in SI.
- Address and repair any electrical concerns as necessary.
