Service Bulletin

Bulletin No.: 19-NA-168

Subject: Airbag Warning Lamp Illuminated in Driver Information Center (DIC), DTCs B0014 0E, B0021 0E Set

Brand:	Model:	Model Year:		Breakpoint:		Engine:	Transmission:
		from	to	from	to	Eligilie.	Transmission.
Buick	Encore	2018	2019				
Chevrolet	Trax

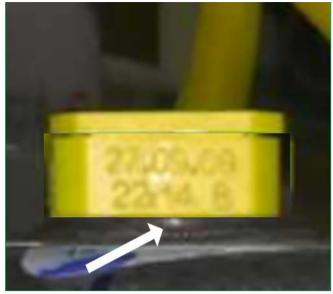
5380952

Involved Region or Country	North America and N.A. Export Regions		
Condition	Some customers may comment on the airbag warning lamp being illuminated in the Driver Information Center (DIC). Technicians may find DTCs B0014 0E, B0021 0E set.		
Cause	This condition may be caused by the driver's side airbag connector and CPA not being fully engaged, as shown in the graphic above.		
Correction	Remove the driver front seat outboard seat back airbag and re-seat the CPA clip for the airbag.

- Disconnect first, then reconnect the CPA clip fully for the front seat outboard seat back airbag, as shown in the graphic above.
- 3. Reinstall the driver front seat outboard seat back airbag. Refer to *Front Seat Outboard Seat Back Airbag Replacement* in SI.
