# Service Bulletin

Bulletin No.: 19-NA-173

**Subject:** Digital Engine Coolant Temperature Gauge Disappears Over an Ignition Cycle When in Track Display Mode

Brand:	Model:	Model Year:		VIN:		Engine:	Transmission:
		from	to	from	to		
Chevrolet	Corvette	2017	2017			All	All

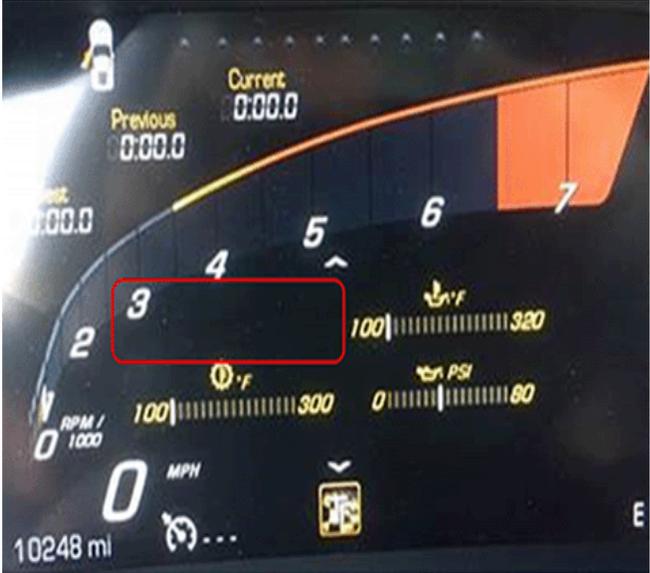
5258806

<b>Involved Region or Country</b>	North America, Japan, Europe, Middle East, Russia
<b>Condition</b>	<p>Some customers may comment that after the vehicle's ignition has been turned off for an extended amount of time, and the ignition has been turned back on, the Engine Coolant Temperature (ECT) gauge has actually disappeared from the Track display mode screen.</p>

<b>Cause</b>	The cause of the condition may be a software issue within the Instrument Panel Cluster (IPC).
