Service Bulletin

Bulletin No.: 19-NA-174

Subject: Rear of Headliner Sagging, Rear Edge Visible Through Rear Window

Brand:	Model:	Model Year:		VIN:		Engine:	Transmission:
		from	to	from	to		
Chevrolet	Camaro (Coupe only)	2016	2019			All	All

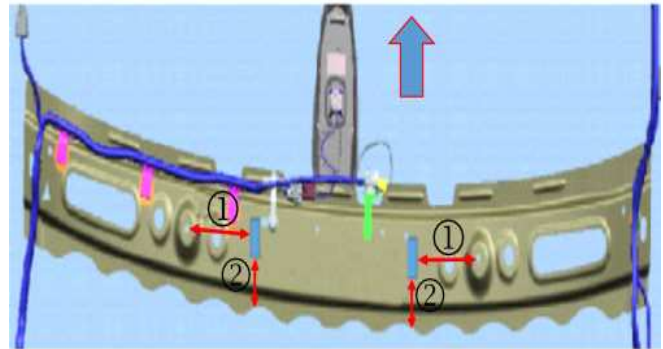
5381469

Involved Region or Country	North America, Europe, Russia, Middle East, Israel, South America, South Korea, China, Japan, Thailand
Additional Options (RPOs)	Coupe Model only.
Condition	Some customers may comment on the headliner sagging, and the rear edge of the headliner is visible through the rear window.
Cause	There may be various causes for this condition.
Correction	Following the steps in the Service Procedure below, add magnets to the rear of the headliner.

- 2.2. Position the tape edges at the locations dimensioned off of the rear crossmember in the graphic above. 153 mm (6.0 in) (1) inboard of the CENTER hole location and 51 mm (2.0 in) (2) from the rear edge of the crossmember.

- 2.4. Apply the hot glue to each magnet, then press the magnets to the headliner at both tape edge mark locations.
- 2.5. Allow the glue to cure for a few minutes before repositioning the headliner and securing the magnets to the roof sheet metal.
3. Reinstall the headliner and any trim removed. Refer to the appropriate *Headlining Trim Panel Replacement* in SI.
4. Reposition the rear seat back.
