Service Bulletin

PRELIMINARY INFORMATION

Subject: Diagnostic Tips for Reduced Acceleration at Low Speed and/or Transmission Slipping from a Launch, DTC P0751 Set

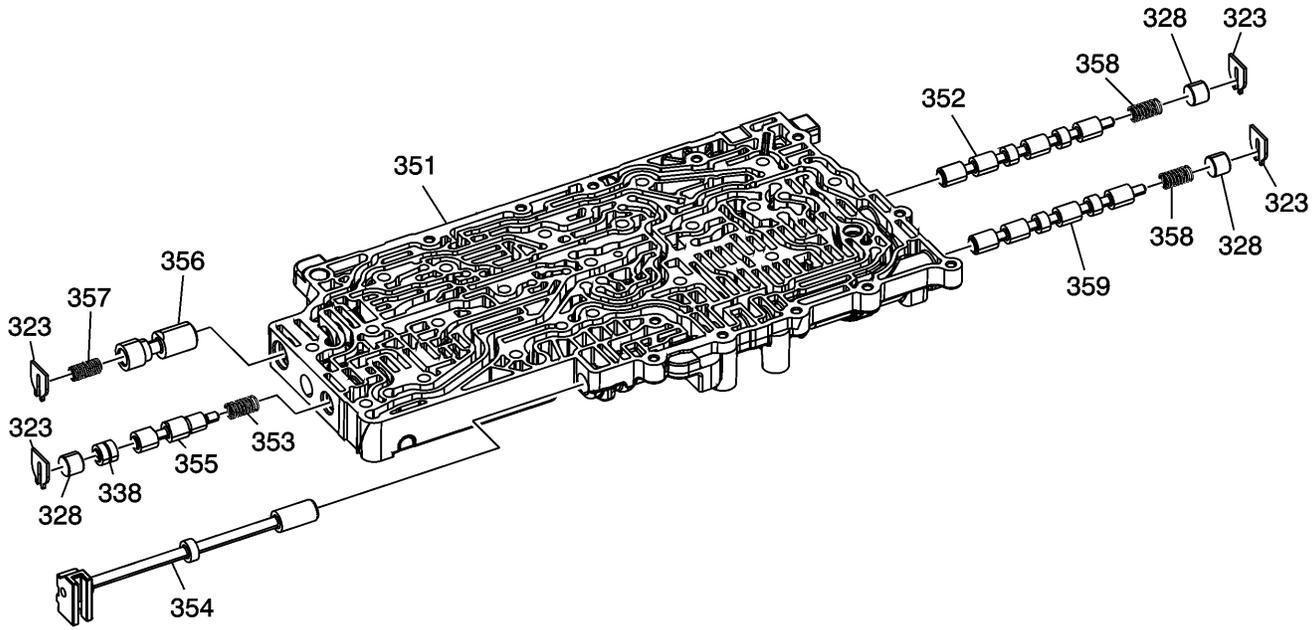
This condition may be caused by the Clutch Select Solenoid Valve 2 (359), located in the lower valve body, sticking in its bore resulting in a 4th gear start.

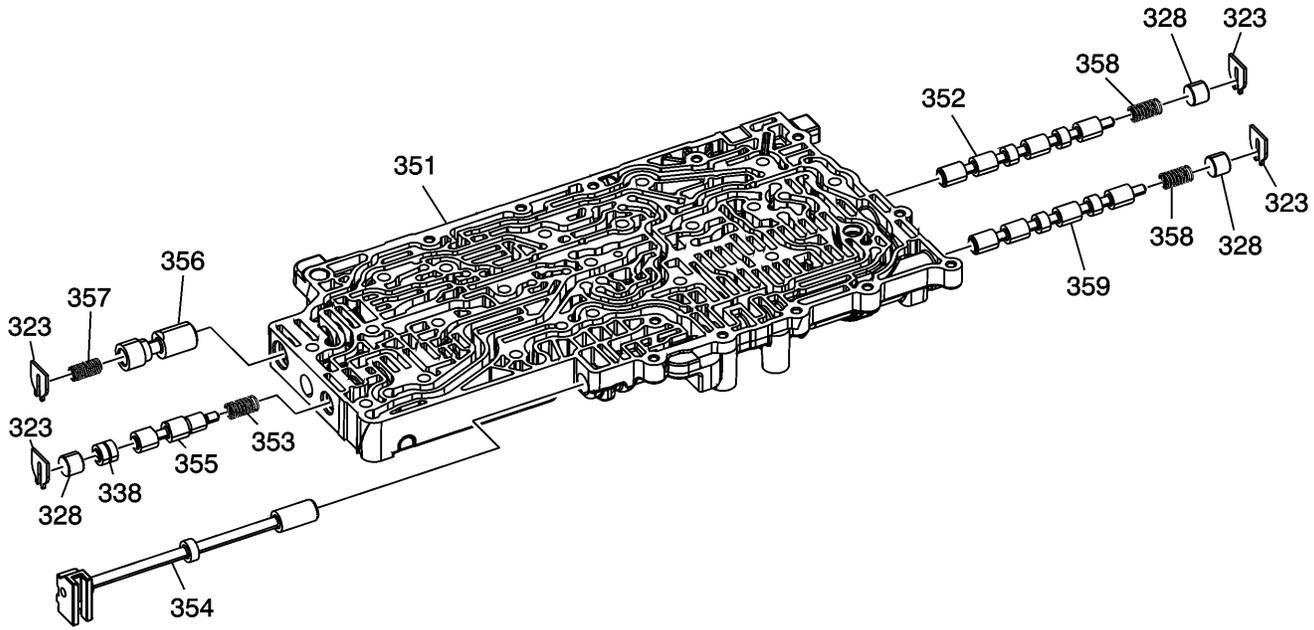
During inspection of the Clutch Select Solenoid Valve 2 (359), the valve may or may not be stuck in the bore due to the valve body bolts being loosened.

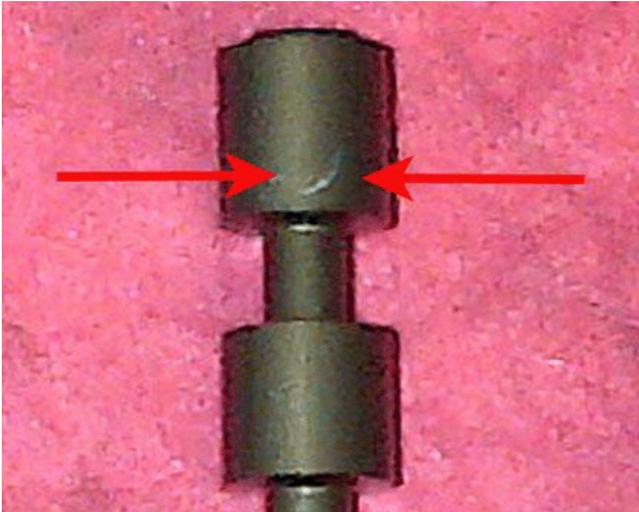
The recommended inspection procedure is to remove the valve and inspect it for any scratches on the valves. The illustration above shows an example of a valve with a scratch mark on it. If the valve is stuck in the bore or shows signs of scratching or damage, the lower valve body should be replaced.
