Technical Service Bulletin Notification TSB #19-030

Battery Merge Solenoid Replacement

Bulletin Type:	TSB Technical Service Bulletin	Publication Date:	July 2019
Bulletin #:	19-030	Make(s):	Entegra
Job Code:	9803437	Model(s):	Anthem / Cornerstone
Flat Rate:	1 hour	Model Year(s):	2020

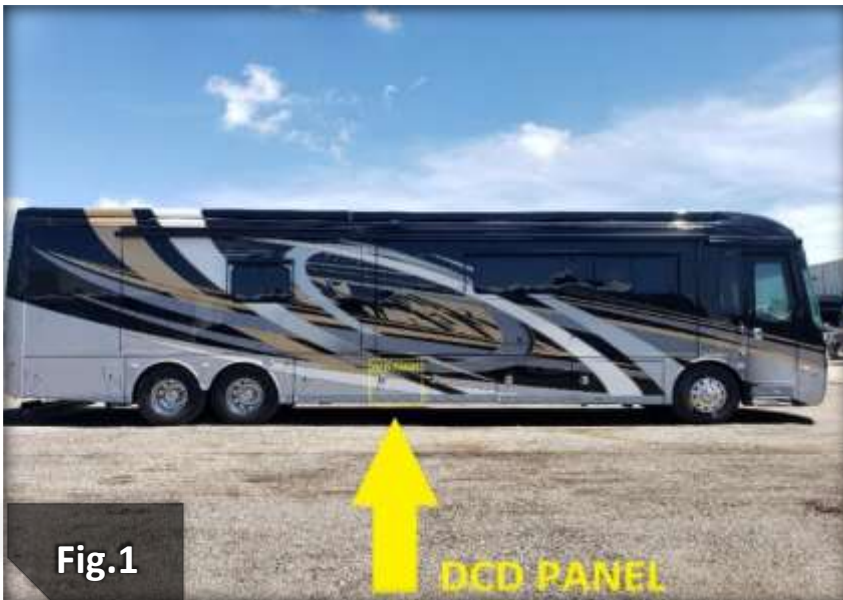
Fig.1

FIG 1:

- Locate the DCD Panel on the coach.
- DCD Panel is located the fourth bay back from the entrance door.

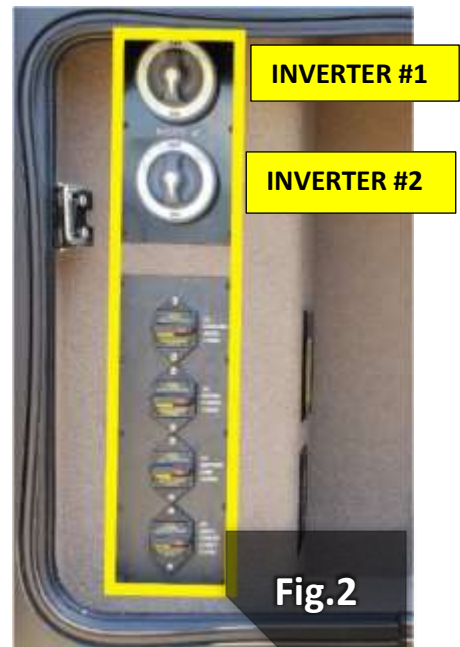
Fig.2

FIG 2:

- Inverter shutoff switches and breakers are located in the same bay as the DCD Panel.

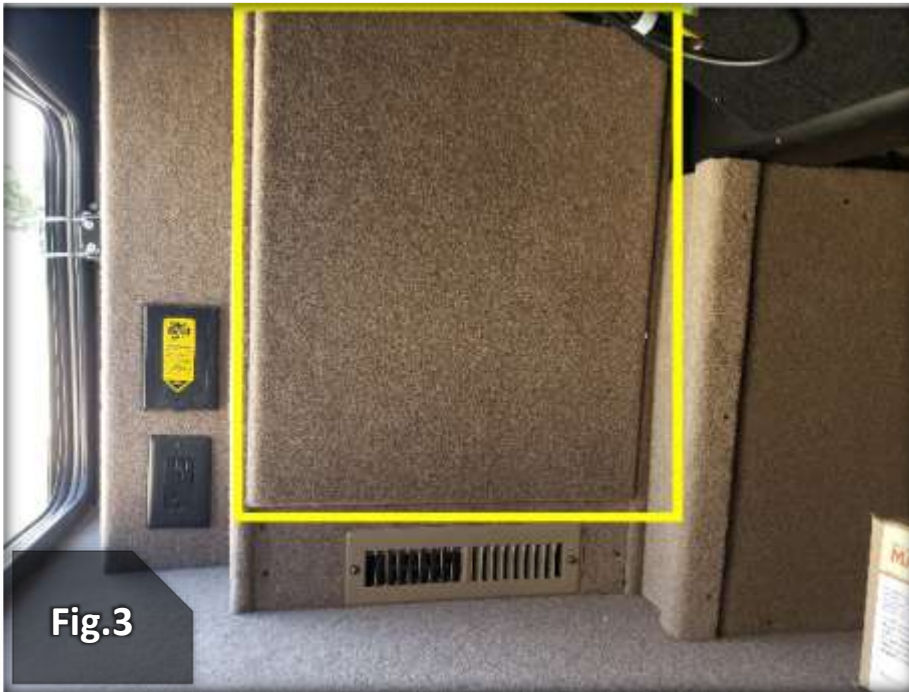
Fig.3

FIG 3:

- **POWER MUST BE DISCONNECTED BEFORE CONTINUING!**
- The DCD Panel is located behind a false carpeted panel.
- False panel is held in place with velcro, simply pull it away to remove it.

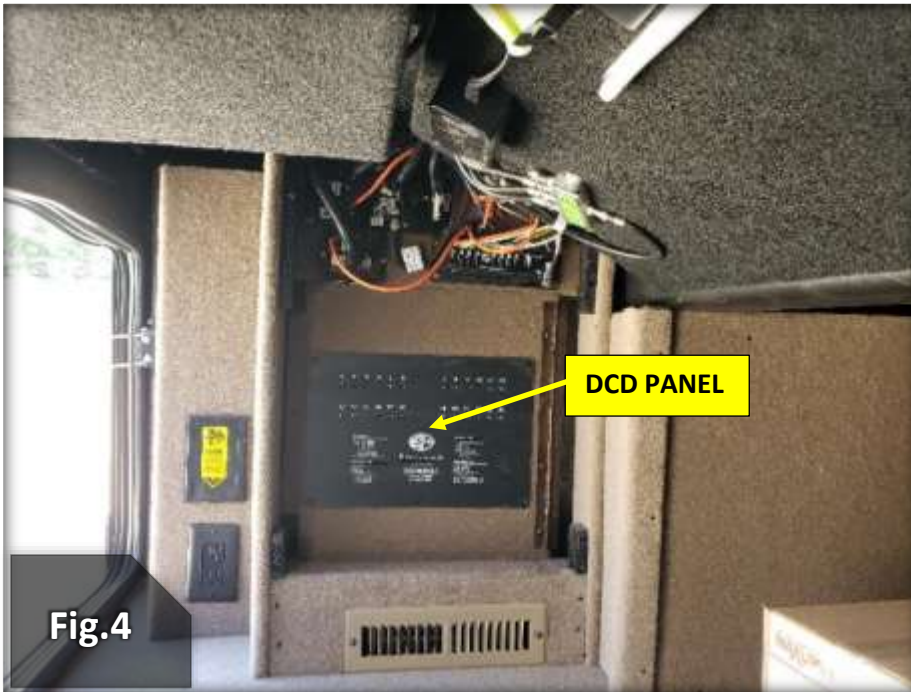
Fig.4

FIG 4:

- DCD Panel with the cover removed.

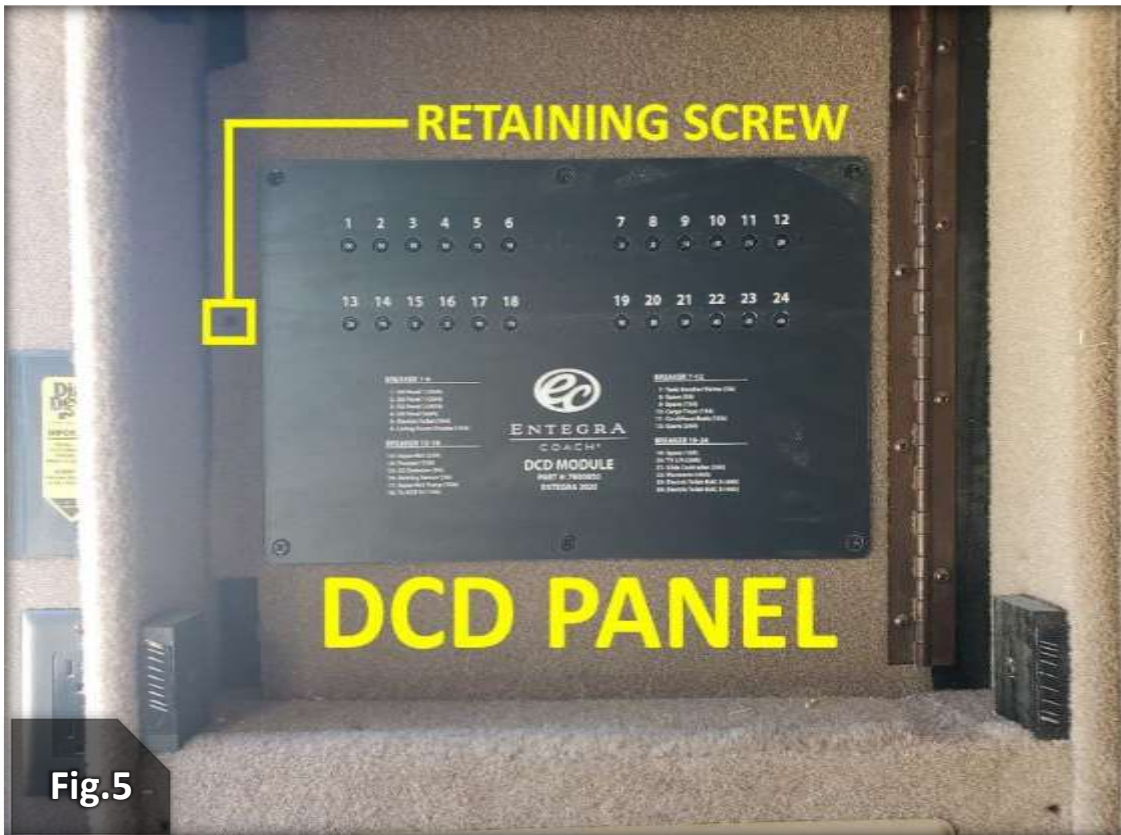
Fig.5

FIG 5:

- Remove **ONLY** the single retaining screw (square bit) holding the DCD Panel door closed.
- The panel is hinged and will swing out so you can access the back side.
- **DO NOT REMOVE ANY SCREWS HOLDING THE PANEL TO THE WALL.**

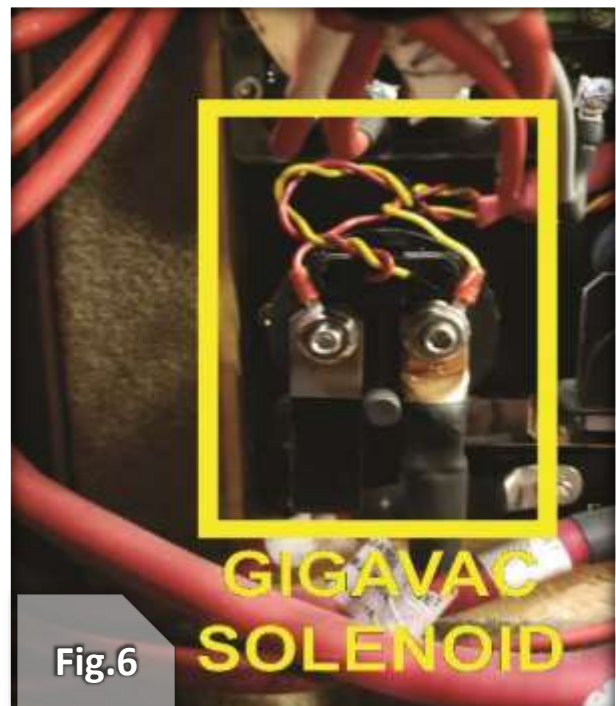
Fig.6

FIG 6:

- Locate the Gigavac Solenoid on the back side of the DCD Panel.
- Take note of cable and wire colors on the Gigavac Solenoid as they will need to be removed and re-installed on the new Solenoid in the same positions further on in the instructions.

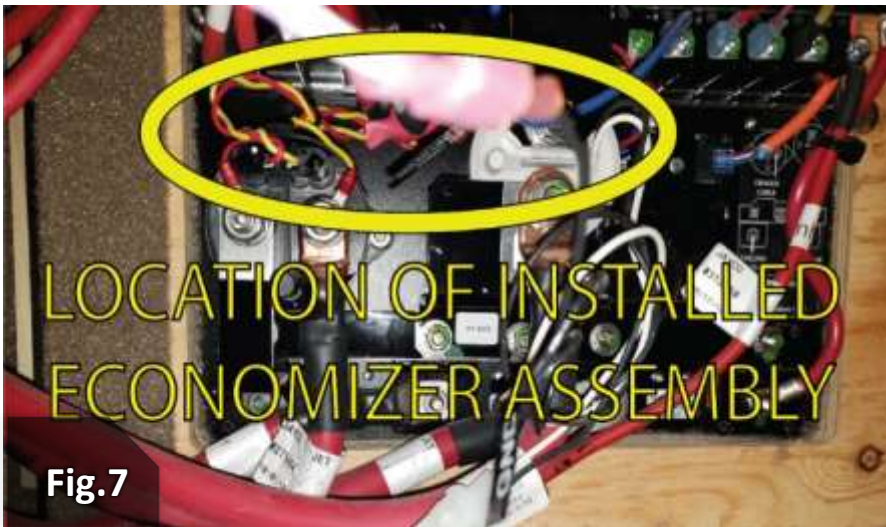
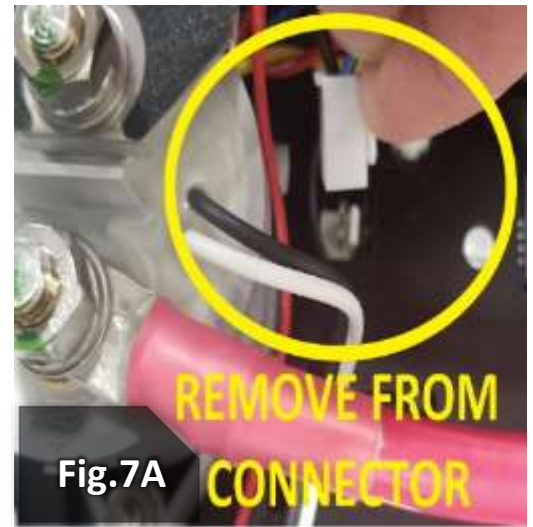
FIG 7 & 7A:

- Locate the Economizer assembly (**Fig 7 & 8**).
- Unplug the white connector (with Black, Red, Blue wires) from the DCD Panel (**Fig 7A**) (this connector will be re-installed later in the instructions)
- Unplug the black header from the top of the Gigavac Solenoid.

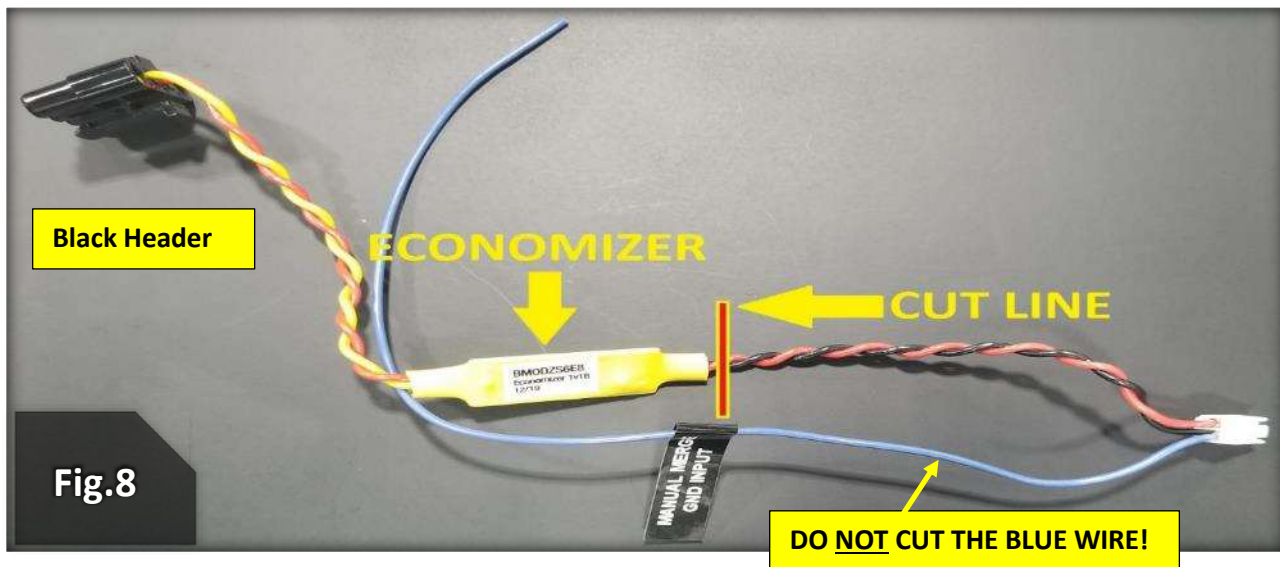
FIG 8:

NOTE: The Economizer assembly may have a different color shrink wrap that what is pictured in **Fig 8**.

- On the opposite side of the black header, cut the Red and Black twisted pair of wires (**DO NOT CUT THE BLUE WIRE!**).
- Ensure the cut is as close to the Economizer as possible to allow maximum wire length.
- The black header with the Economizer attached may be discarded.

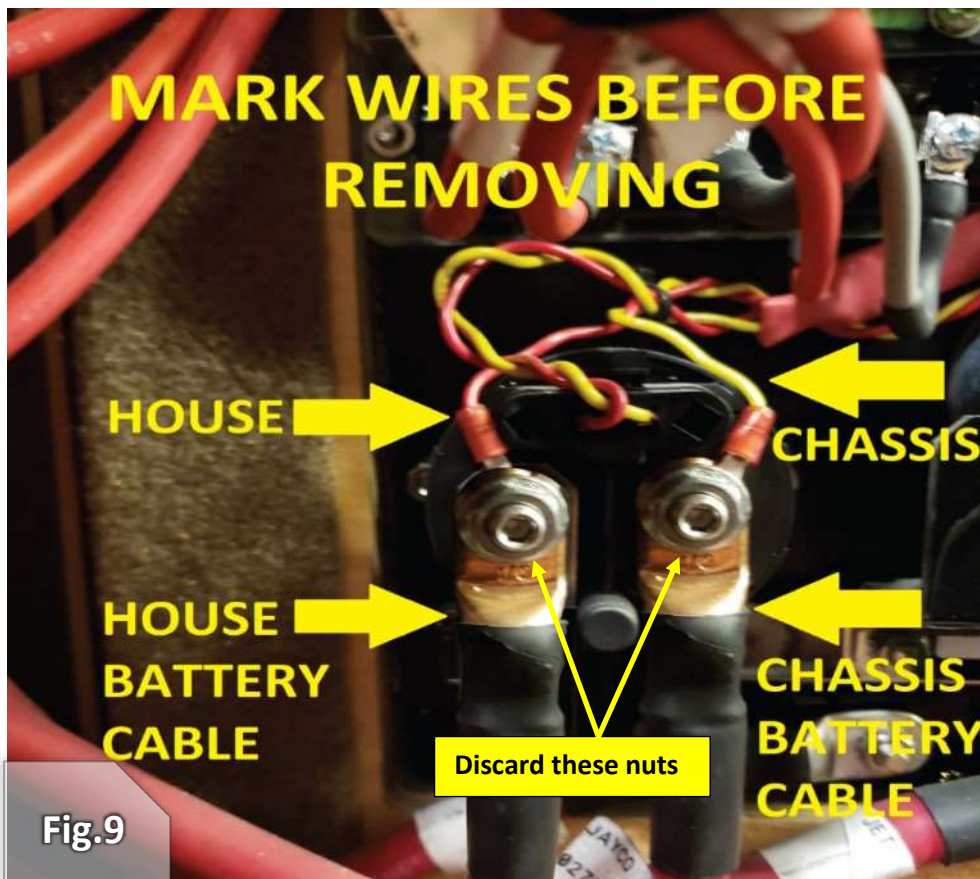
Fig.9

FIG 9:

- **ENSURE CIRCUIT BREAKERS ARE TURNED OFF BEFORE THIS STEP!**
- Mark and then remove Chassis and House sense wires (Red & Yellow wires) from the top of the Gigavac Solenoid.
- Mark and remove Chassis and House battery cables.
- Discard the nuts previously used to secure the House and Chassis terminals (**Fig 9**).

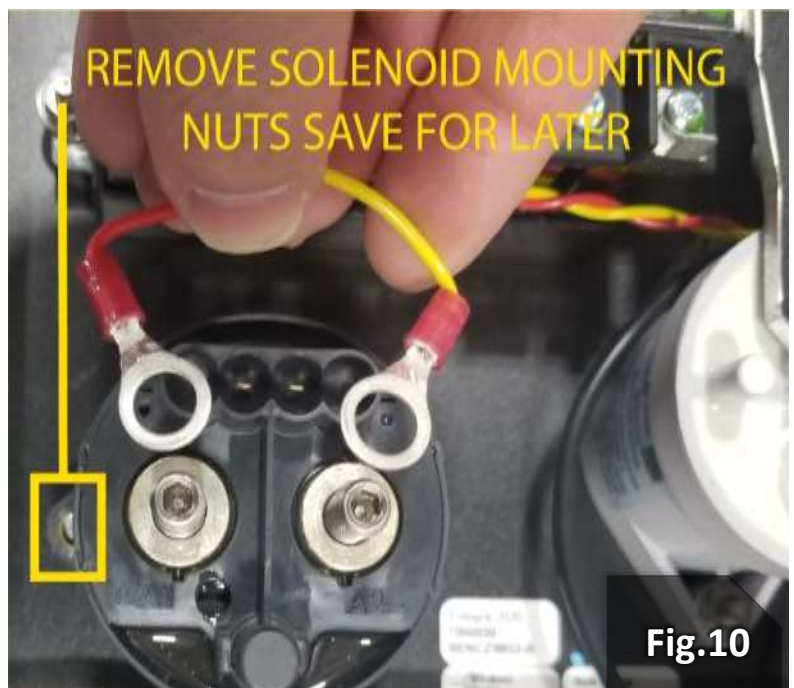
Fig.10

FIG 10:

- Remove the old Gigavac Solenoid from the panel.
RETURN THE OLD SOLENOID TO JAYCO. There are 2 nuts securing it to the panel. (Refer to rectangular box with yellow line pointing to one of the nuts)

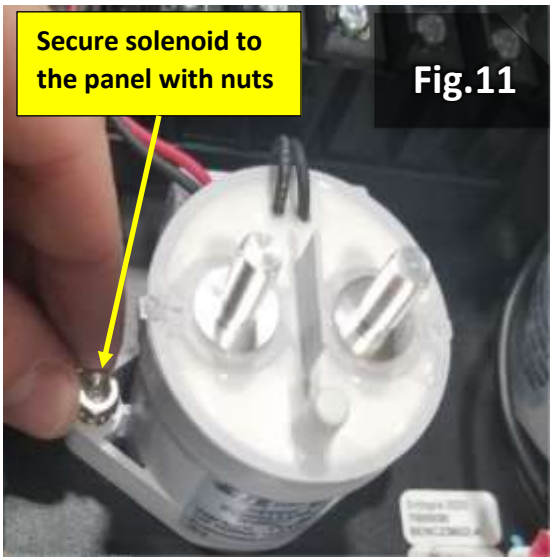
FIG 11:

- Install the new TE Solenoid from the kit, and secure with nuts that were previously used to secure the Gigavac Solenoid to the panel.
- TE Solenoid should be installed exactly as shown with the 2 pairs of wires positioned at the top.

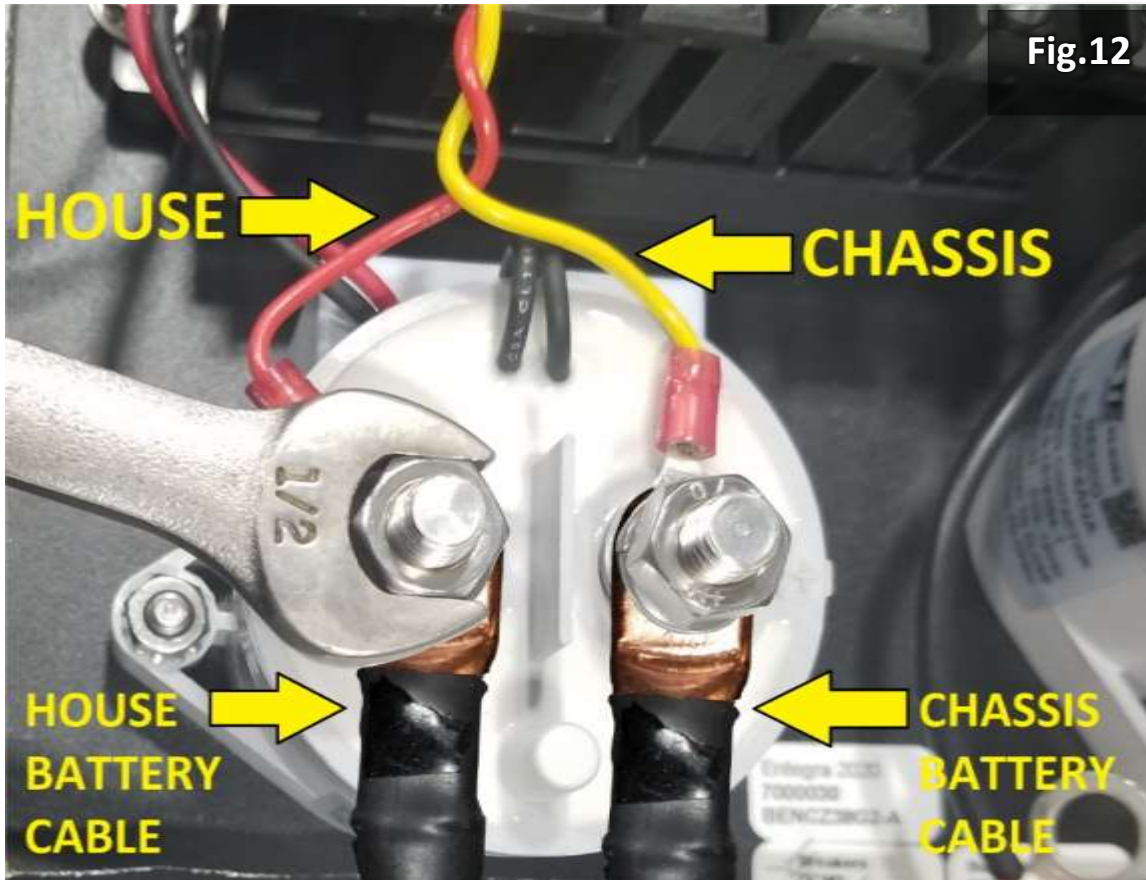
FIG 12:

- Install the House & Chassis battery cables first on the proper solenoid terminals.
- Then install the House (red wire) & Chassis sense (yellow wire) on the proper terminals.
- Use the new hardware provided with the new TE solenoid:
- Install the washers on the solenoid terminals.
- Install the nuts on the solenoid terminals.
- Tighten the nuts using the wrenches.

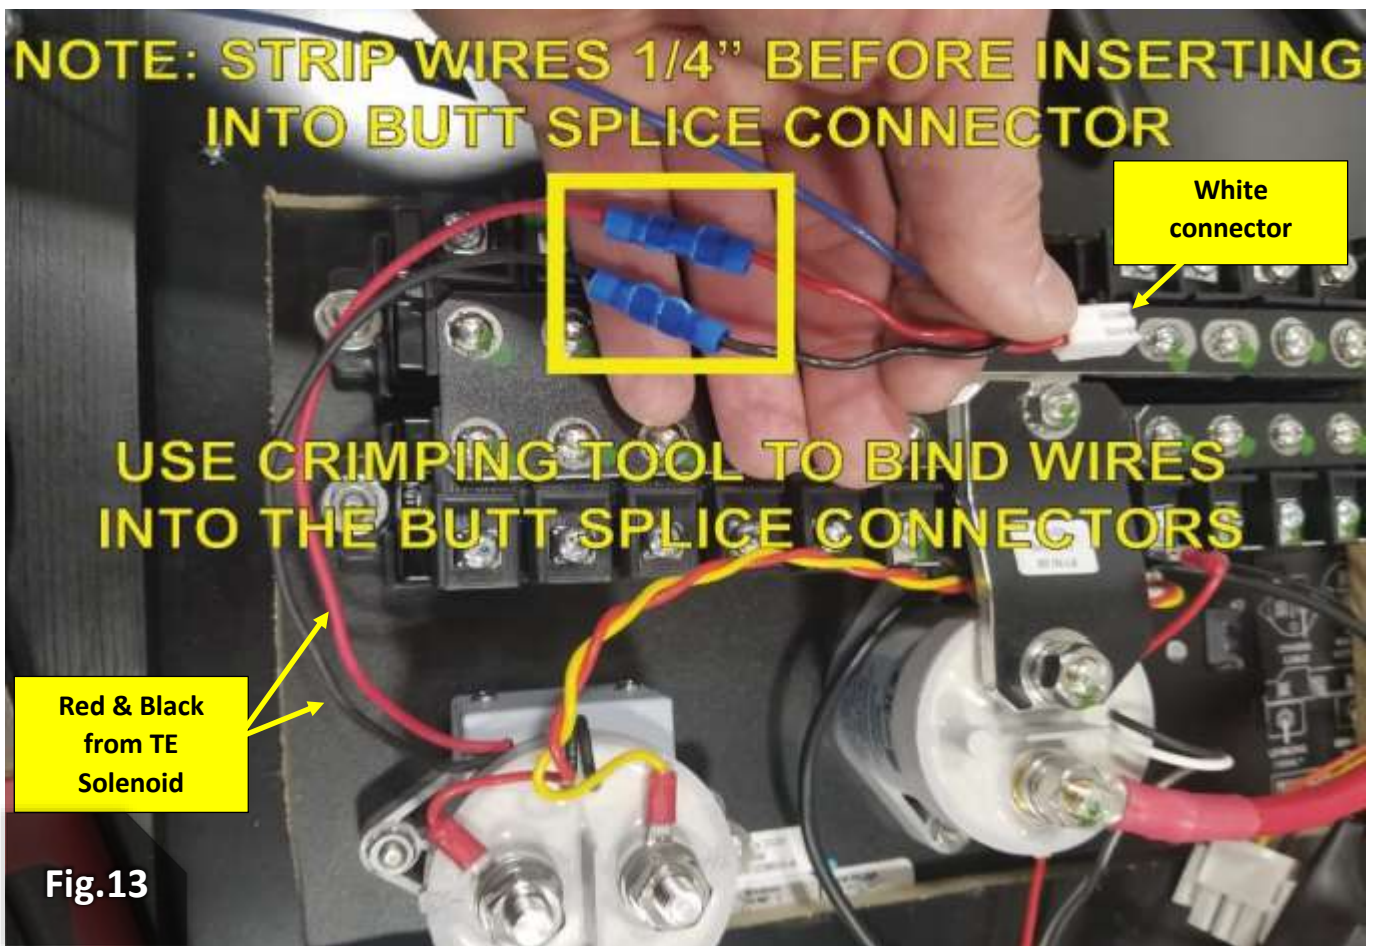
FIG 13:

- Strip the following wires 1/4":
- Red & Black wires from the TE Solenoid.
- Red & Black wires from the white connector (**From Fig 8**)
- Crimp the black wire from the TE solenoid to one end of a butt splice connector.
- Crimp the red wire from the TE solenoid to one end of a butt splice connector.
- Crimp the black wire from the white connector to the other end of the butt splice connector with the black wire attached.
- Crimp the red wire from the white connector to the other end of the butt splice connector with the red wire attached.
- Wires should be connected: black to black, and red to red (as shown).

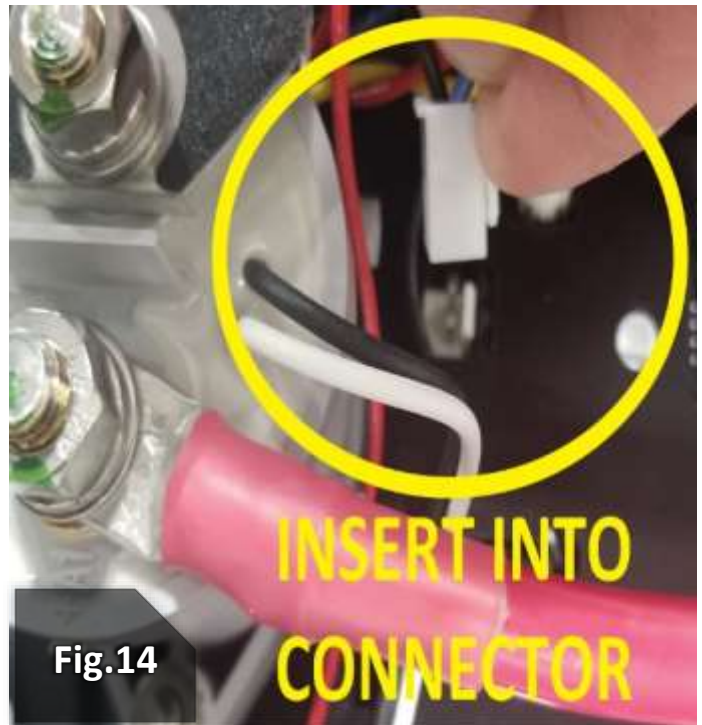
FIG 14:

- Insert the white connector (with the Red, Blue, and Black wires) back into the header it was removed from in **Fig 8**. (circled in photo)
- Header is located next to the TE Solenoid. Make sure the connector is securely connected.
- Make sure the Manual Merge Ground Input (Blue wire) is still connected to ground.
- Secure any loose wires, close the DCD Panel and reinstall the retaining screw.
- Replace the false panel back over the DCD Panel.

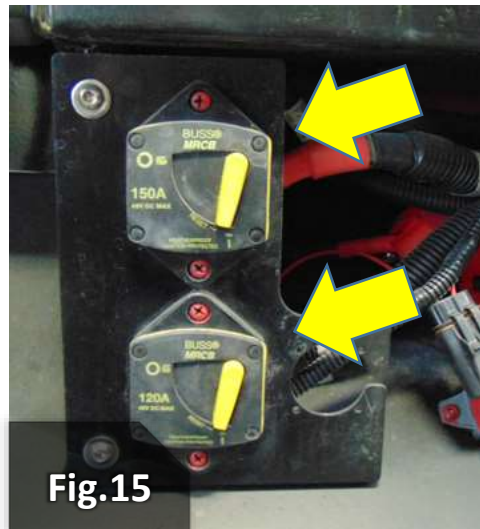
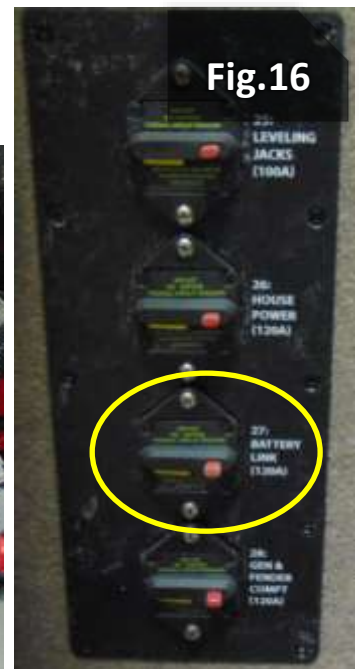
FIG 15 & 16:

- Turn power **ON** to the coach by performing the following steps.
- Open the last compartment on the entrance door side of the coach, there are two breakers (**Fig 15**).
- Turn both breakers **ON**. (120A and 150A) Breakers are shown **ON** in photo.
- Open the 4th bay back from the entrance door.
- Locate the row of 4 breakers (**Fig 16**).
- Turn **ON** the **BATTERY LINK** breaker which is circled in **Fig 16**.
- Turn the ignition **ON**.

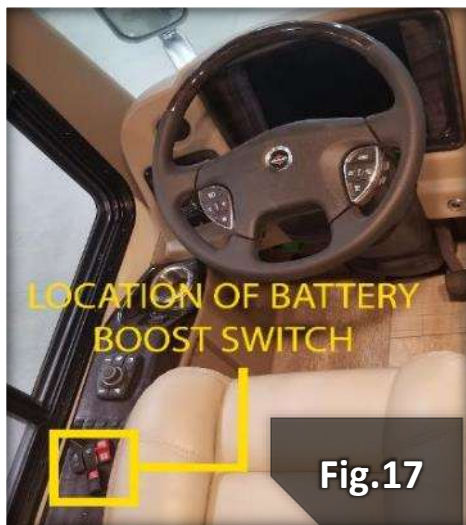
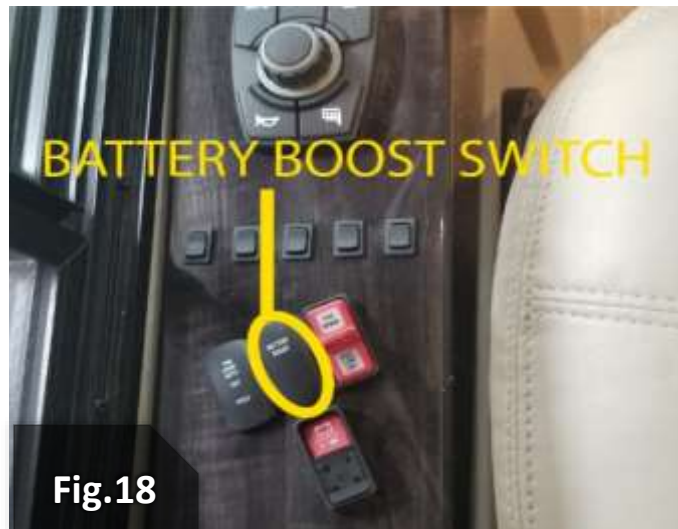
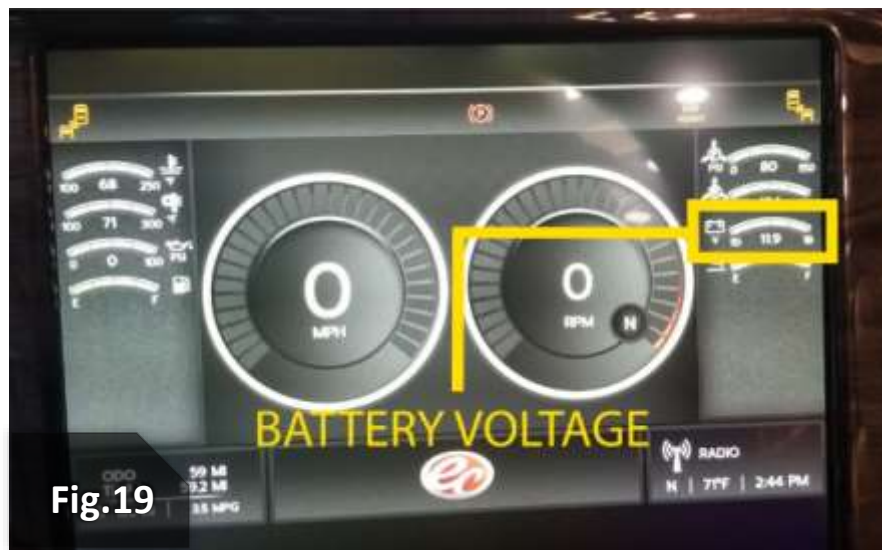
FIG 17, 18 & 19:

- Locate the **BATTERY BOOST** switch to the left of the driver seat.
- Locate the chassis battery voltage indicator to the right of the RPM gauge on the digital instrument panel screen (**Fig 19**).
- Take note of the voltage shown on the gauge.
- After noting the voltage, press and hold the **BATTERY BOOST** button (**Fig 18**) for a minimum of 30 seconds to verify the battery voltage changes.
- If the voltage changes, the merge solenoid is working correctly.
- Turn ignition **OFF**.
