Technical Service Bulletin Notification TSB #19-038

ANTENNA CABLE INSTALLATION

Bulletin Type:	TECHNICAL SERVICE BULLETIN TSB	Publication Date:	July 2019
Bulletin #:	19-038	Make(s):	Entegra
Job Code:	9803442	Model(s):	Qwest
Flat Rate:	1.3 Hours	Model Year(s):	2020

Incident:	GPS Antenna Cable omitted
Affected Units:	2020 Qwest L1ZL8051-8057, 8059-8062 L1ZK8051-8058
Parts Kit:	Antenna Cable
Misc. Tools & Supplies:	Screw gun with #2 square drive bit Staple gun Small flat blade screwdriver

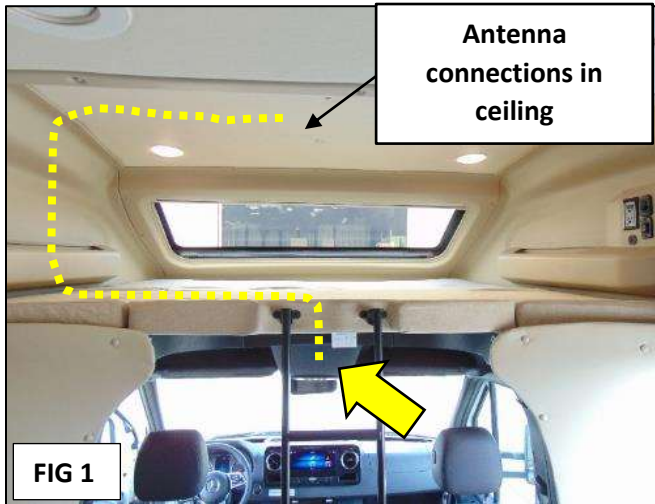
FIG 1:

- The antenna cable supplied in the kit, must be connected to the roof antenna connections which are behind the ceiling panel, and to the connectors inside the ceiling console (large arrow).
- Dashed line shows how the cable will need to be installed to reach the roof antenna.

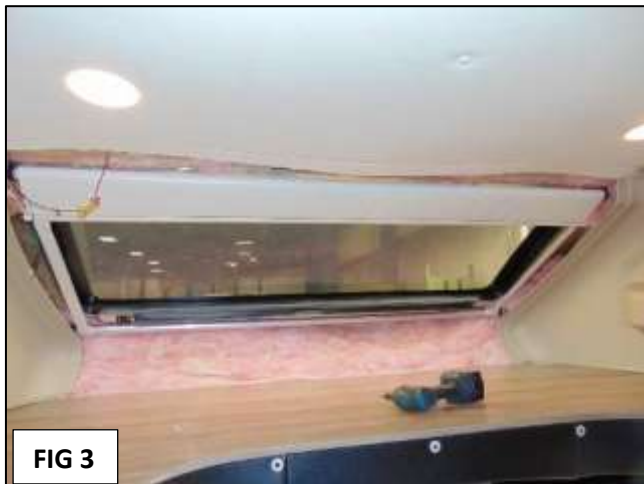
FIG 3:

- Front window surround removed.

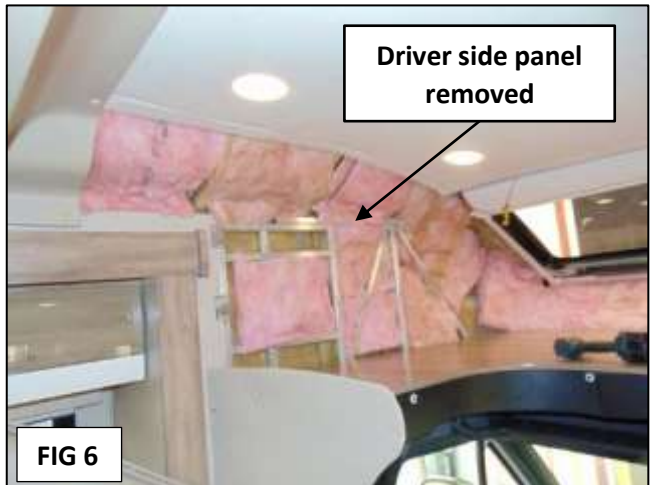
FIG 6:

- Driver side panel removed.

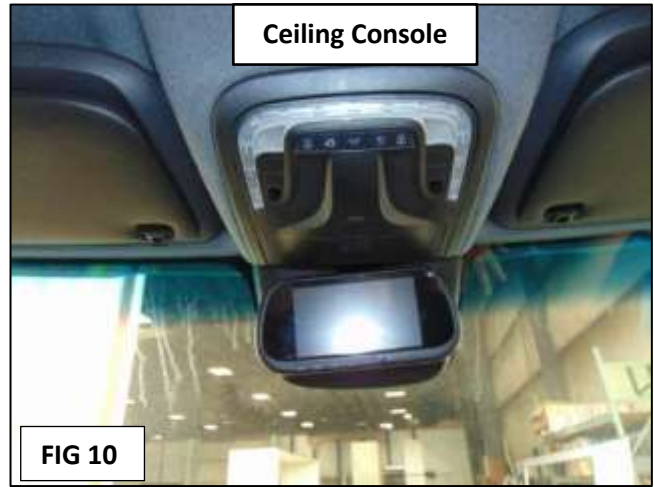
FIG 10:

- Ceiling Console between the visors.

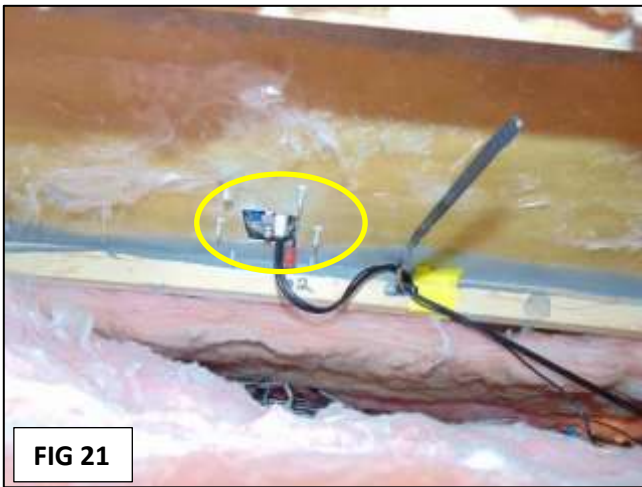
FIG 21:

- Antenna connection location in ceiling (circled).
- There is already one connection to the roof antenna plugged into a Black connector.

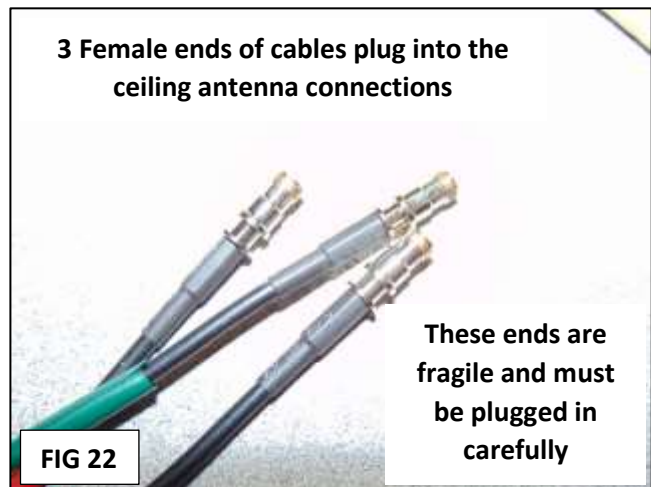
FIG 22:

- Female ends of the cables which plug into the antenna ceiling connectors (Fig 23).
- **NOTE: THESE CONNECTORS ARE VERY FRAGILE, CARE MUST BE TAKEN WHEN PLUGGING THEM IN.**
