| Title | Diagnostic Trouble Codes (DTC) P20EE And P103C, Diagnostic Procedure; <b>REPLACE S GUIDED DIAGNOSTICS IN PREMIUM TECH TOOL ( PTT ) - US17+OBD16 And Newer Chassis ONLY</b> |

| Cause | Procedures and checks to follow for P20EE and P103C on US17 and newer chassis. |

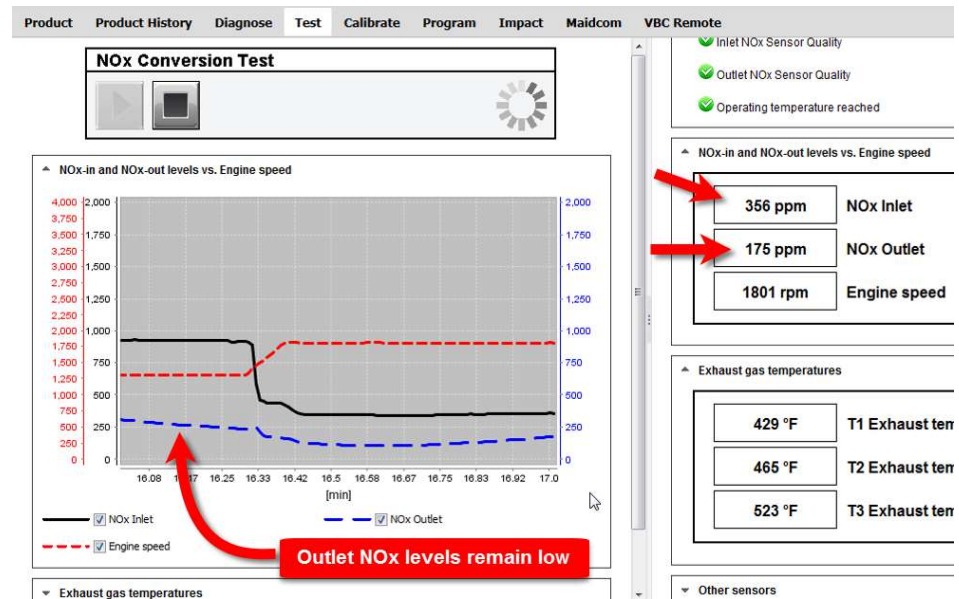
EMS Main Software Part Numbers 23470183 and 23470187, used for US17+OBD18 emissions, has a bug that allows DEF dosing to continue during the NOx conversion test. This causes continued low Outlet NOx sensor values as seen in the screen shot below and prevents

the desired behavior shown above.

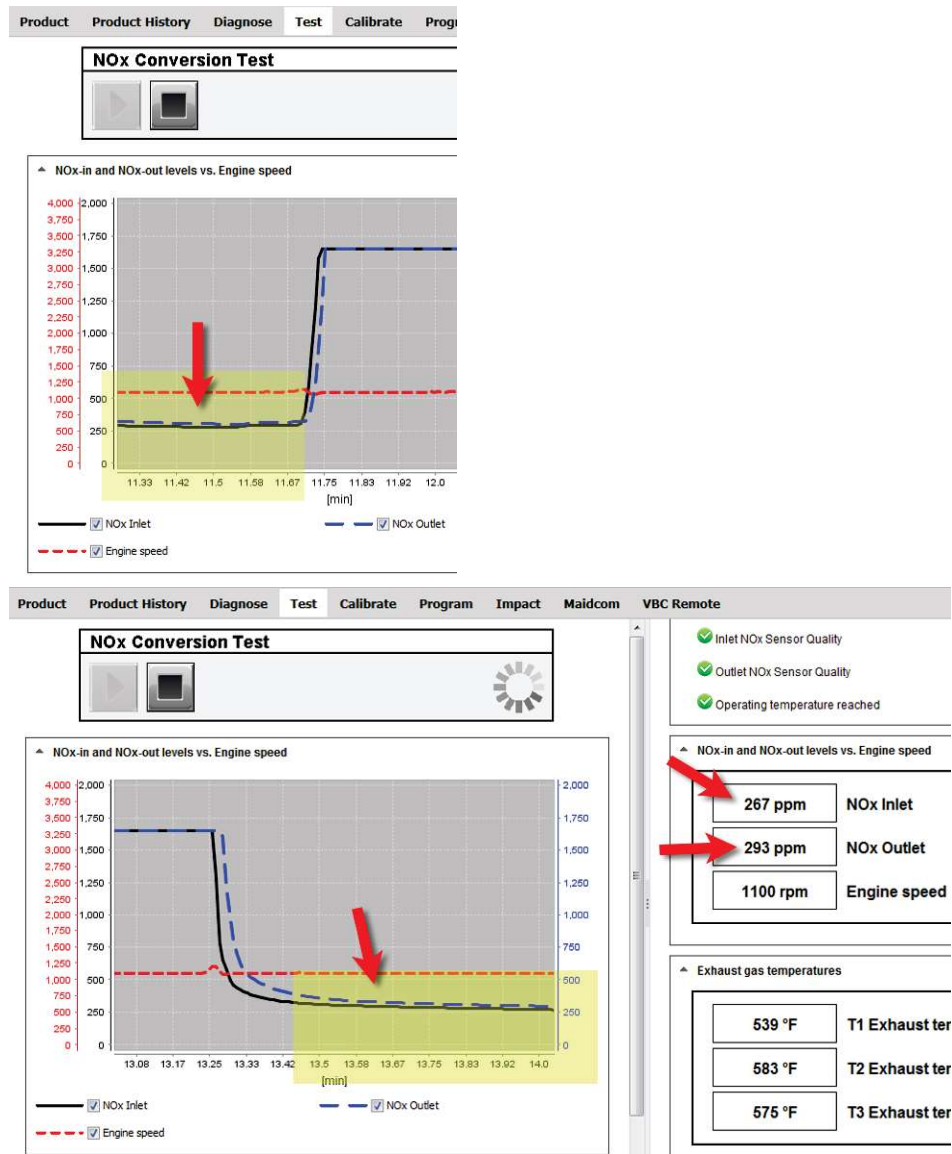
In this instance, review earlier sections of the test to ensure that both sensors are responding to changes in the same manner. Examples of different stages to review are shown below.

**COMPARISON SHOULD BE DONE WHEN BOTH NO<sub>x</sub> SENSORS ARE READING BELOW 600 PPM.**
