Latest Vehicle Concern Fixes

Coolant Leaks in AJ20P6 equipped vehicles

2019 RR Sport with AJ20P6

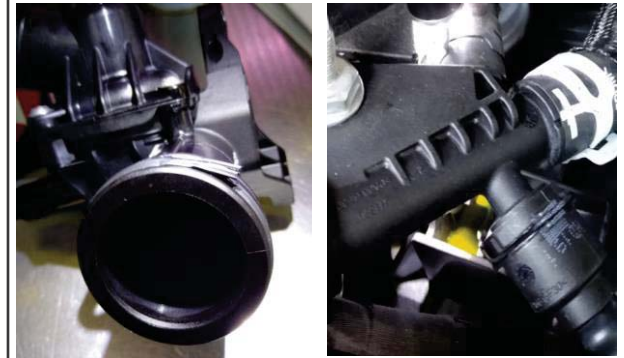
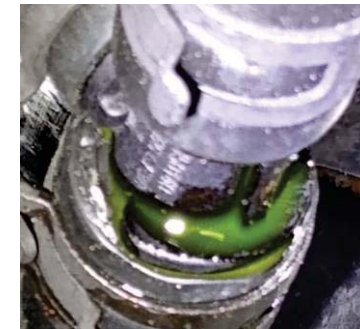
- A leak is identified from the engine cooling system.

- There have been reports of leaks from multiple locations in the engine cooling system at PDI or low TIS.
- It is essential that an EPQR is raised including clear pictures and/or videos of the leak and an image from TOPIx or EPC, if necessary, to identify location.
- Also include contact information for someone in the retailer who can support PRR in the EPQR.
