Latest Vehicle Concern Fixes

| Air Conditioning Not Cooling | Discovery 19MY |

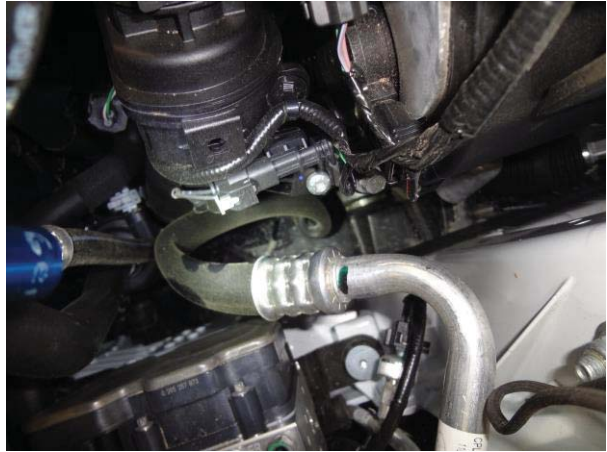
| Air Conditioning Not Cooling | Discovery 19MY |
|---|--|
| <p><u>Customer Voice:</u></p> <ul style="list-style-type: none">• Customers may report that the air conditioning system is not blowing cold air from the HVAC vents. <p><u>Technical Description:</u></p> <ul style="list-style-type: none">• This may be caused by a refrigerant line that has been kinked during manufacturing, restricting the flow of refrigerant around the system. <p><u>Status:</u></p> <ul style="list-style-type: none">• The process for installing the refrigerant line has been corrected in manufacturing with a containment VIN of K2413394.• A SSM is due to be published for this concern, providing repair guidance. | |
