Latest Vehicle Concern Fixes

Hood Release Lever May Become Detached

New Range Rover Evoque 20MY

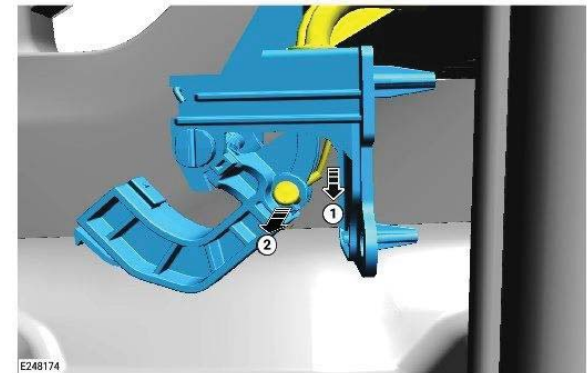
- A customer may express a concern that the hood release lever has become detached during operation.

- This may be caused by insufficient fastening of the hood release lever.

- A revised lever assembly has been developed to address this concern.
- TSB LTB01303NAS1 will be published once sufficient part stock is on hand of the revised lever assembly.
- Should a customer express a concern, please refer to the TSB for repair guidance.
