Latest Vehicle Concern Fixes

Outer Tail Lamp Water Ingress/ Lenses Cracking

New Range Rover Evoque 20MY

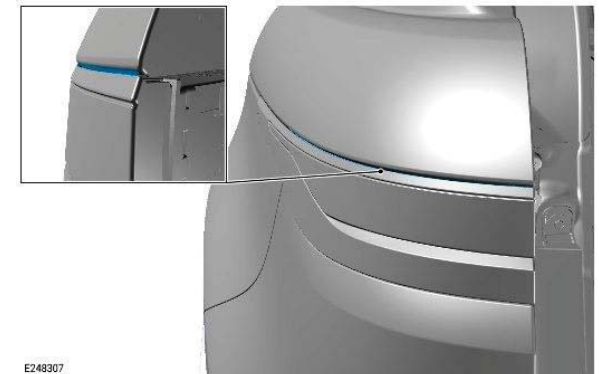
- A customer may express a concern of moisture in the outer tail lamp or cracking of the outer tail lamp lenses and or a squeak type noise from the rear of the vehicle while driving.

- This may be caused by an insufficient gap between the outer tail lamp and the rear quarter panel.

- TSB LTB01304NAS1 is being published to provide outer tail lamp to body clearance checks and adjustment procedures.
- Should a customer express a concern, please refer to the TSB for repair guidance.
