Service Information Bulletin

B41 03 19

Streaks/blisters in the carbon fiber roof after removal of the Bodyguard film

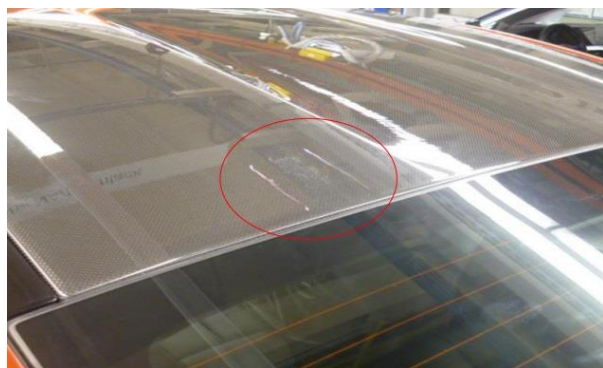
Streaks or blisters are present (circled) in the carbon fiber roof.

Note: Streaks or blistering will only be present on newer vehicles, shortly after the Bodyguard® film is removed from the roof.

Due to environmental influences, moisture can become trapped between the carbon roof and the Bodyguard® protective film used during new vehicle transportation and storage.

If these streaks or blisters do not disappear naturally in 48 hours, heat-treat the carbon fiber roof to evaporate residual moisture.

1. Expose the vehicle to direct sunlight (in summer months); or
2. Store the vehicle inside at room temperatures above 73°F.

3. Heat up the affected area slightly using a hot air blower.

Note: When using a hot air blower, the surface of the carbon fiber roof **must** be monitored using a thermometer. The surface temperature of the roof must reach at least 104°F, **but must not exceed 140°F. The hot air blower must remain at least 8 inches from the surface of the carbon fiber roof.**
