# Service Information Bulletin

B51 20 19

## Rattle noise from tailgate

| Engineering Designation | Model Description |
|---|---|
| G32 | 640i xDrive Gran Turismo |

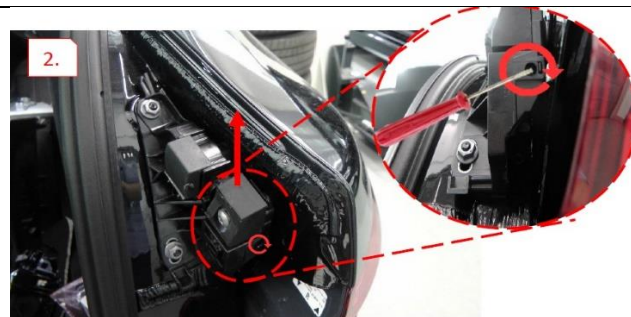
A rattle noise is present in the area of the tailgate while driving.

The tailgate stop is improperly adjusted.

2. Turn the adjustment screw clockwise  $\frac{1}{2}$  turn to raise the adjustment stop.

Raising the stop adds a slight amount of pre-load to the tailgate, which should stop the rattling sound.

3. Re-test the vehicle before installing the water channel.

**Yes:** Turn the adjustment screw an additional ½ turn and retest.

Note: Make adjustments in ½ turn increments until the noise is no longer present. Do not adjust more than ½ turn before retesting.
