CREASES/RIPPLES IN THE 2ND ROW 60/40 BENCH SEAT BACKREST SYNTHETIC LEATHER COVER

G05 (X5 Sports Activity Vehicle)	G07 (X7 SAV)
----------------------------------	--------------

GRUSB5219-30

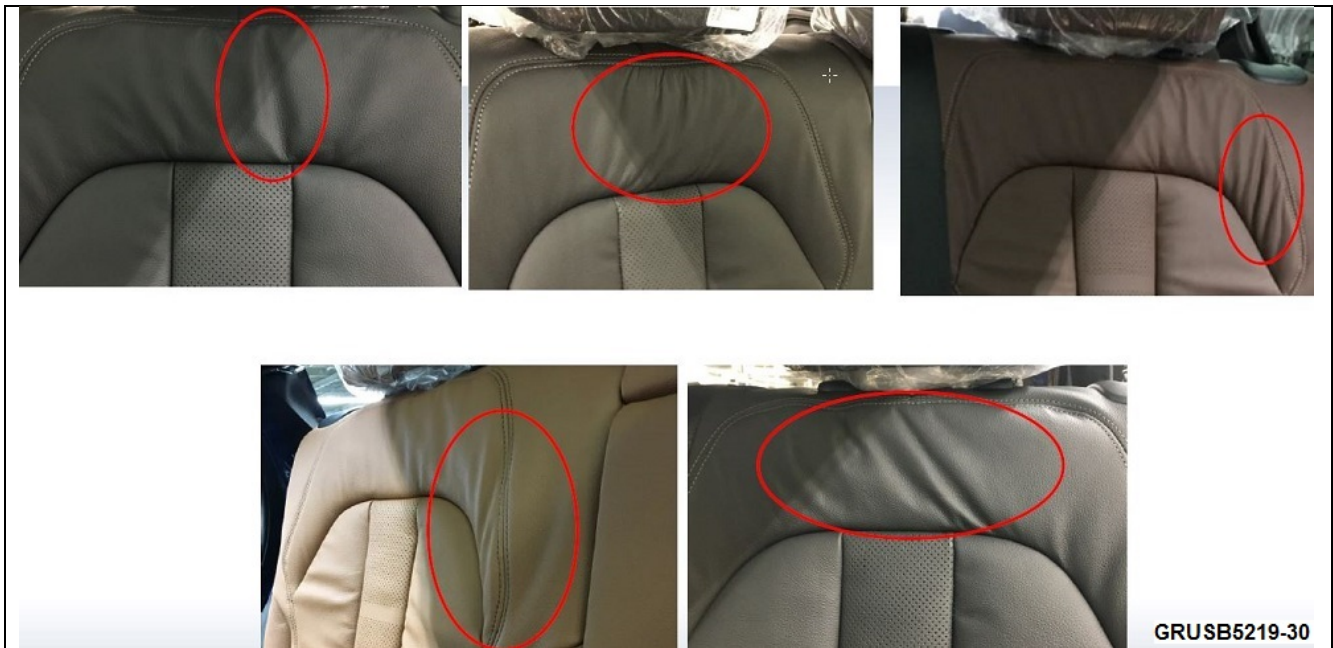
There are creases/ripples in the leather upholstery of the upper part of the backrest for the 2nd row of seats. This only applies to the 60/40 bench seat.

To address customer complaints that the leather was too tight & uncomfortable on previous models, the G05 and G07 incorporate a looser fit of the leather to improve long distance driving comfort.

However, in this particular area of these seats, the leather was cut slightly oversize. This excess material can cause creases and ripples.

Install a layer of foam in this one area of the seat(s). To repair both sides of the 2nd row seat you will need 2 pieces of the foam.

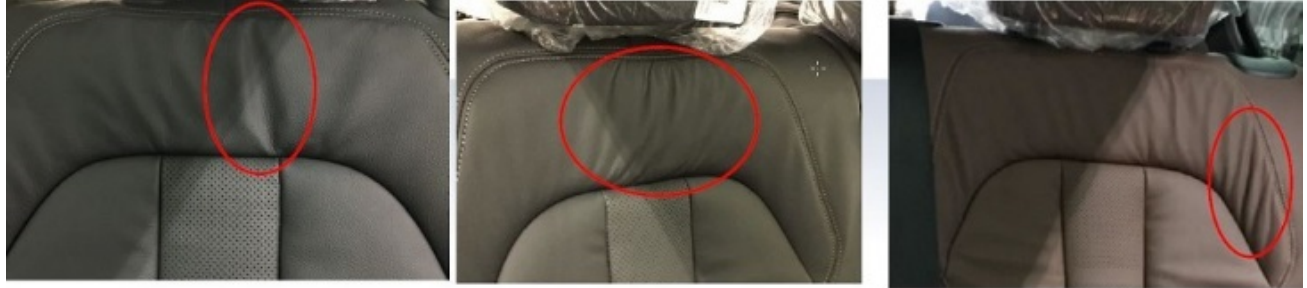
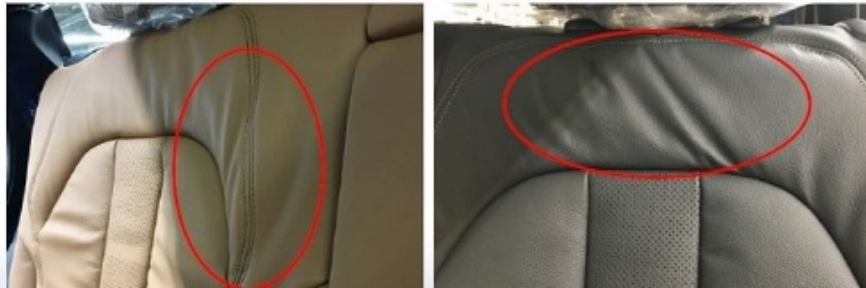
Check if the looseness in this area exists as per these images.

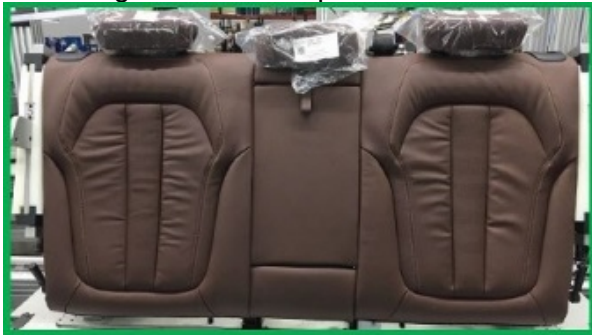
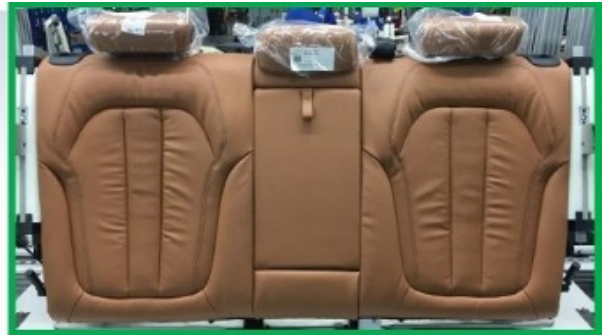
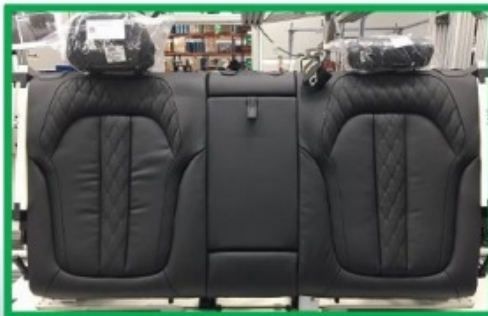
This image shows examples of the backrest after the foam installation.
