Technical product information

Topic	Bentayga W12 TSI - Engine hesitates and jerks during acceleration
Market area	Bentley: worldwide (2WBE),Hongkong-Macau (5HK)
Brand	Bentley
Transaction No.	2055535/1
Level	EH
Status	Approval
Release date

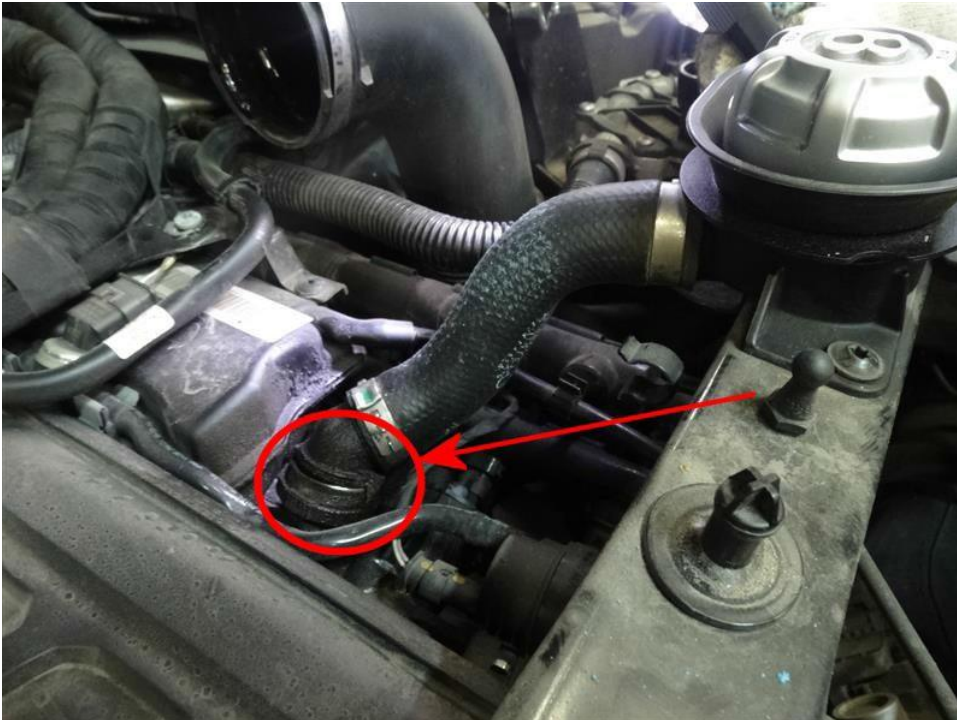
Figure 1

When accelerating the engine hesitates and jerks

Upon further inspection oil residue can be seen leaking around the Remote oil filler neck “quick connect” (Figure 1)

The quick connect O-ring on further inspection is cracked/damaged

Replace the remote oil filler neck – Refer to Repair manual Rep.Gr 17
