Subject: REAR PARKING SENSOR BEEPS WITHOUT ANY OBSTACLE BEHIND VEHICLE WHEN REAR USB POWER OUTLET IS BROKEN	Bulletin No.: 09-033/19
	Last Issued: 08/16/2019

2017-2019 Mazda6 vehicles with VINS lower than JM1GL*****502177 (produced before Feb 20, 2019)

2018-2019 CX-5 vehicles with VINS lower than JM3KF*****581112 (produced before Feb 20, 2019)

2016-2019 CX-9 vehicles with VINS lower than JM3TC*****319650 (produced before Feb 20, 2019)

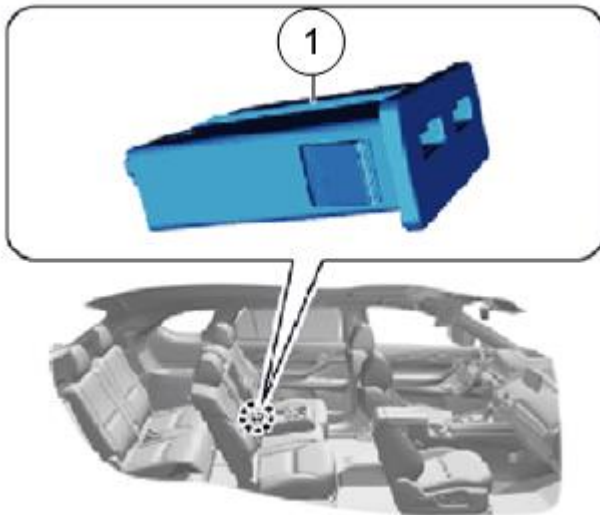
Some vehicles may exhibit the rear parking sensor beeping without any obstacles behind it when the shift lever is shifted into Reverse. This concern only occurs when the rear USB power outlet (1) is broken. This is caused by noise from USB interference with the harness of the rear parking sensor (when the USB power outlet is broken).

To correct this issue, the configuration of the USB power outlet has been changed to improve durability.

- YES: Go to next step.
 - NO: This TSB does not apply.
6. Replace the USB power outlet with a modified one according to the instructions on MGSS.
 - Mazda6 (USB POWER OUTLET REMOVAL/INSTALLATION)
