Subject: TURN ON/OFF LIGHTS MANUALLY WARNING MESSAGE AND DTC B10AD:09 STORED WHEN PARKED UNDER HOT WEATHER CONDITIONS	Service Alert No.: SA-035/19
	Last Issued: 08/09/2019

2019 Mazda3

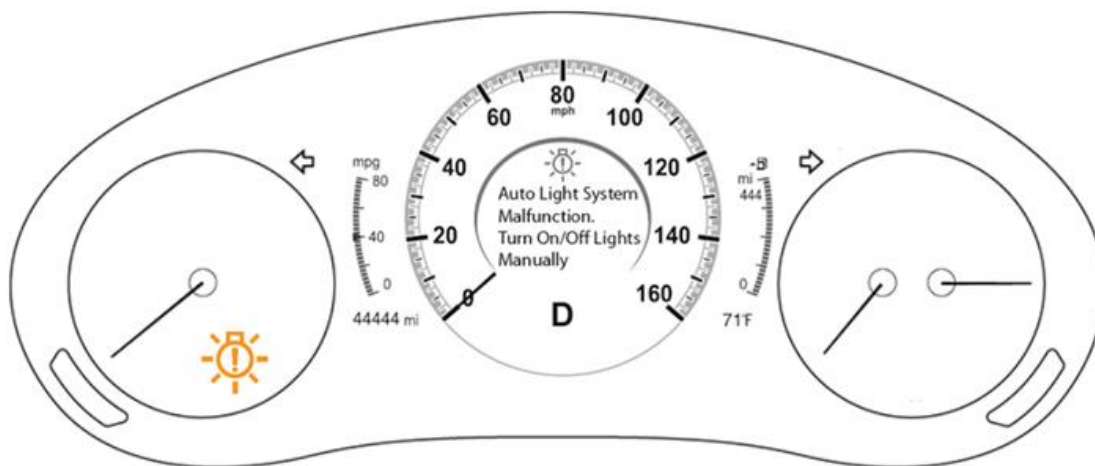
Some customers may complain about instrument cluster warning message "Auto Light System Malfunction. Turn On/Off Lights Manually". DTC B10AD:09 (Humidity sensor/solar radiation sensor/auto light sensor/rain sensor malfunction) may be stored and the exterior light warning indicator light may be ON.

This can sometimes be duplicated after the vehicle is parked under the hot sun for a period of time.

If the rain sensor detects temperature higher than the operation range, the auto light system temporarily stops and the exterior light warning indicator light turns ON.

The auto light system starts to operate normally after the interior temperature drops.

1	Rain sensor, auto light sensor and humidity sensor	
2	Rain sensor detection area

If this condition occurs, use the climate control system to cool the interior. The auto light system will operate normally after the temperature around the rain sensor has dropped.
No parts replacement is needed.

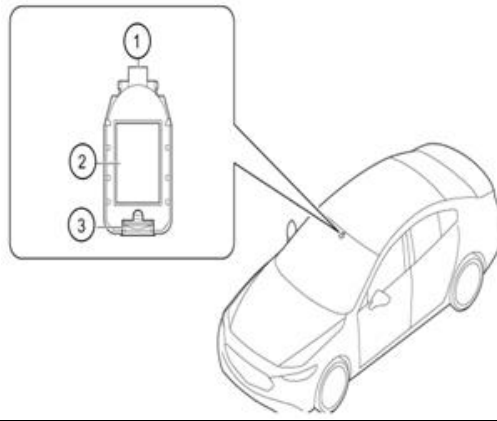
3 Auto light detection area
