# Keystone RV Company

## SERVICE ADVISORY # 19-356

### Cougar 32RDB Ceiling Vents

8/15/19

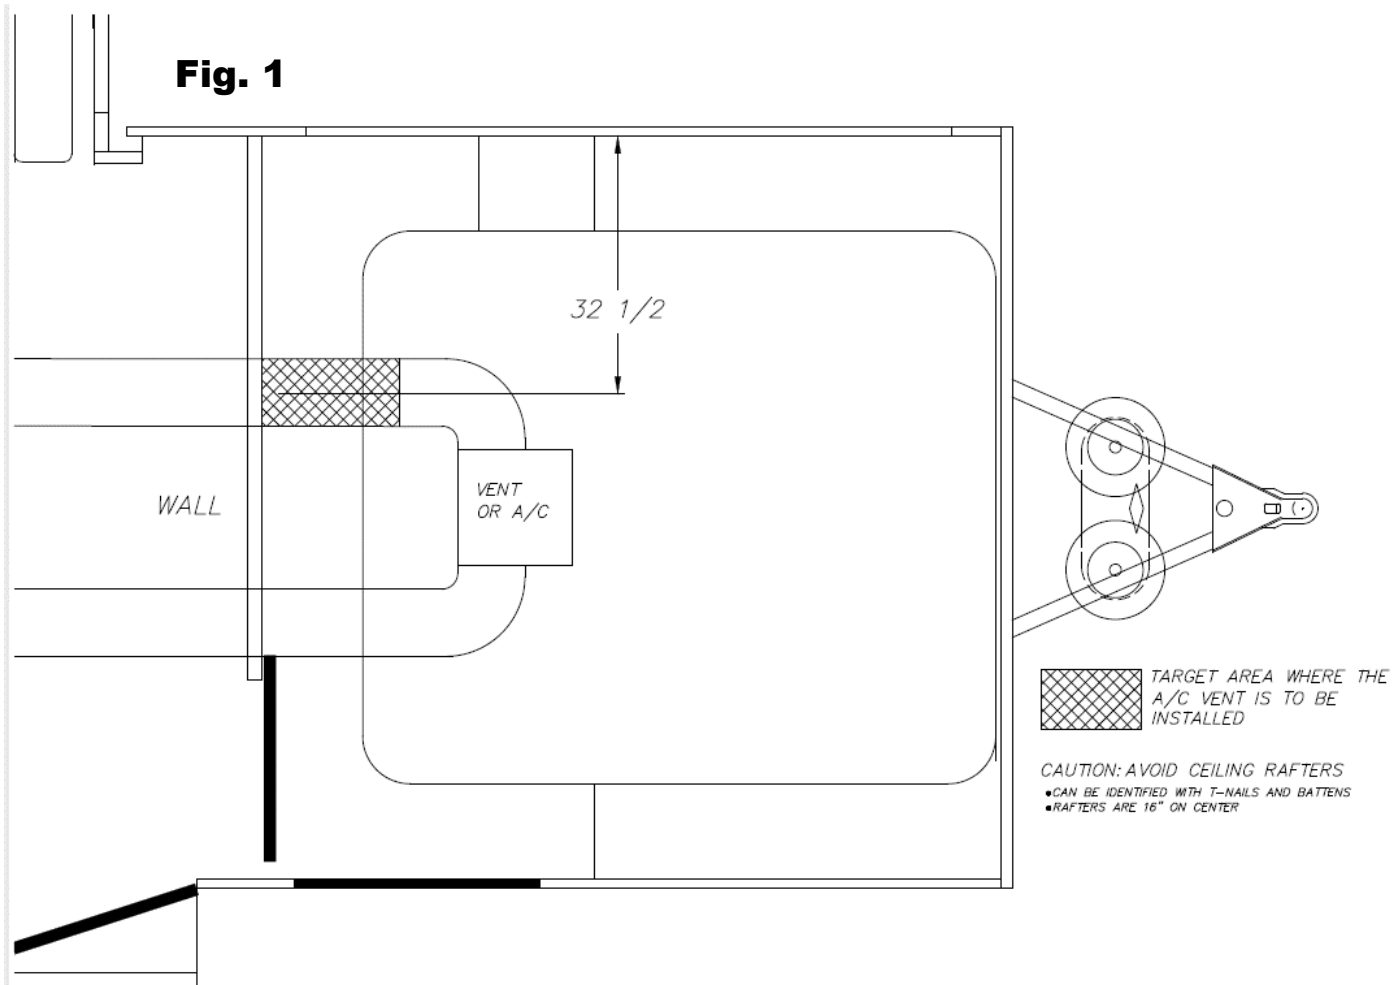
**Fig. 1**

Updated  
Bedroom Ceiling  
Vent Location

It has been determined that the Cougar 32RDB units may not have the adequate amount of A/C ceiling vents installed. The following procedure describes the locations and how to install the required A/C ceiling vents.

In the bedroom an A/C vent can be installed between the rear wall of bedroom and within 15 inches of the 14" x 14" opening of the bedroom A/C or ceiling vent (2nd A/C is an option), Figure 1. The ceiling ducting, forward from the main A/C, runs parallel with the off-door-side wall. The center of this ducting is 32 ½" from the off-door-side wall. Do not drill into the ceiling rafters which are 16 inches on center (measurements can be taken from the ceiling batten trim). Using a 5" hole saw, add a vent as needed, drilling into ceiling panel and A/C duct, being careful to stop short before drilling into the top side of the A/C duct.

Install KRV#101886 Grill – 5" – Ducted Ceiling – AC in the bedroom using HVAC tape to seal the vents to the ducting.
