GLOBAL SAFETY FIELD INVESTIGATIONS
DCS5062
URGENT - DISTRIBUTE IMMEDIATELY

Subject: N192210750 - Service Update
Brake Pipe Contacting Brake Booster (Expires with base warranty)

Models: 2019 Chevrolet Blazer

N192210750 Brake Pipe Contacting Brake Booster (Expires with base warranty)

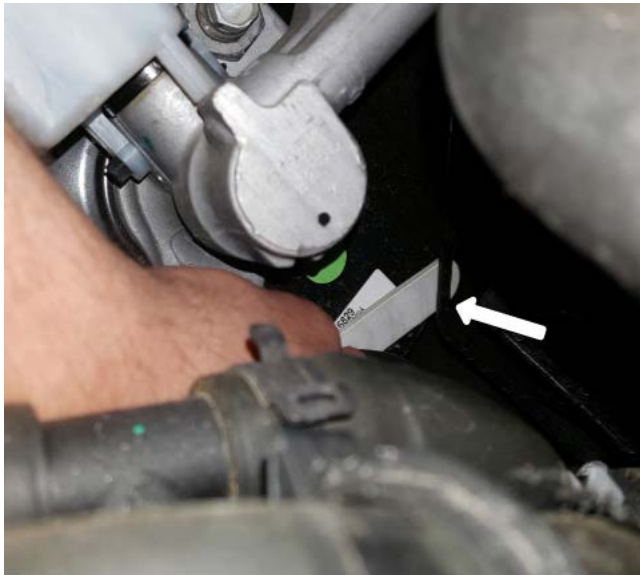
5354597

Condition	Certain 2019 Chevrolet Blazer vehicles may have a condition where the brake line may make contact with the brake booster causing a rub-thru condition.
Correction	Bend the brake line away from the brake booster, assuring a 7mm clearance.

2. Using a 7mm feeler gauge, or a stack of feeler gauges with a total width of 7mm, check the clearance between the brake pipe shown and the brake booster.
 - If the clearance is less than 7mm, proceed to step 3.
 - If the clearance is 7mm or greater, no further action is required. Proceed to step 4.
