GLOBAL SAFETY FIELD INVESTIGATIONS  
DCS5067  
URGENT - DISTRIBUTE IMMEDIATELY

Subject: N192219480 - Special Coverage  
Driver's Front Seat Belt Lap Pretensioner

Models: 2009 – 2014 Buick Enclave  
2009 – 2014 Chevrolet Traverse  
2009 – 2014 GMC Acadia  
2009 – 2010 Saturn Outlook

## N192219480 Drivers Front Seat Belt Lap Pretensioner

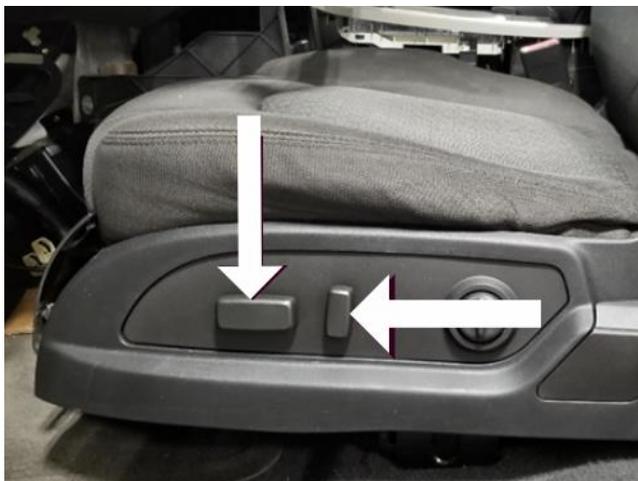
5357877

1. Move the driver seat to the full forward and full down position.

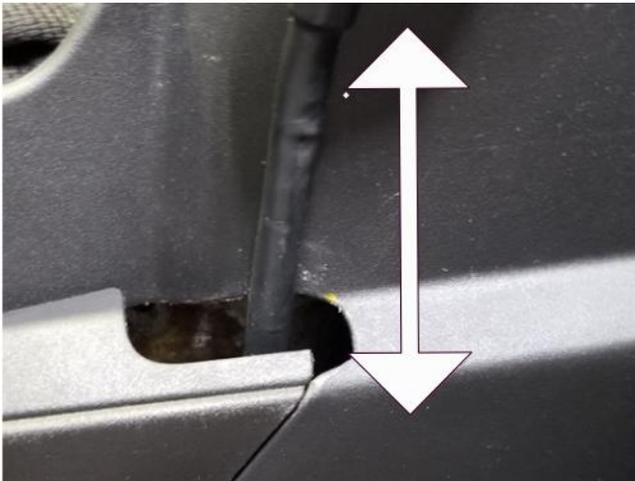
5357882

2. With the seat in the full forward and down position, inspect the seat belt tensioner cable cover for damage. Inspect the complete cable cover from the base of the cable to the latch. Damage includes any splits, holes or cracks.

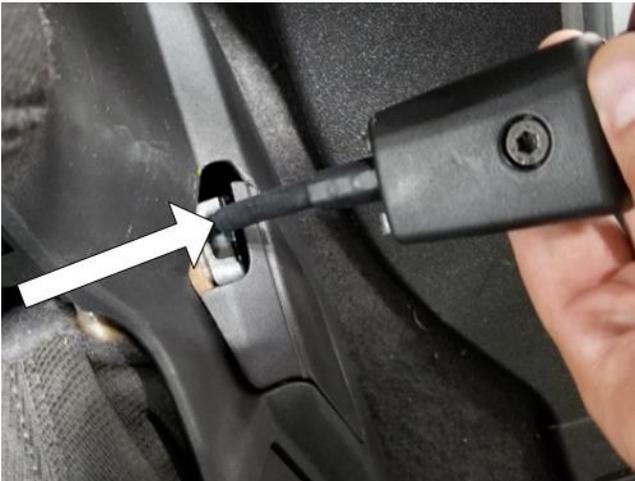
5357887

3. Flex the seat belt in an outboard direction and look on inboard side of driver seat seatbelt anchor cover for damage.

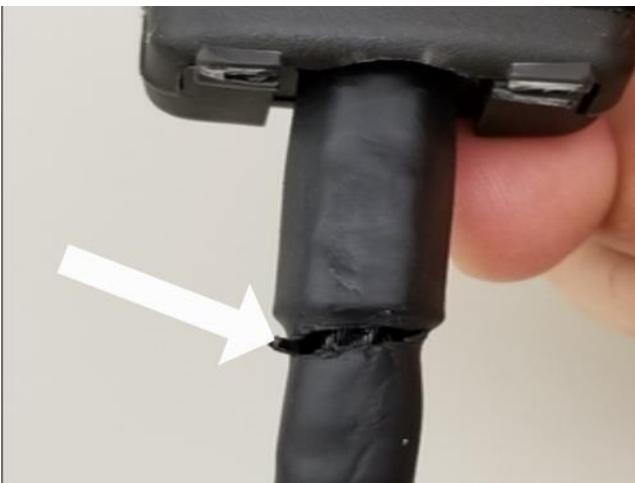
5357891

#### Damage Examples

4. If inspection finds cuts, splits, tears or cracks exposing the metal components underneath, replace the driver side front seat belt anchor plate tensioner. Refer to *Front Seat Belt Anchor Plate Tensioner Replacement* in SI.
5. If no damage is found, inform the customer that the special coverage condition is not present on their vehicle.

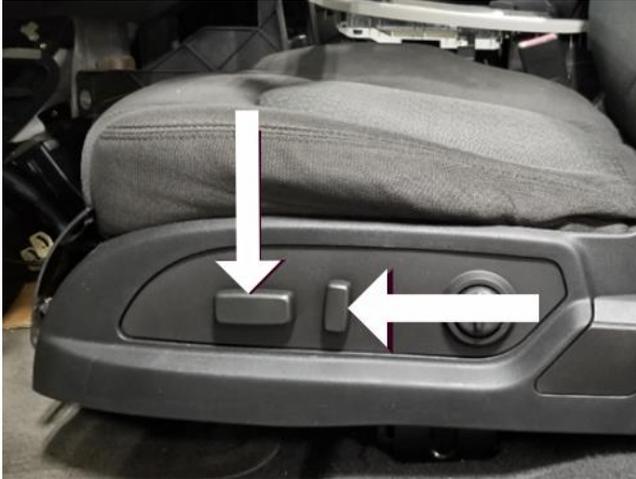
1. Move the driver seat to the full forward and full down position.

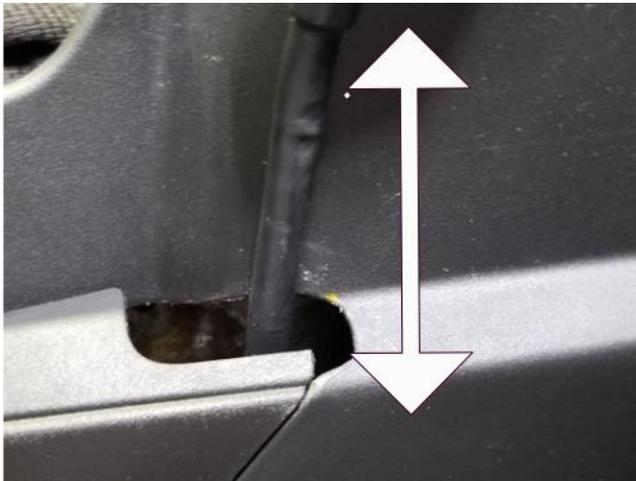
2. With the seat in the full forward and down position, inspect the seat belt tensioner cable cover for damage. Inspect the complete cable cover from the base of the cable to the latch. Damage includes any splits, holes or cracks.

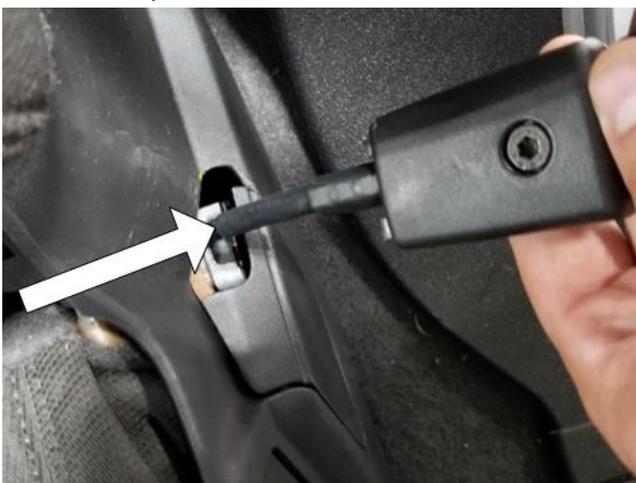
3. Flex the seat belt in an outboard direction and look on inboard side of driver seat seatbelt anchor cover for damage.

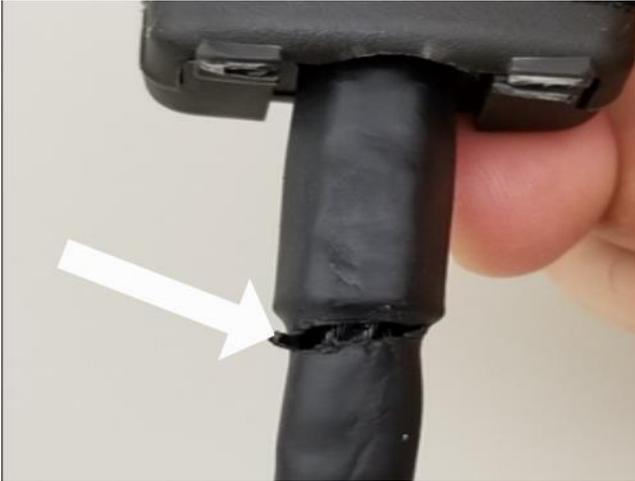
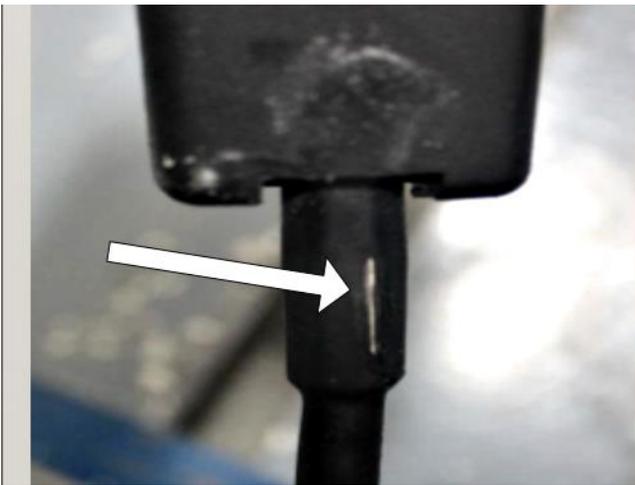
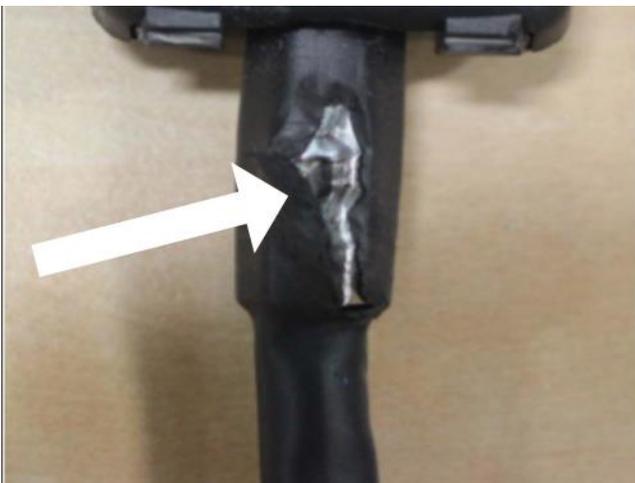
### Damage Examples

4. If you find cuts, splits, tears or cracks exposing the metal components underneath, or you are unsure of the condition of your seat belt system, take your vehicle to the dealer for inspection.
