GLOBAL SAFETY FIELD INVESTIGATIONS
DCS5063
URGENT - DISTRIBUTE IMMEDIATELY

Subject: N192217490 - Customer Satisfaction Program
Loss of Audio Chime and Wrong Splash Screen

Models: 2018 Cadillac ATS Equipped with Infotainment System (RPO IOS/IOT)
2018 Cadillac CTS Equipped with Infotainment System (RPO IOS/IOT)
2018 Cadillac XTS Equipped with Infotainment System (RPO IOS/IOT)
2018 GMC Terrain Equipped with Infotainment System (RPO
IOS/IOT/IOU)

N192217490 Loss of Audio Chime and Wrong Splash Screen

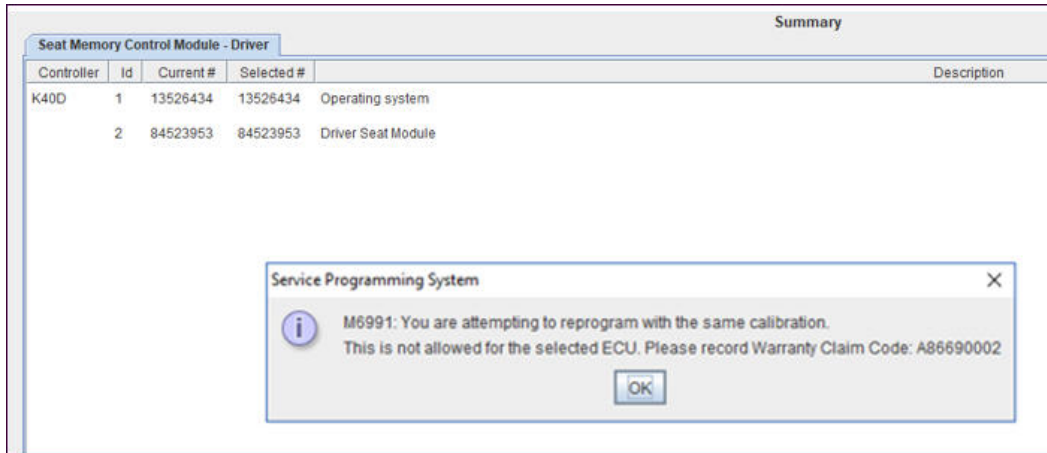
5164840

Note: If the Same Calibration/Software Warning is noted on the SPS Summary screen, record the warranty claim code (WCC) and select OK and follow screen instructions. After a successful programming event, the WCC is located in the Service Programming System dialogue box of the SPS Summary screen. No further action is required. Refer to the Warranty section of the bulletin.
