GLOBAL SAFETY FIELD INVESTIGATIONS
DCS5078
URGENT - DISTRIBUTE IMMEDIATELY

Subject: N182198330 - Service Update
ECM Does Not Provide Correct CARB Required CVN Or Detect
Memory Faults

Models: 2019 Buick Cascada
2017 & 2019 Chevrolet Cruze
2018 Chevrolet Malibu
2018 GMC Terrain

N182198330 ECM Does Not Provide Correct CARB Required CVN Or Detect Memory Faults

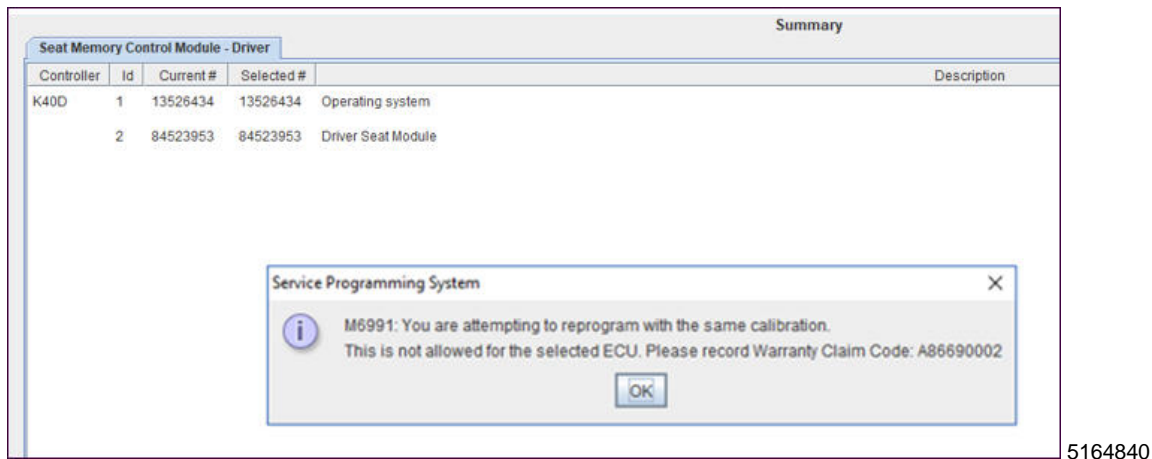
Note: If the Same Calibration/Software Warning is noted on the SPS Summary screen, record the warranty claim code (WCC) and select OK and follow screen instructions. After a successful programming event, the WCC is located in the Service Programming System dialogue box of the SPS Summary screen. No further action is required. Refer to the Warranty section of the bulletin.
