GLOBAL SAFETY FIELD INVESTIGATIONS
DCS5038
URGENT - DISTRIBUTE IMMEDIATELY

Subject: N192210460-01 – Service Update
eBoost Control Module Software False Detection with DTC Associated
Revised Labor Times and Service Procedure

Models: 2019 Cadillac CT6 w/ LSY or LTA motors
2019 Chevrolet Silverado 1500 (New Model)
2019 GMC Sierra 1500 (New Model)

N192210460 eBoost Control Module Software False Detection with DTC Associated

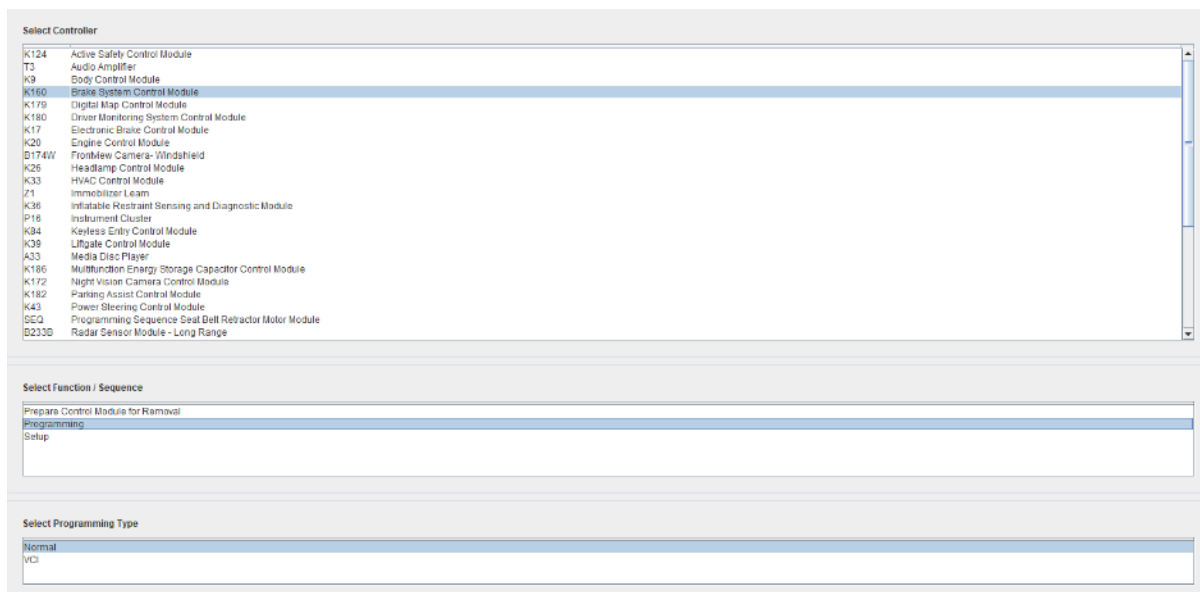
5263446

Note: If the Same Calibration/Software Warning is noted on the SPS Summary screen, record the warranty claim code (WCC) and select OK and follow screen instructions. After a successful programming event, the WCC is located in the Service Programming System dialogue box of the SPS Summary screen. No further action is required. Refer to the Warranty section of the bulletin.
