Service Bulletin

Bulletin No.: 19-NA-025

Subject: Front Turn Signal Lamp Flashing Fast, or Inoperative

Brand:	Model:	Model Year:		VIN:		Engine:	Transmission:
		from	to	from	to		
Cadillac	XT4	2019	2019	SOP	Prior to November 15, 2018	All	All

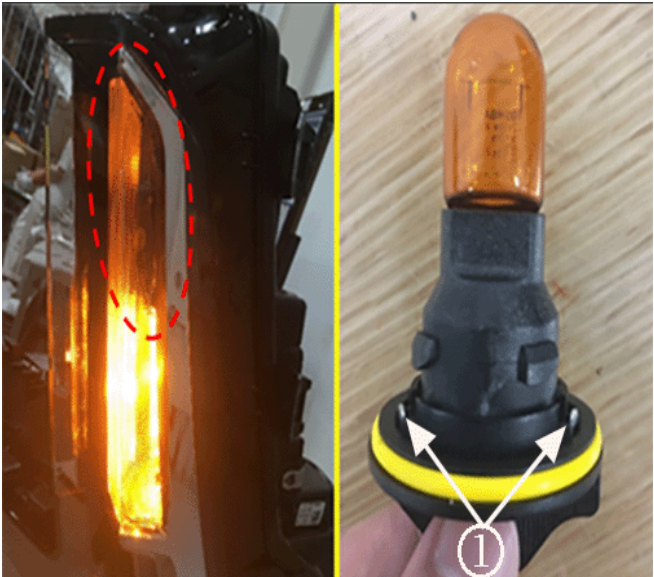
</div> <p>5233431</p> <p>Some customers may comment on a front turn signal flashing fast or inoperative.</p>
Cause	The cause of the condition may be that the original lamp socket body was molded with a void under the terminal pins (1). This space would sometimes allow the terminal to move, resulting in an intermittent or complete loss of contact to the ring inside the lamp.

For vehicles built prior to the breakpoint noted above, replace the sockets (1) on the affected side (Qty 2) and inspect the bulbs (2) to determine if the bulb is actually burnt out. Replace bulb only as necessary.

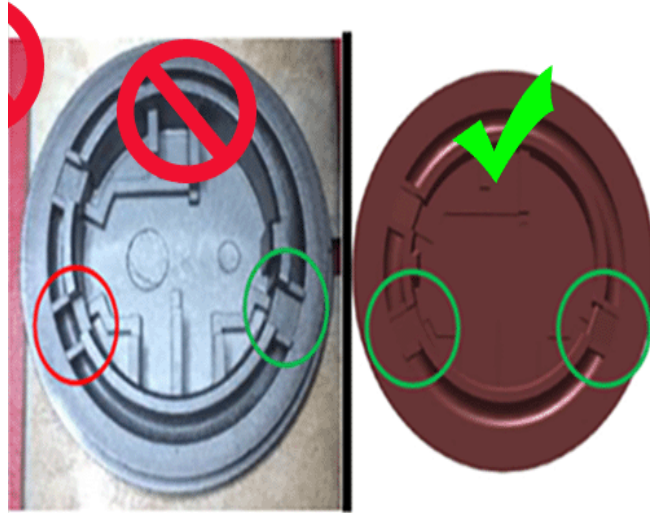
5233432

Note: A design change was made to the socket mold to fill in the void area. The graphic above shows the void filled in to eliminate terminal movement and correct the condition.
