Service Bulletin

Bulletin No.: 19-NA-150

Subject: Information on Rough Idle, Malfunction Indicator Lamp (MIL) Illuminated After Engine Repairs - DTC P0016 Set

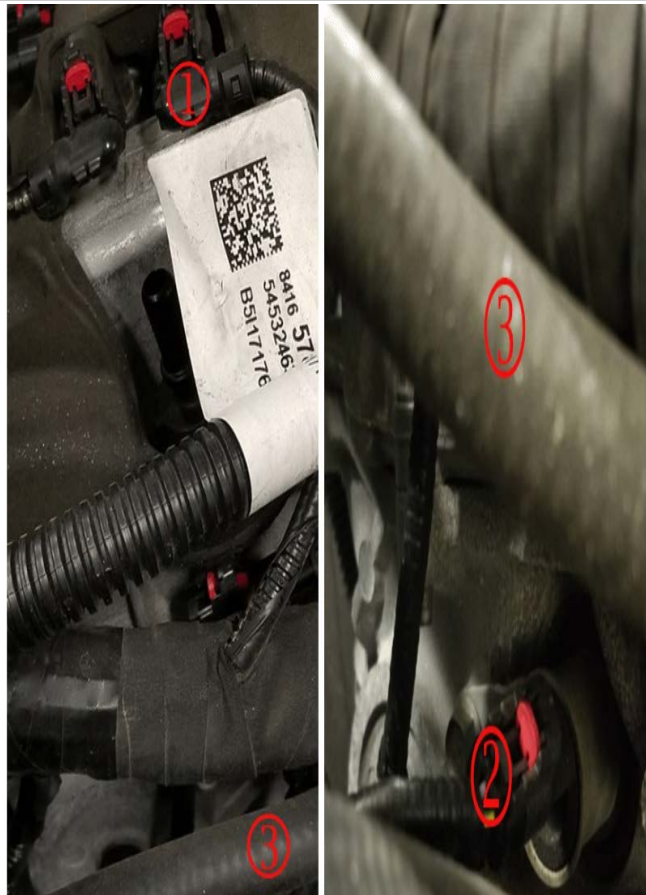
5368138

1. Bank 1 intake actuator
 2. Bank 1 intake park lock solenoid
 3. Same hose in both pictures shown for location.
- If they are incorrect swap them back and clear the code to verify repair.
 - If they are already in the correct location then refer to the correct service information diagnostic for this DTC.
