Service Bulletin

Bulletin No.: 19-NA-160

Subject: Intermittent or Continuous Horn Blowing, Horn Activation Sensitive to the Touch

Brand:	Model:	Model Year:		VIN:		Engine:	Transmission:
		from	to	from	to		
Cadillac	XT4	2019	2019			All	All
Chevrolet	Blazer	2019	2019				
	Silverado 1500 (New Model)	2019	2019				
GMC	Sierra 1500 (New Model)	2019	2019

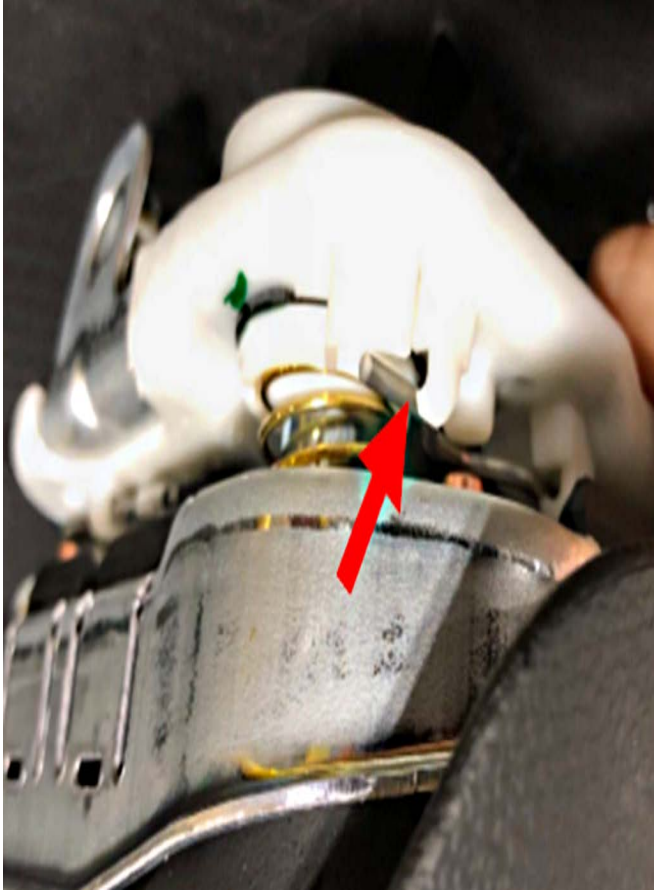
<p style="text-align: right;">5368149</p> <p>The cause of the condition may be that the horn spring, located on the backside of the steering wheel airbag, is out of position.</p>
<p>Correction</p>	<p>Upon verifying the condition, remove the steering wheel airbag assembly and inspect for proper engagement of the horn spring to the airbag housing.</p>
