**SERVICE BULLETIN**

**APPLICABILITY:** 2019MY Impreza  
 2019MY Crosstrek (Including Hybrid Model)  
 2019MY Forester  
 2019MY Legacy/ Outback  
 2019MY WRX  
 2019MY BRZ- Navigation -equipped ONLY  
 2019MY Ascent

**NUMBER:** 15-236-18R  
**DATE:** 12/04/18  
**REVISED:** 08/21/19

**SUBJECT:** Reprogramming File Availability for Optimization of Harman Gen 3.1 Audio and Navigation Head Units

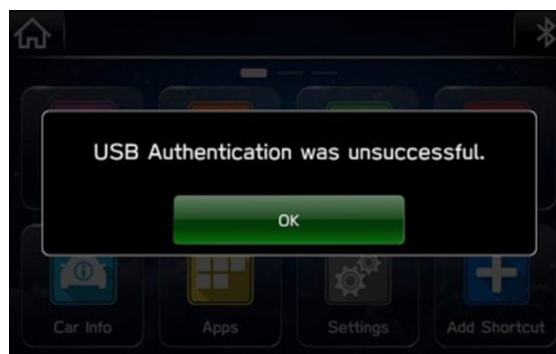
**NOTE:** If an attempt is made to install the wrong “grade” file into the wrong grade head unit (EXAMPLE: “Base” update file into a “Base Plus or Mid” or “High” head unit), the USB Authentication error screen below will be displayed:

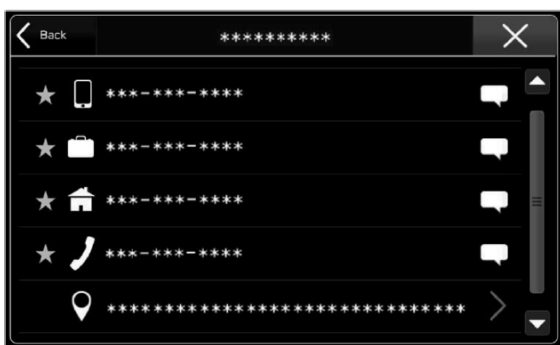
- 1) AM/FM radio station presets are lost.
- 2) Favorite Phone Contacts list is lost.

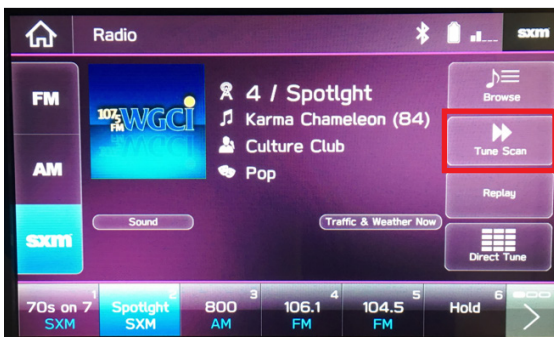
- 3) <Scan> previously displayed on SXM screen was changed to <Tune Scan> (a.k.a. SEEK).
