# Technical Service Bulletin

## 37 Transmission malfunction, DTC P17F600, U008000, and/or U010100 stored in the TCM or ECM

37 19 88 2053878/4 August 14, 2019. Supersedes Technical Service Bulletin Group 37 number 19-86 dated March 21, 2019 for reasons listed below.

Model(s)	Year	VIN Range	Vehicle-Specific Equipment
A6, A7	2019	000001 - 121296	3.0TFSI

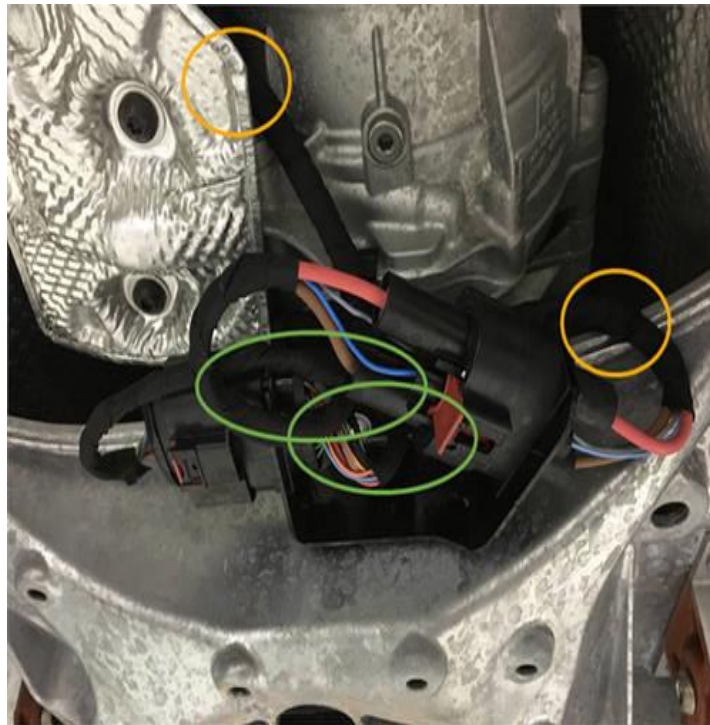
The transmission harness can come in contact with the crossmember and could be damaged.

**Figure 1.** Common areas for harness damage.

2. Replace the transmission harness with a new part and reroute the transmission harness. The transmission harness should not be repaired.

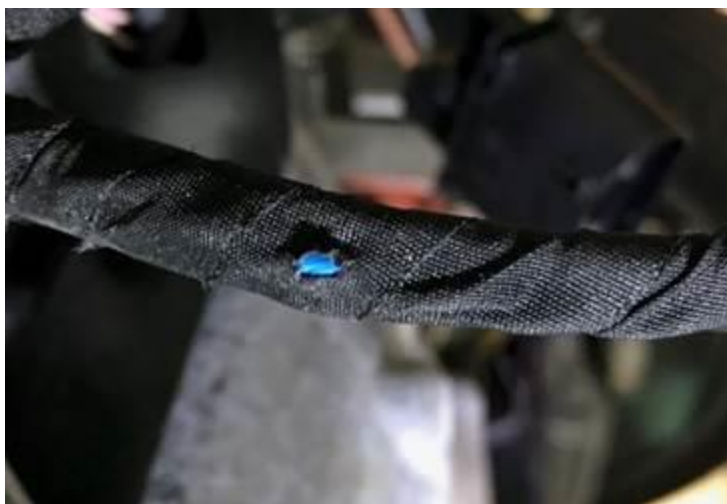
*Figure 2. Example of a small rip in the protective tape.*

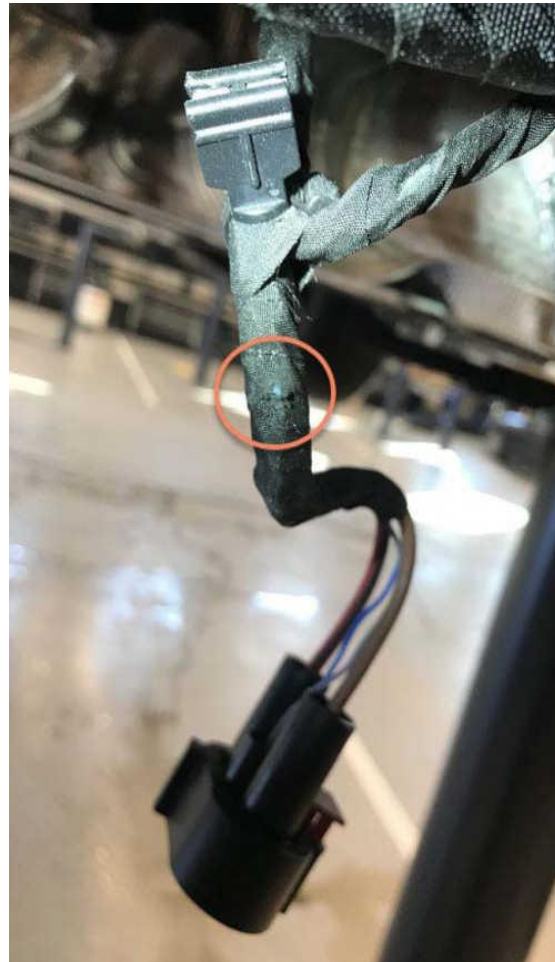
*Figure 3. The damage on the harness might be difficult to spot.*

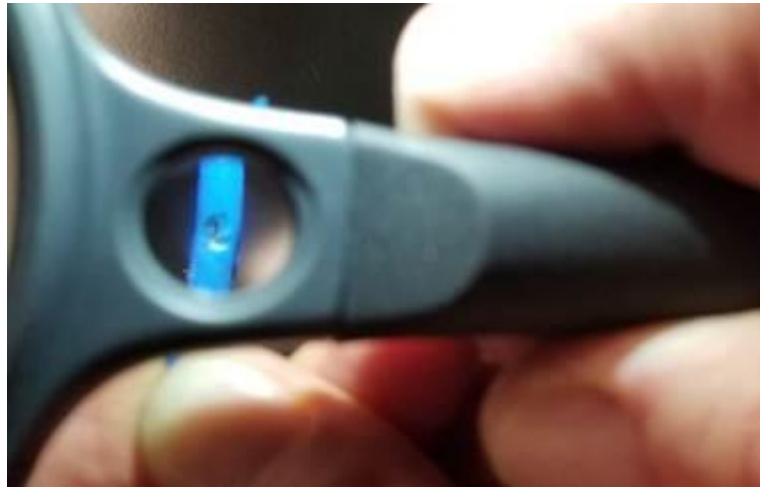
**Figure 4.** The cause of the DTC may be as small as a pinhole.
