Technical Service Bulletin

PSS 92 Washer system sprays automatically and uses an excessive amount of fluid

92 19 20 2054527/2 August 15, 2019. Supersedes Technical Service Bulletin Group 92 number 19-19 dated April 3, 2019 for reasons listed below.

Model(s)	Year	VIN Range	Vehicle-Specific Equipment
A6, A7, A8, and Q8	2019	All	With Laserscanner

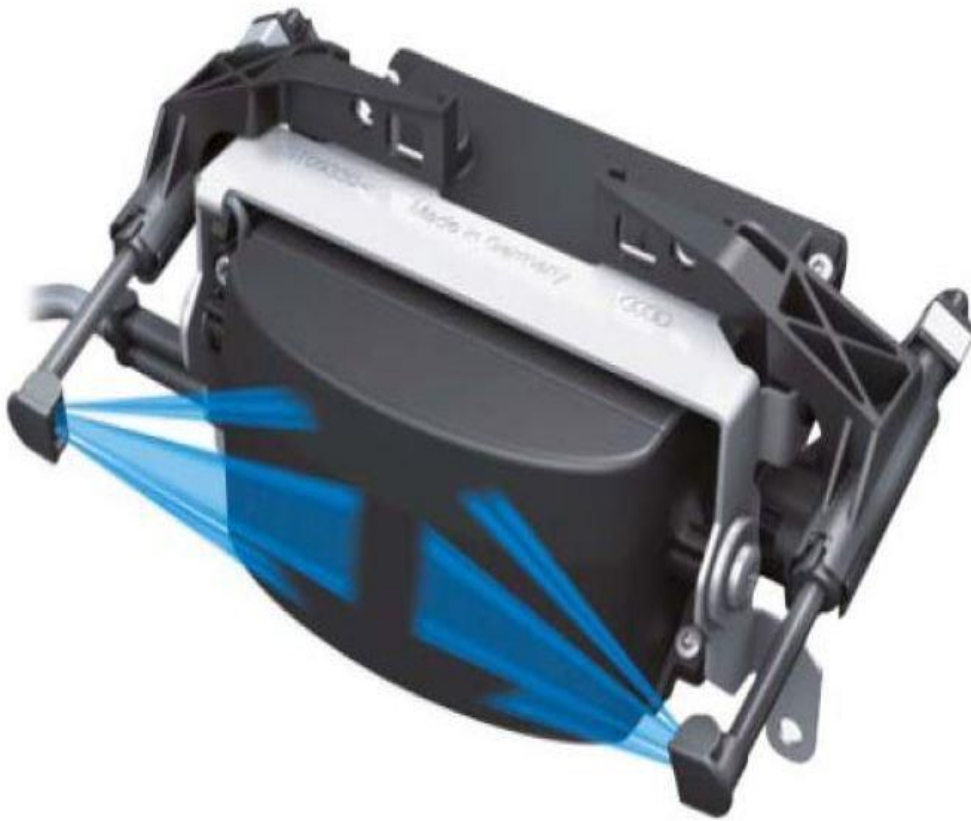
Figure 1. Laserscanner cleaning system.

1. The laserscanner is only cleaned while driving (Figure 1).
On the A6, A7, and Q8 vehicles the laser scanner is located in the right upper single frame area (Figure 2).

As a result, the customer can get the impression that the headlight washer system activates itself. Depending on weather and road conditions (like snow, slush or dirt roads) the laserscanner might clean itself frequently.

If the sensor is very dirty, for example, due to driving over dirt roads or through slush, the laserscanner might be unable to clean itself. After three tries, the cleaning function goes into a 45-minute timeout which is reset by an ignition cycle.

As this also leads to higher consumption of the washer fluid, the customer might be concerned about excessive washer fluid use.

2. Explain to the customer that a solution is forthcoming and that no repairs are necessary at this point. Do not replace any components for this condition since this will not resolve the customer's concern.
3. Create a PSS record in the PSS application through the Pending Service Solutions (PSS) link in AccessAudi (under *Related Links* >> *Service*), or through the Technical Assistance page in Elsa.
