Technical Service Bulletin

93 Various warning messages about drive in the cluster, DTC U029200 stored in the ECM or the electric drive module

93 19 13 2055804/1 August 19, 2019.

Model(s)	Year	VIN Range	Vehicle-Specific Equipment
Audi e-tron quattro	2019	All	Not Applicable

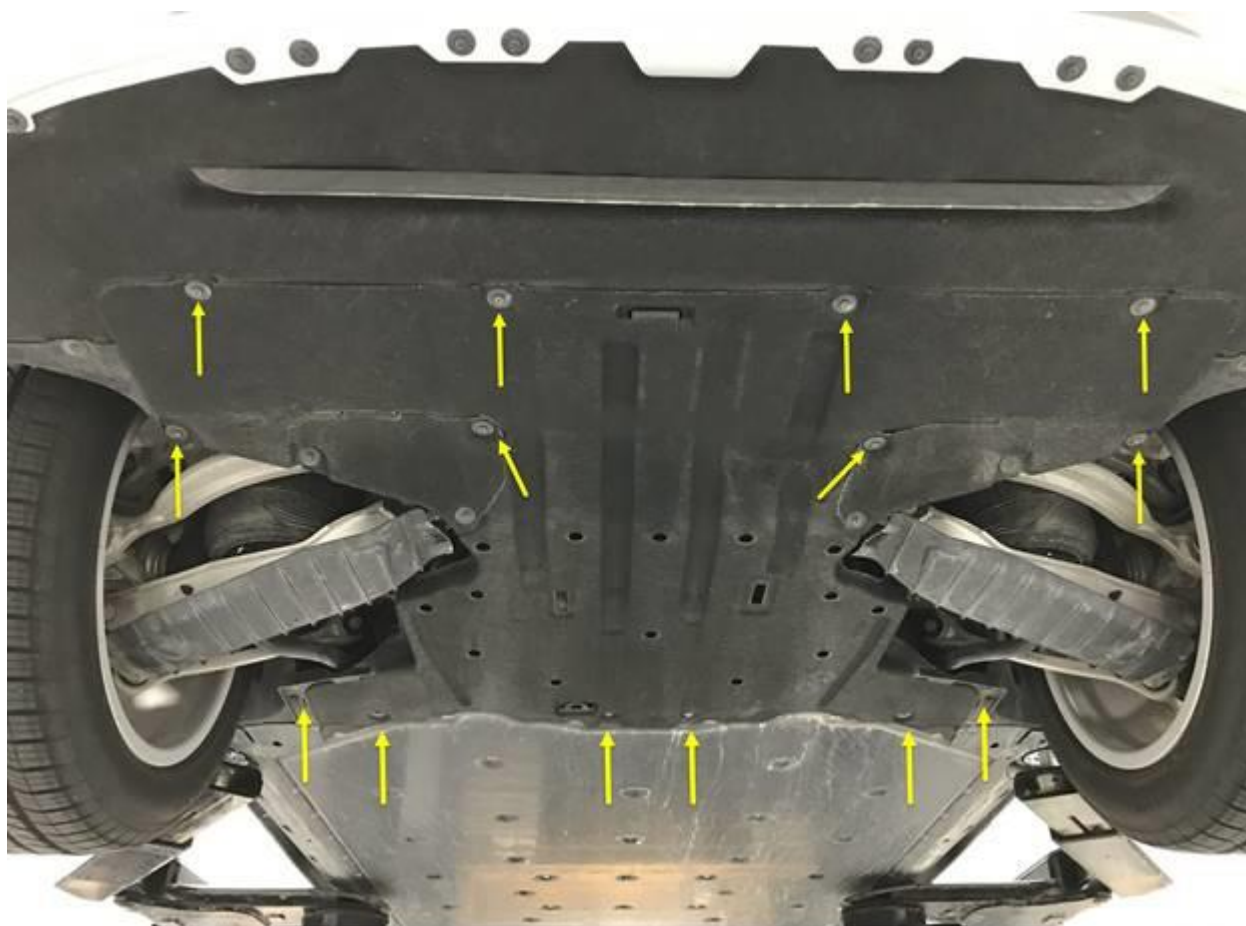
Figure 1. Remove the lower shield.

1. Remove the lower under shield from the rear of the vehicle and gain access to the rear electric drive harness for inspection (Figure 1).

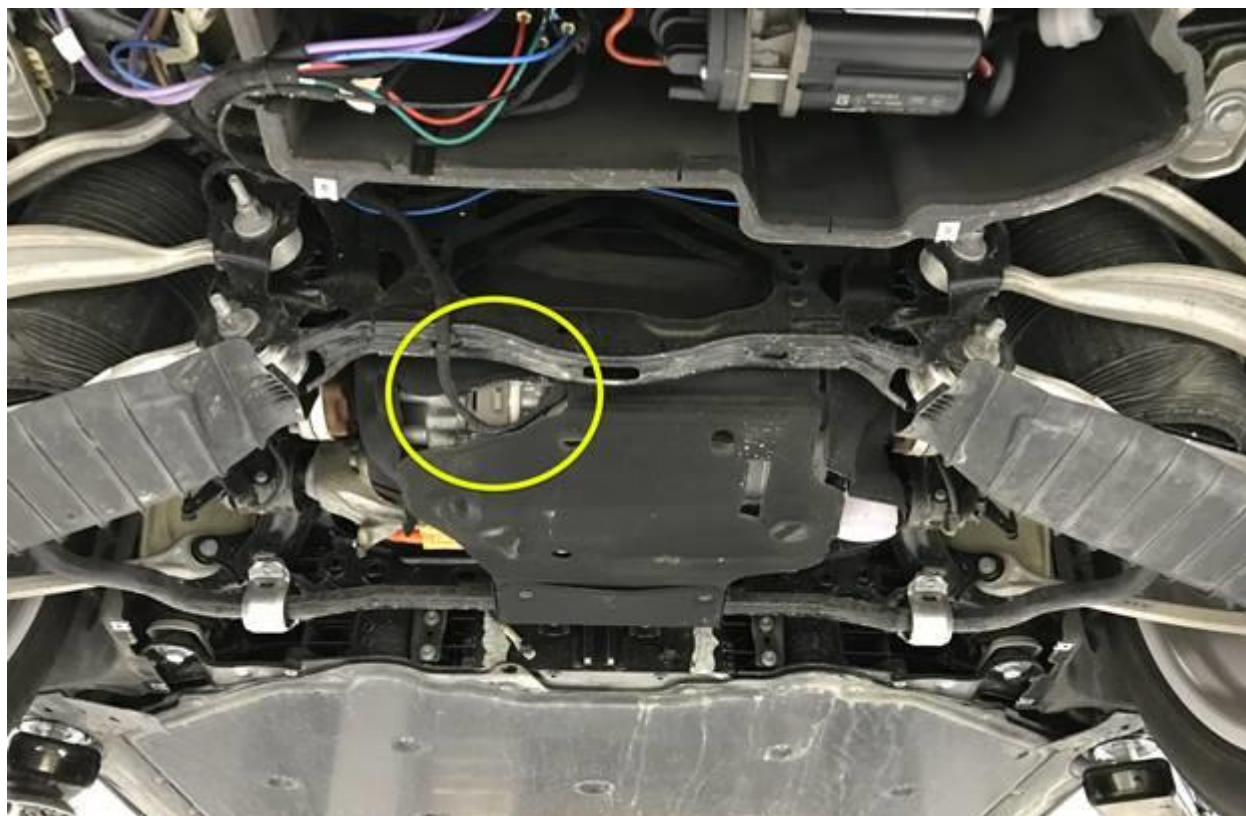
2. Inspect the harness for chaffing in the location indicated at the yellow circle. Pay close attention to the areas indicated in Figures 3 and 4.

Figure 2. General area of inspection.

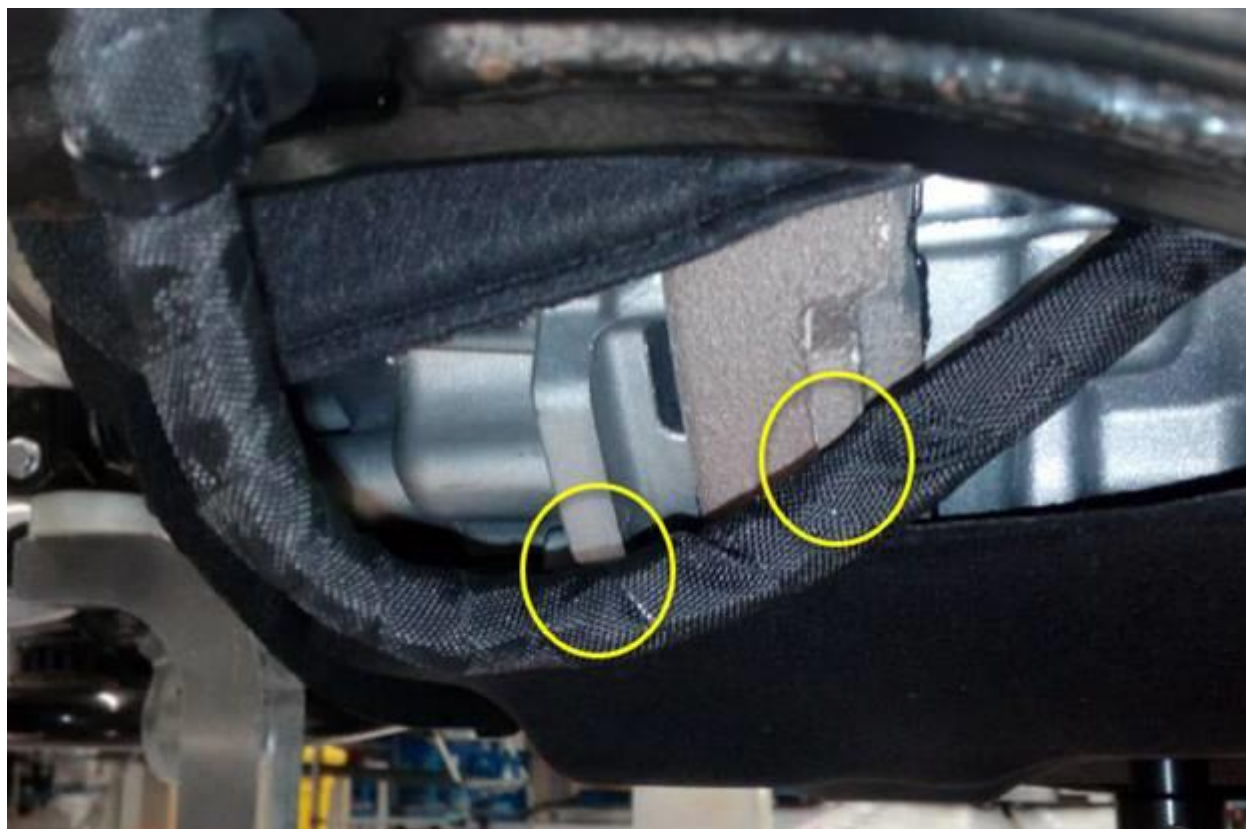
The low voltage wiring harness for the rear electric drive motor may be damaged due to incorrect routing.

Figure 3. *Inspect for potential chaffing between the transmission lugs and the harness.*

3. If damage is found repair the affected cables as needed with the VAS1978B.

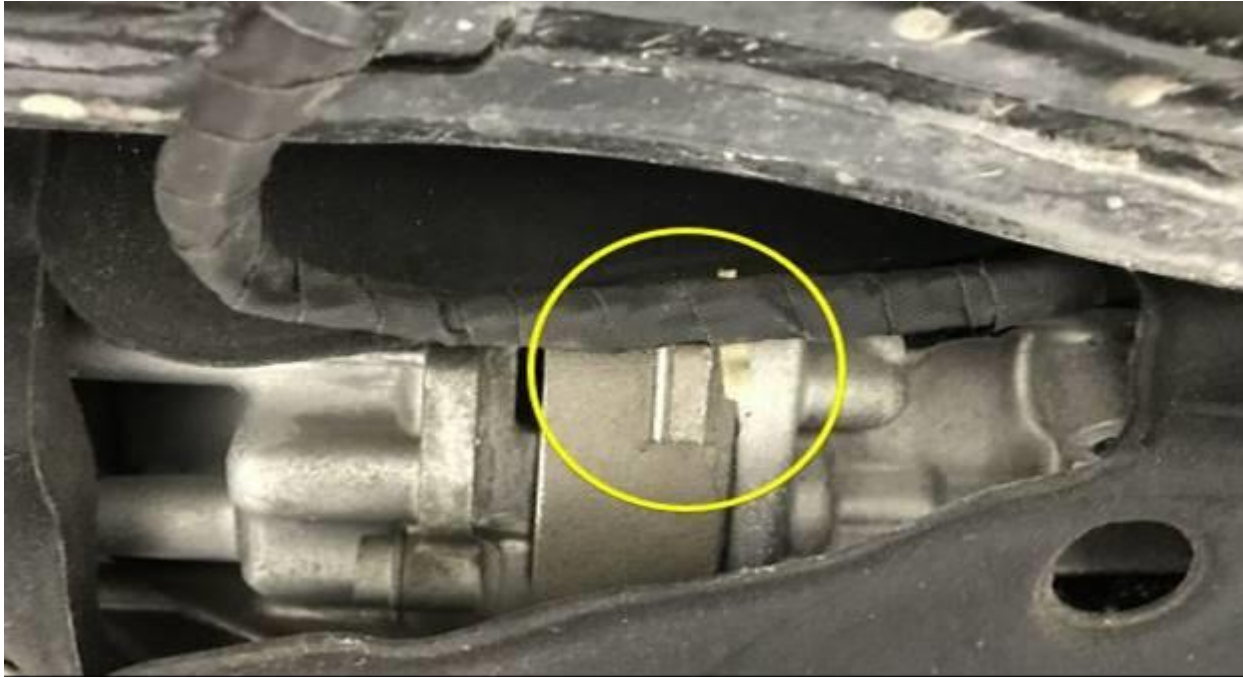
Figure 4. Harness may be routed under the lugs (Figure 3) or over the lug.

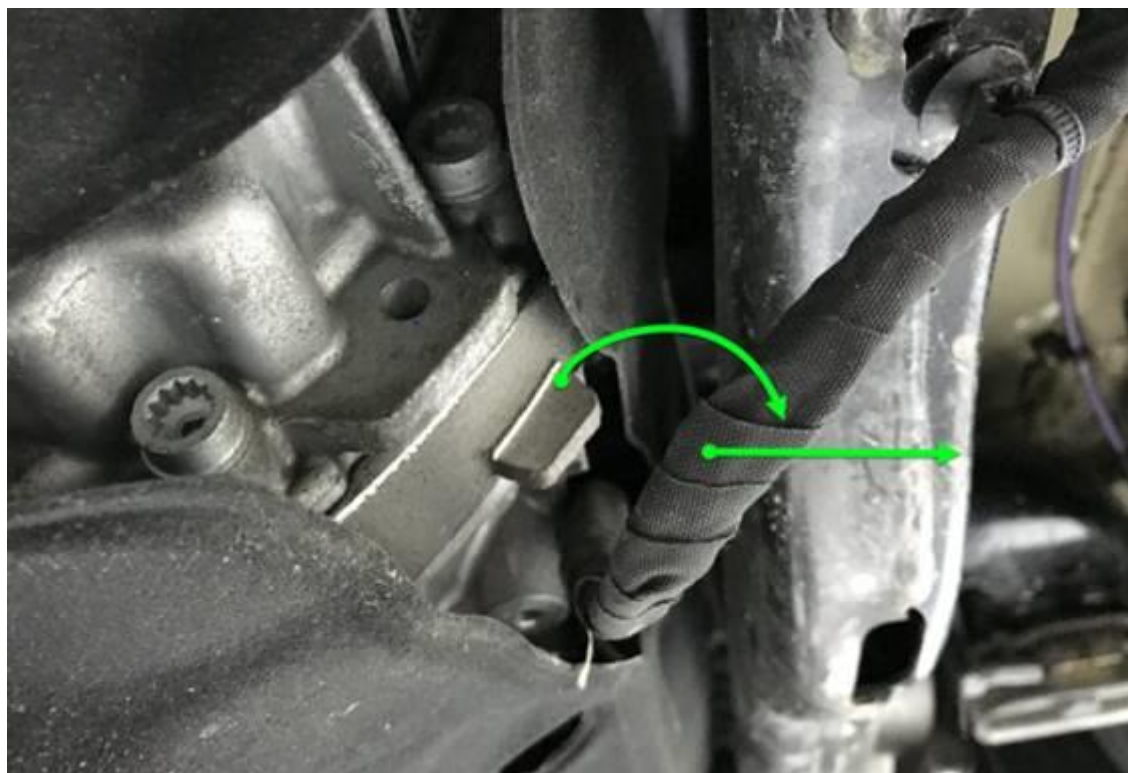
Figure 5. Re-routing of the harness.

4. Lift the harness away from the lugs and pull the harness towards the rear of the vehicle to gain sufficient clearance to avoid contact with the transmission/drive motor casing (Figures 5-7). The harness is robust enough to maintain its position.

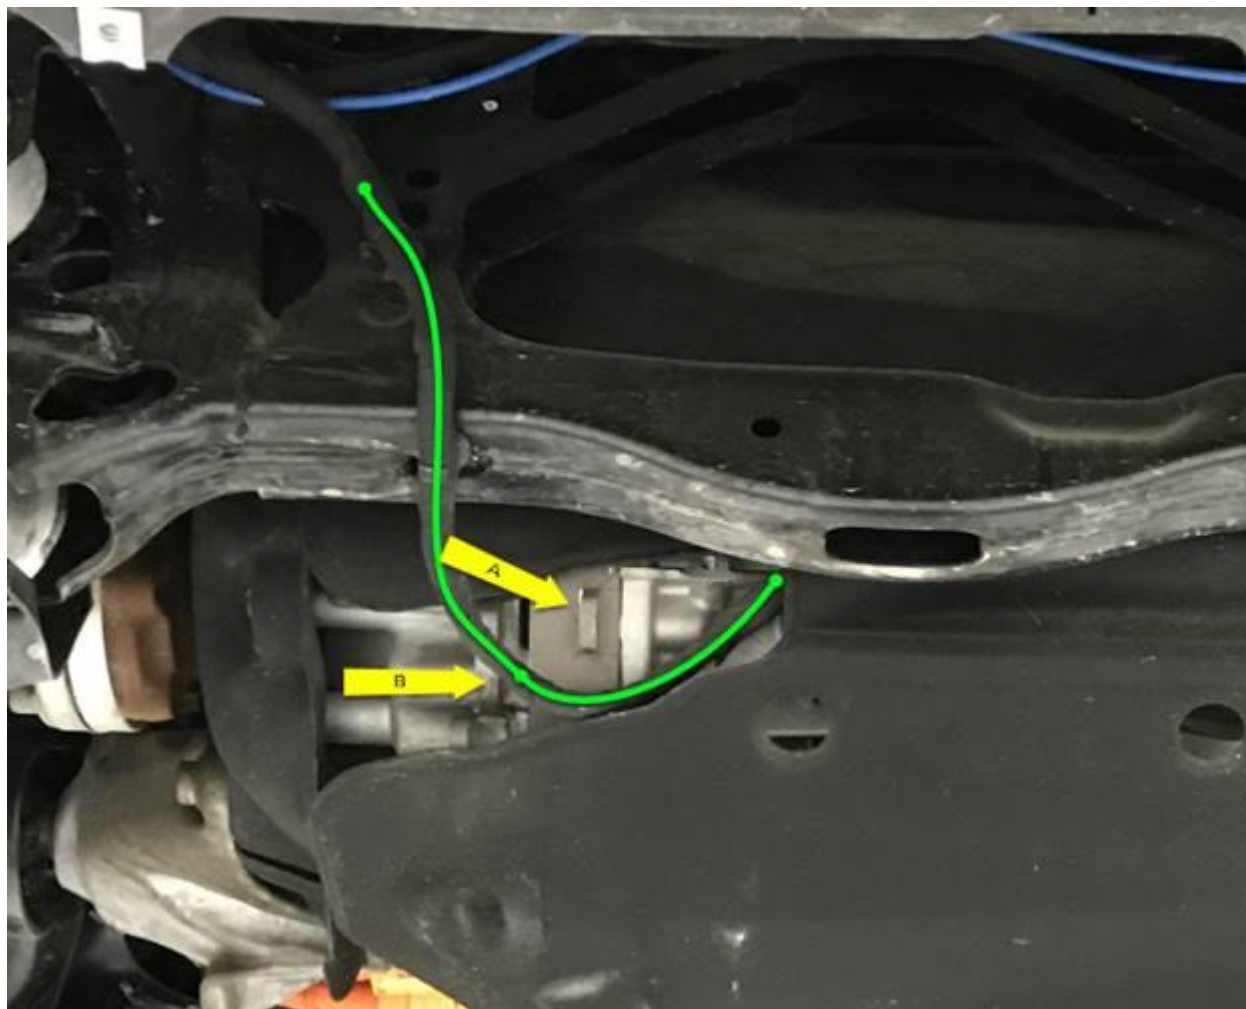
Figure 6. Desired harness routing, ensure the harness has sufficient clearance near the lugs (A and B).

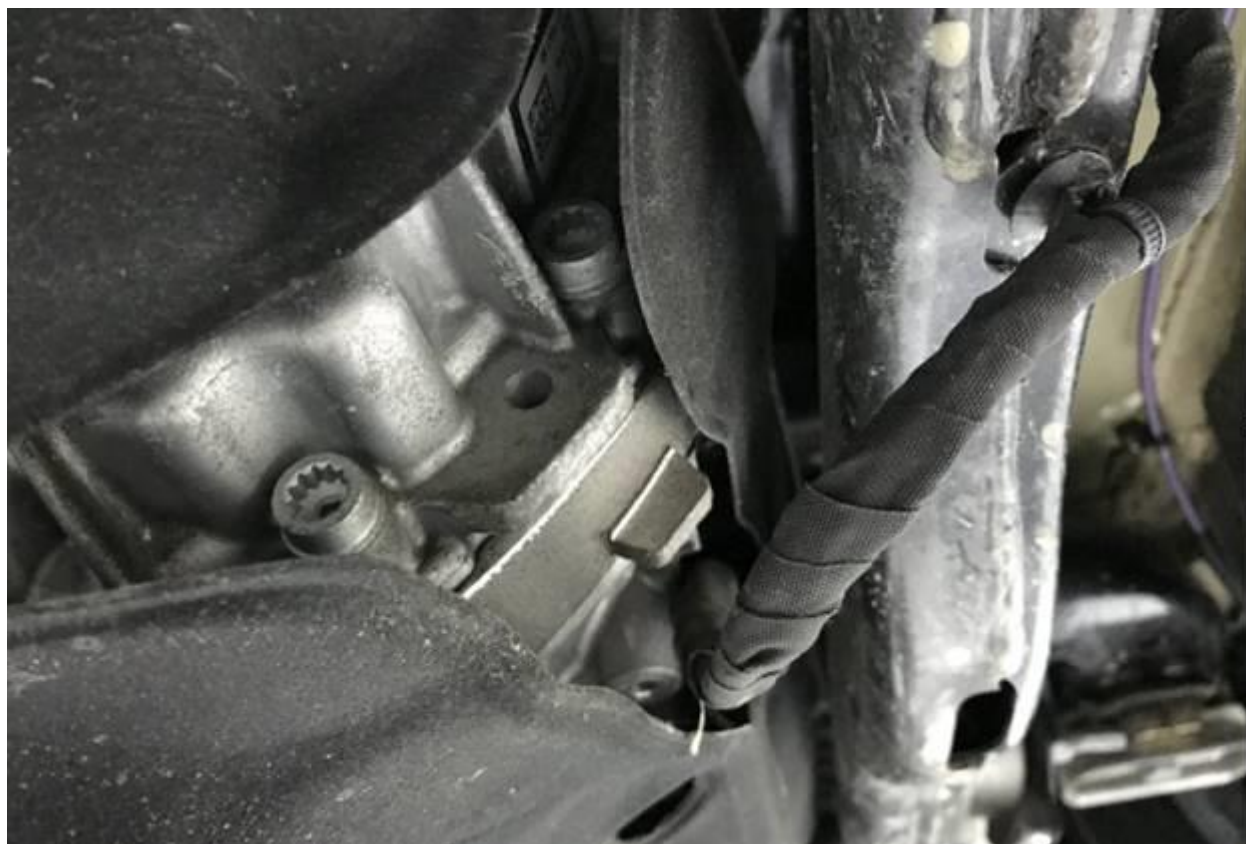
Figure 7. Final harness routing.
