UPDATE Technical Bulletin

UPDATE – 55K5 Emergency Release for Rear Lid (NVLW)

Model(s)	Year	VIN Range	Vehicle-Specific Equipment
Arteon	2019 - 2020	See Campaign/Action screen in Elsa	None

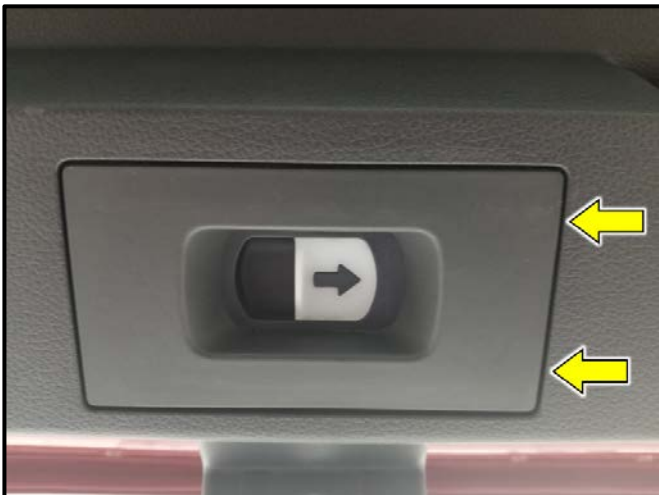
Remove emergency release for rear lid:

- Open the rear lid.
- Carefully pry out the emergency release for rear lid using the -3409-, starting at <arrows>.

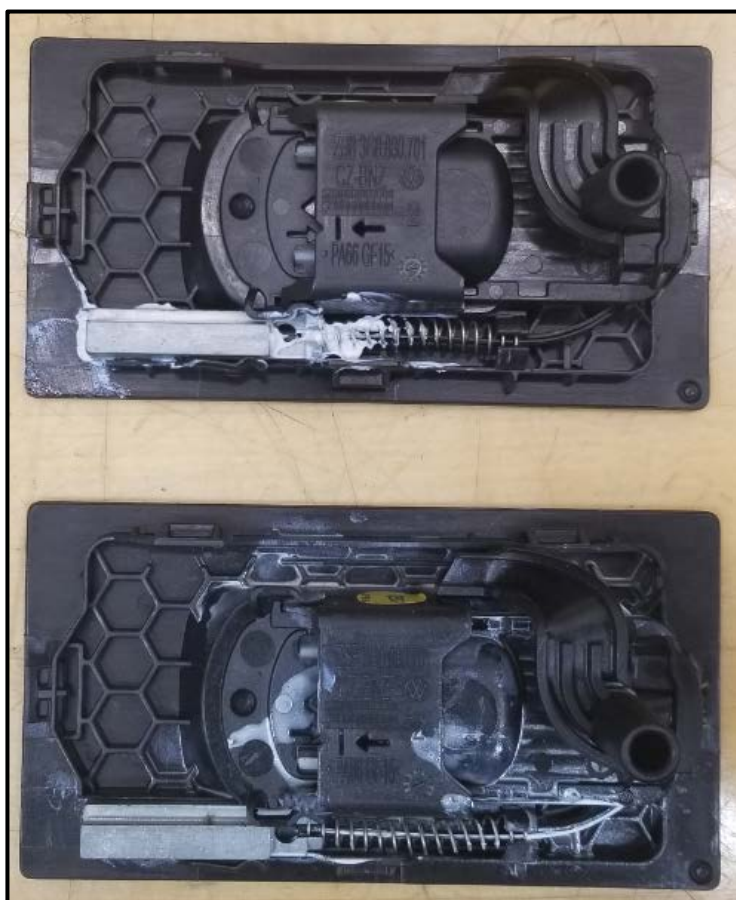
The emergency release for rear lid may already have some white paste applied in varying areas as shown. The 55K5 repair should still be performed in its entirety even if any white paste is already present.
