Technical Service Bulletin

REAR DOOR LOWER GARNISH CRACKING

Bulletin No.: 09-034/19

2017-2019 CX-5 vehicles equipped with piano black garnish

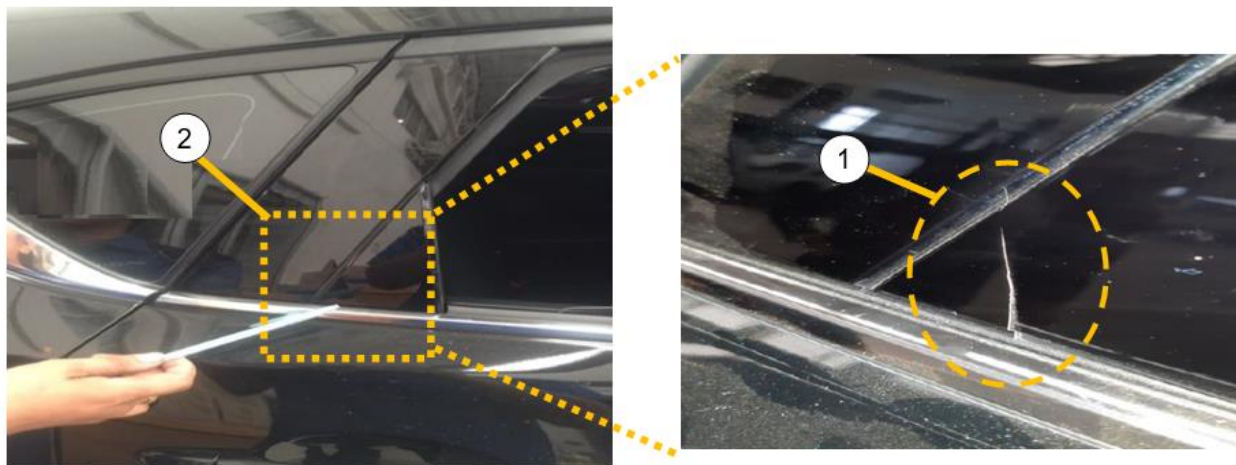
Some vehicles may exhibit cracking (1) at the lower part of the rear side, rear door garnish (2). This concern is caused by excess stress applied to the rear door garnish. To eliminate this concern, the clip and tape position on the rear door garnish has been improved.

NOTE: This concern only occurs to the piano black garnish.

1. Verify the customer concern.
2. Replace the rear side, rear door garnish with a modified part according to the instructions on MGSS online (REAR DOOR GARNISH REMOVAL/INSTALLATION).
3. Verify the repair.
