Service Bulletin

E241

PACCAR MX-13 EPA13 EMY2013 - 2015A NOx Emissions Improvement and On Board Diagnostic (OBD) System Readiness and Other OBD System Issues

8/16/2019

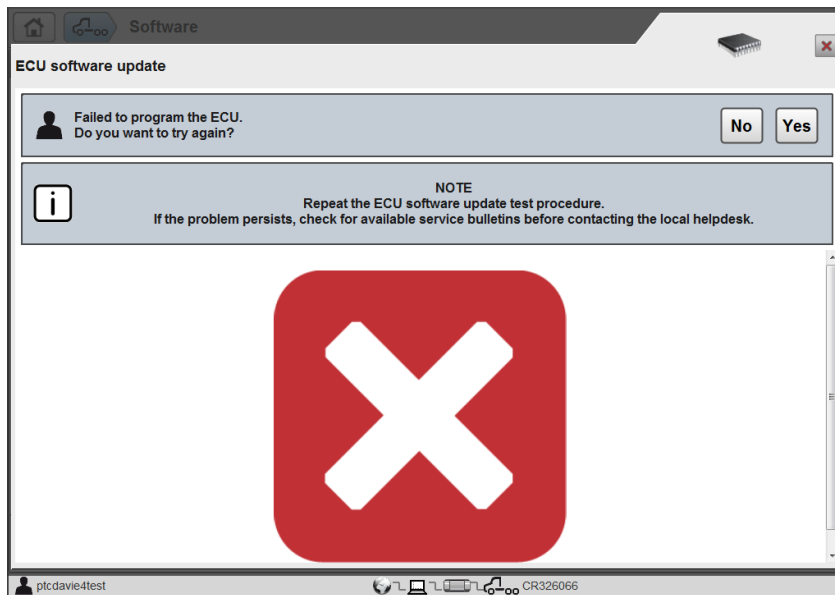
Failed to program the ECU Model Year 2015A chassis

Flashing fails at 100% progress during PCI flashing and returns a generic fail to program PCI message.

- The PCI behaves as though in boot mode.
- On the DAVIE4 software page, the Latest Release column lists part numbers from Part Number Set 1 (refer to Part Number Lookup Table)

1. Cycle the key switch.
2. Start a SupportLink case (see Filing a Support Link Case). Include a screenshot of the I-pane (

The Latest Release component groups will be updated to Part Number Set 2 (refer to Part Number Lookup Table)

3. Flash the PCI.

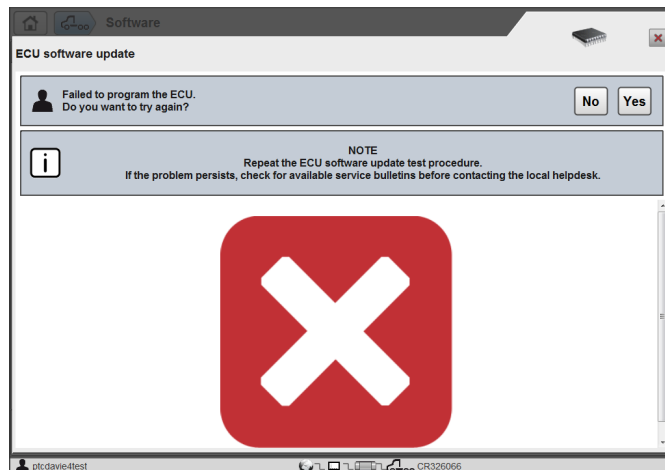
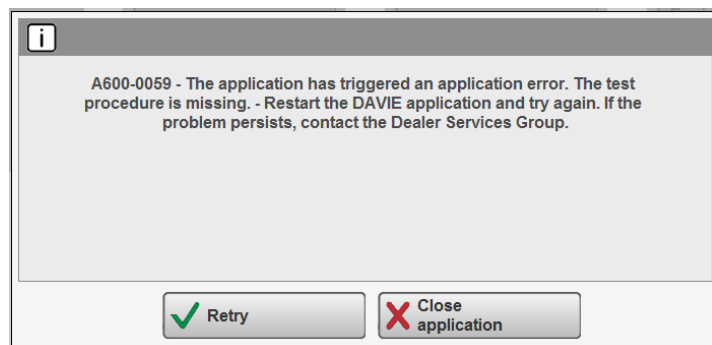
Failed to program the ECU Model Year 2013/2014 chassis

Flashing fails and returns a generic fail to program PCI message. An A600-0059 error is displayed on the home page.

- A600-0059 error displays on the home page.
- PCI acts as though it is in boot mode.
- On the DAVIE4 software page, the both the Installed (ECU) column and the Latest Release column list part numbers from Part Number Set 2 (refer to Part Number Lookup Table)

1. Cycle the key switch.
2. Start a SupportLink case (see Filing a Support Link Case). Include a screenshot of the I-pane (

The Latest Release component groups will be updated to part numbers from Part Number Set 1

3. Flash the PCI.
