## Stowage compartment in center console only opens on one side or not at all

| Topic number | LI68.20-P-070037 |
| Function group | 68.20 Center console |
| Validity | BR167 |

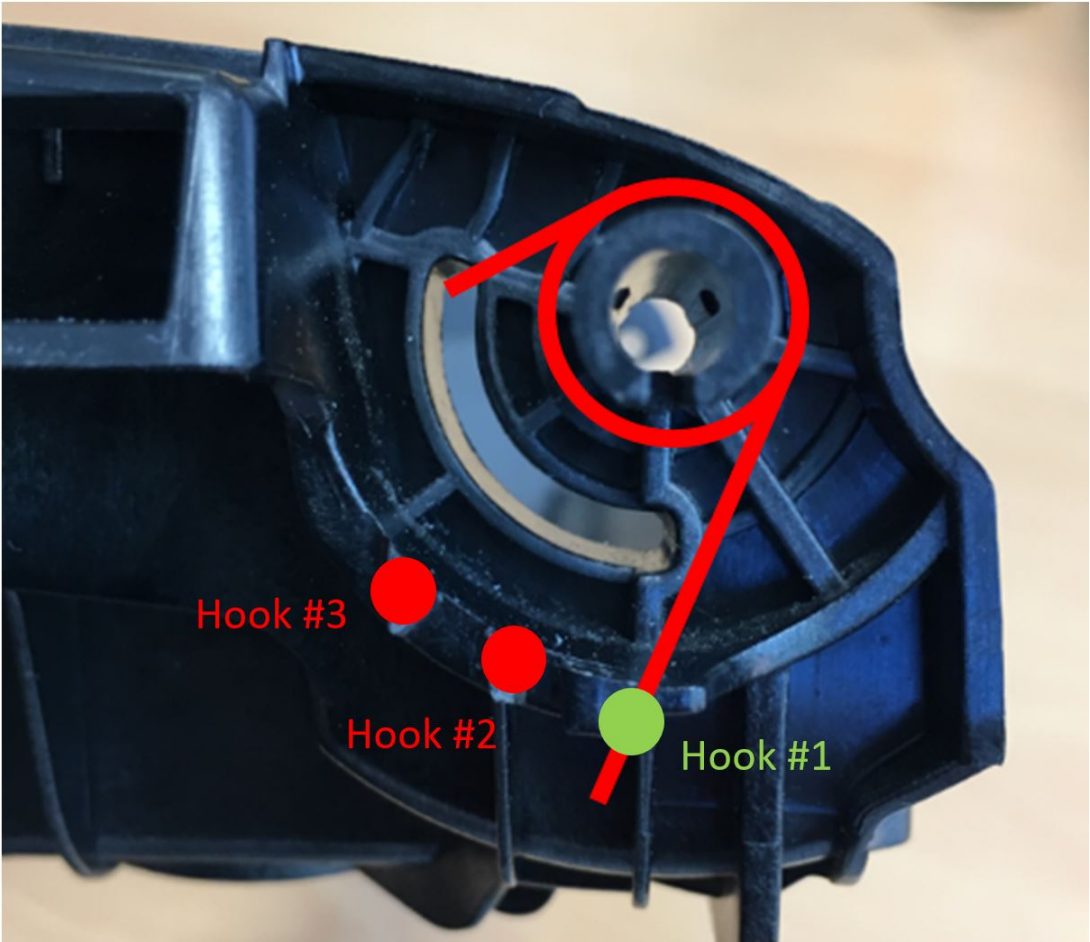
Hook.JPG:

Cause 2: The hook on which the pop-up spring is hooked into may be broken.

| Attachments | |
|---|---|
| Hook.JPG | Attach spring at hook number 1 |

Remedy 2. Hook spring into first of the three hooks (see picture in attachment), as this hook is designed to be the most stable. Both halves of the storage compartment cover should always be used for hooking in. This measure can increase the opening period for the stowage compartment.
