## COMAND Online (code 531): Wrong date in system settings, incorrect time in instrument cluster

| Topic number | LI82.85-P-069725 |
| Function group | 82.85 Navigation and Communication system (CNS, ICS, COMAND, FleetBoard) |
| Validity | Model 205 with code 531 (COMAND Online) and 805, 806, 807, 808.<br>Model 253 with code 531 (COMAND Online) and 805, 806, 807, 808, 809.<br>Model 217 with code 531 (COMAND Online) and 805, 806, 807, 808.<br>Model 222 with code 531 (COMAND Online) and 804, 805, 806, 807. |

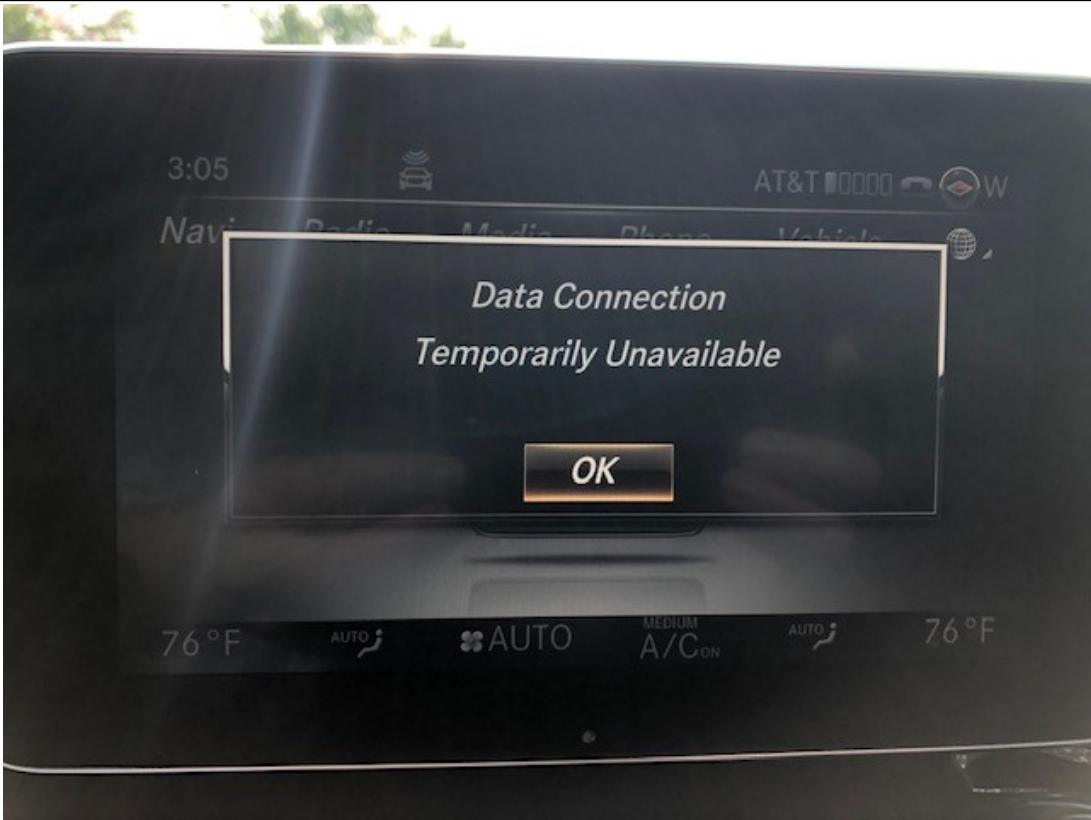
Data connection message.jpg:

| Attachments | |
|---|---|
| Data connection message.jpg | Data Connection Temporarily Unavailable |

The date stored in the COMAND Online control unit (A26/17 or A40/3) is unable to sync via GPS.

Update COMAND Online control unit software (A26/17) then perform epoch offset as outlined below.

- Press the Vehicle button and slide the controller downwards to System settings.
- Push controller to left and hold there for approx. 8 seconds.
- The "Dealer Menu" selection is then shown.
- Select the following menu items: -> Car -> Time -> Epoch Offset -> 2019-2038.
- Exit the Dealer menu using the "Back" button.
- To finish, "reset" the COMAND Online control unit -> System settings.

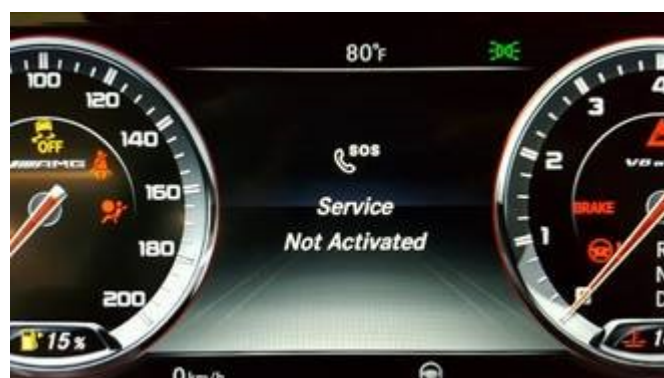
service not activated  
message.jpg:

| Attachments | |
|---|---|
| service not activated message.jpg | SOS Service Not Activated |
