IB17-X-001B

JULY 2019

INTRODUCTION TO FTR

- 2018-2020 MY Isuzu FTR

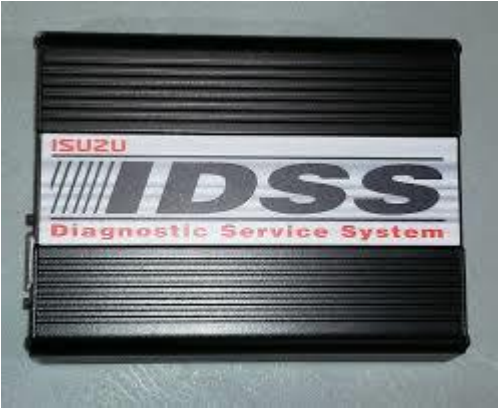
No.	Description	ECUs	IDSS Interface/Scan Tool
1.	The metal case IDSS interface will only communicate with the listed Electronic Control Units (ECUs).	Engine Control Module (ECM) DEF Control Module (DCU) Mimamori ECU Fleet Management System (if equipped) (FMS)

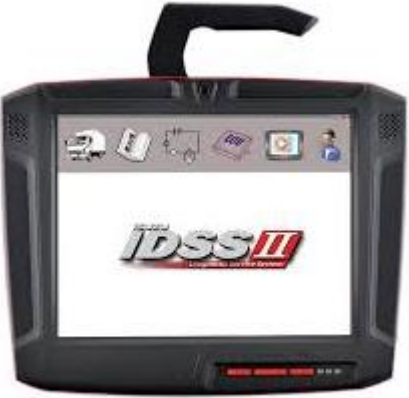
2.	The IDSS Tablet will communicate with all onboard ECUs.	ECM DCU Mimamori ECU Electronic Brake Control Module (EBCM) FMS (if equipped)
