## Technical Information Bulletin

**42-058**

T680/T880/W990 Intermittent Low Coolant Indicator Illumination

8/23/2019

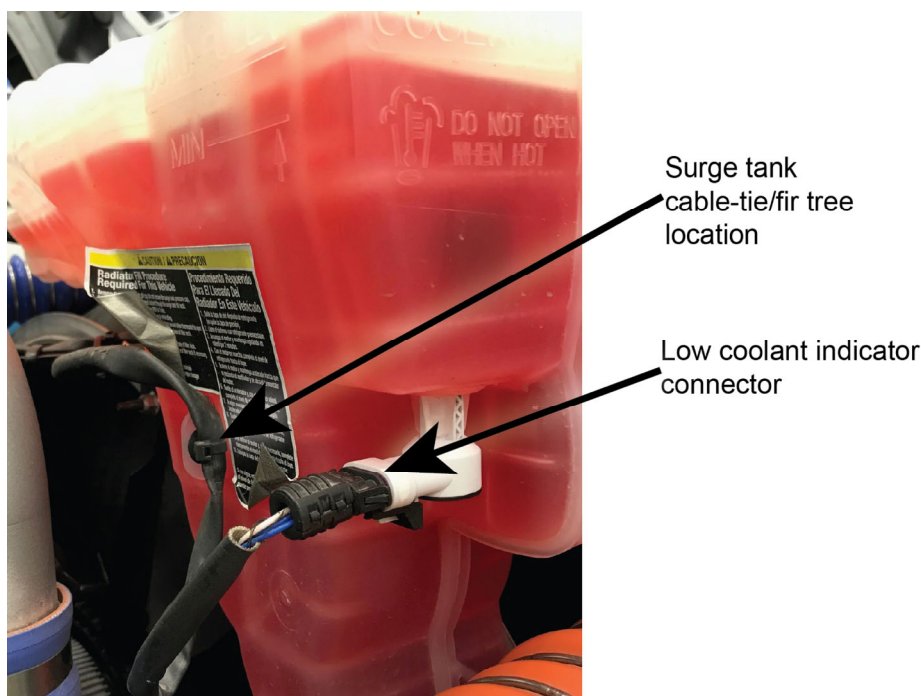
The low coolant indicator may illuminate intermittently even though the coolant level is at or slightly above the MIN line on the surge tank. In some cases, the low coolant indicator may remain illuminated. This condition may be accompanied by a P1560 DTC.

1. [Inspect the coolant level sensor harness for damage where it is retained by a cable tie to a tab on the surge tank.](#)

- If no obvious damage is found, and the cable was retained to the surge tank tab with only a cable tie, replace the cable-tie with a fir-tree cable tie assembly. The cable tie only needs to be tight enough to prevent the harness from moving. If the cable tie is tightened too tightly, it may cause this condition again.

- If damage is found, refer to [TIB 34-081](#) for repair guidance.
2. If no issue was identified in Step 1, the coolant level may be slightly low. If the engine cannot be allowed to cool to ambient temperature, then provide the customer with 1 gal of premixed coolant.

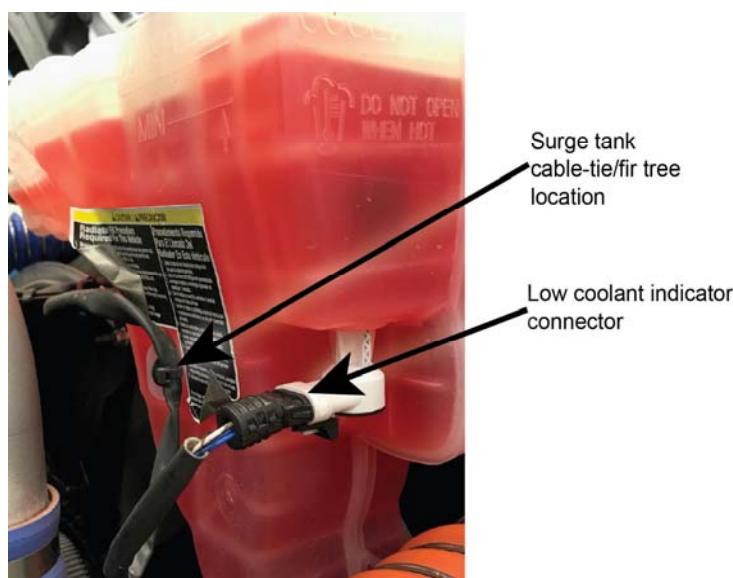
The low coolant indicator may illuminate intermittently even though the coolant level is at or slightly above the MIN line on the surge tank. In some cases, the low coolant indicator may remain illuminated. This condition may be accompanied by a P1560 DTC.

1. Inspect the coolant level sensor harness for damage where it is attached by a cable tie to a tab on the surge tank.

- If no obvious damage is found, and the cable was attached to the surge tank tab with only a cable tie, replace the cable-tie with a fir-tree cable tie assembly. The cable tie only needs to be tight enough to prevent the harness from moving. If the cable tie is tightened too tightly, it may cause this condition to reoccur.
