GROUP	MODEL
CLI	2017-2019MY Sportage (QL)
NUMBER	DATE

046 (Rev 1, 08/30/2019)

# TECHNICAL SERVICE BULLETIN

REDUCED PERFORMANCE OR INOPERATIVE AIR CONDITIONING

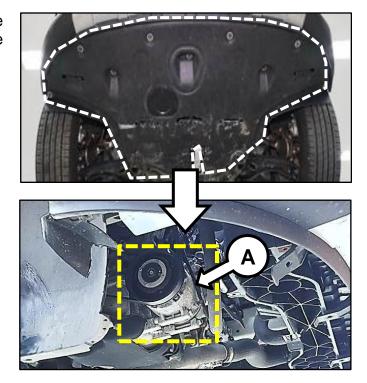
1. Raise the vehicle on a lift and remove the engine under cover to access the A/C compressor (A).

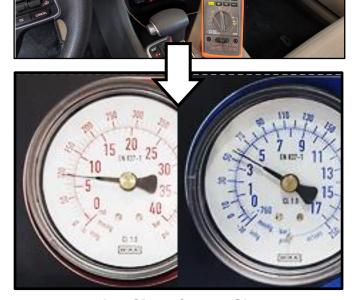
High Side / Low Side

Note: When connecting gauges, if the compressor is inoperative, there will be no significant difference between high and low pressure reading (as shown). Pressure difference will be within 2-3 bar (29-44 psi).

If the A/C compressor operates normally during engine idle, replace the ETS and if applicable, replace the ECV (pages 5 and 6) (pages 5 and 6).

If the A/C compressor is not operating normally during engine idle, replace the compressor **and** if applicable, replace the ETS (page 6).
