ARTICLES CONTAINED IN THIS ISSUE

01 QMR OF THE MONTH

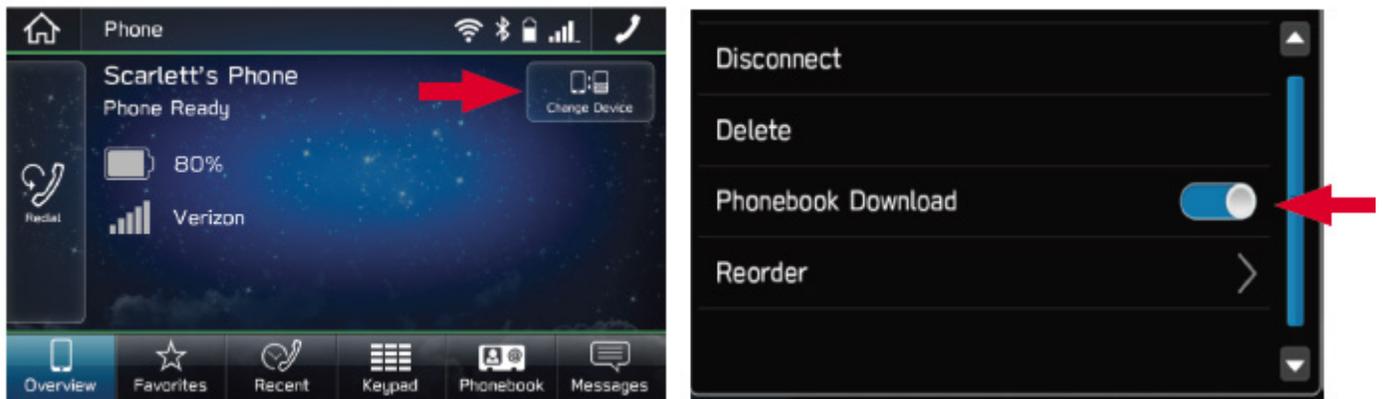
There have been reports received regarding phonebook downloading failure during Bluetooth pairing. Customers report after repeated pairing attempts, the condition continues.

We would like to refresh the steps involved in the process to prevent issue occurrence due to the setup. If the phonebook or messages are not appearing as expected following Bluetooth Pairing, verify the **Phonebook Download** feature has been enabled in the head unit settings. Select the **"Phone"** button then press **"Overview"** on the head unit touch screen. Then select **"Change Device"** and ensure **"Phonebook Download"** is enabled.

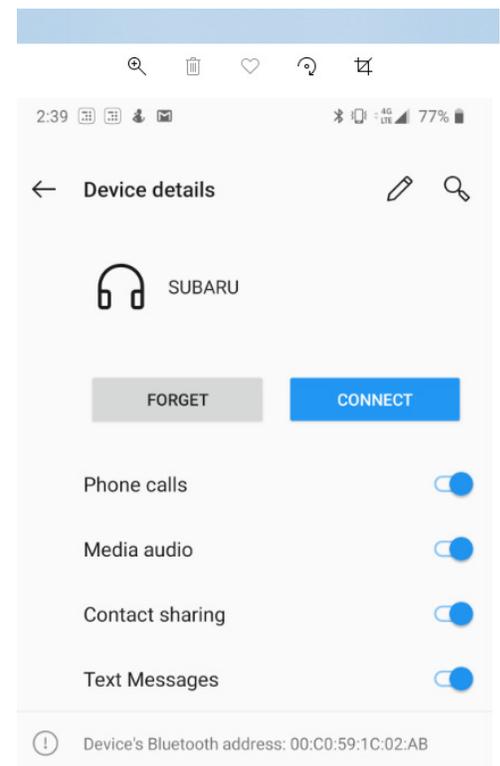
If the customer still cannot access the phonebook or messages, check the phone's Bluetooth settings to ensure all related sharing settings are enabled.

Select the gear icon next to your vehicle device name. Ensure all settings are enabled.

There are no additional settings to check on Apple devices following successful pairing with the head unit. However, it is strongly recommended to restart the vehicle to finalize the pairing process and ensure all devices are in sync.
