Service Bulletin

44-030

Nylon Fuel Lines Too Short or Loose Connection

8/30/2019

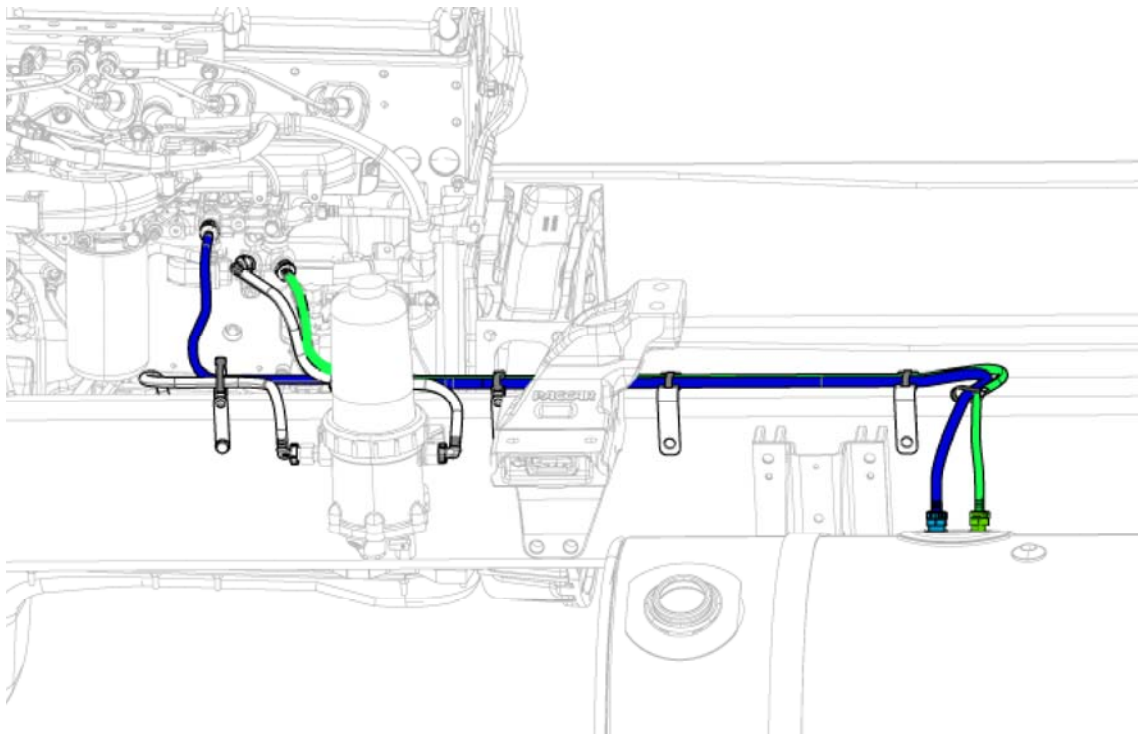
One of the nylon fuel hoses, on certain model 579 and 567 vehicles built between 1/16/2017 and 2/28/2018, may be too short. This could result in a cracked or loose low-pressure fuel fitting at the engine or fuel tank, which could potentially allow air into the fuel system resulting in difficulty starting.

1. Cut the cable-ties that secure the fuel line(s).
2. Disconnect the affected fuel line(s) from the fuel tank and the engine.
3. Remove the affected fuel line(s).
4. Install the new fuel line(s), and if noted on the chassis list, replace the fuel tank fitting.
5. Secure the fuel lines with cable-ties.

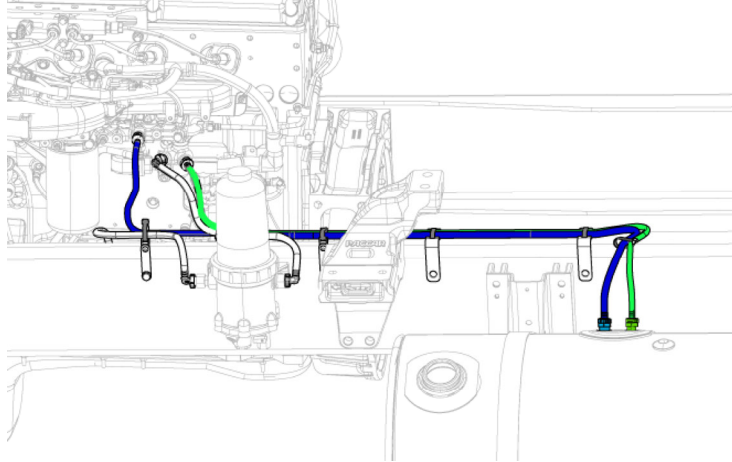
The engine may be hard to start or not start due to a cracked or loose, low pressure fuel fitting introducing air into the fuel system.

1. Cut the cable-ties that retain the fuel lines.
2. Disconnect the affected fuel lines from the fuel tank and the engine.
3. Remove the affected fuel line.
4. Install the new fuel line, and if noted on the chassis list, replace the fitting on the fuel tank.
5. Retain the fuel lines with cable-ties.
