Business Class M2
> Cascadia
108SD/114SD
New Cascadia

**Freightliner
Service Bulletin**

Wiper Motor Inspection and Replacement

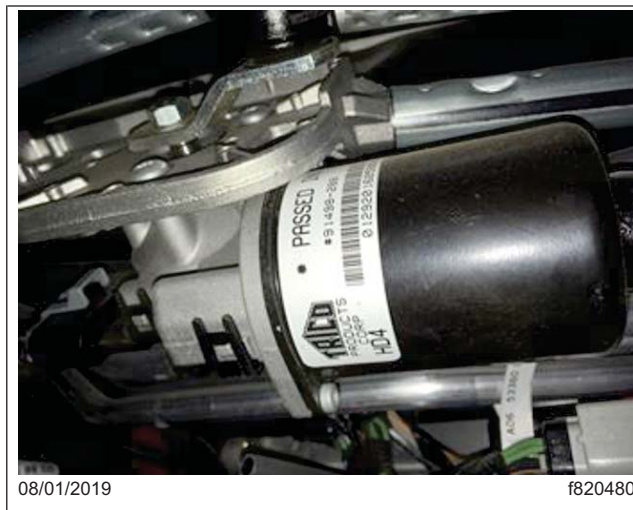
Fig. 1, Wiper Motor

On Cascadia vehicles built with wiper motors installed before 2/2/2017, the wiper park brush that rides against the brush plate may wear, which may result in a diminished wiper park signal.

1. Park the vehicle, apply the parking brakes, and shut down the engine. Chock the tires.
2. Open the hood.
3. Inspect the wiper motor label for the Trico part number. See [Fig. 1](#). For vehicles that have the updated wiper motor (p/n TRI F91498 495), no further action is necessary. For vehicles with wiper motor part number TRI F91498 288, continue with the next step to replace the wiper motor.

If these conditions are occurring, or if fault code **SA 33 FMI 52209 SPN 2 - Wiper Park –Data Erratic, Intermittent or Incorrect** displays, verify whether or not the updated wiper motor (p/n TRI F91498 495) is installed. If the updated wiper motor is not installed, use the instructions in this bulletin to replace the wiper motor.
