Repair Notice

45-060

Engine Harness and Ladder Bracket Rub

8/22/2019

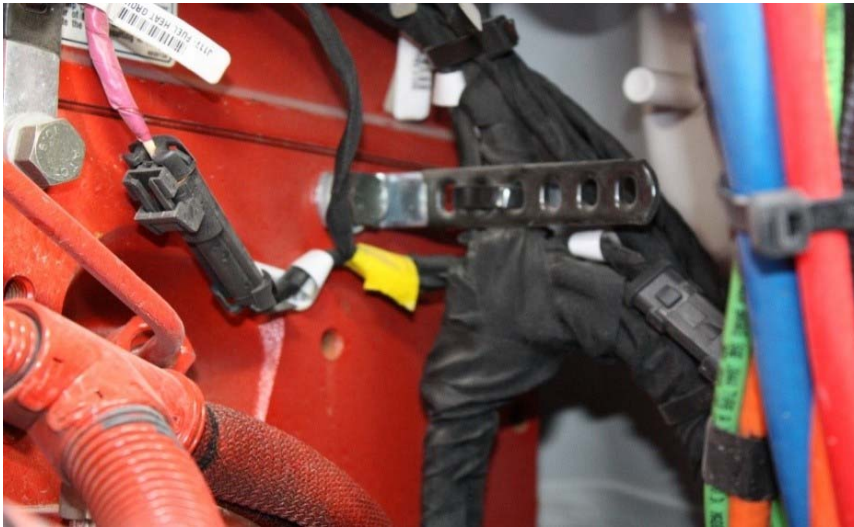
Peterbilt has determined that certain 579 and 567 vehicles, built from 1/03/17 to 6/01/18 and equipped with ISX15 / X15 engines, were built with a ladder bracket that aides in the routing of the engine harness. If left in place, this bracket could eventually cause damage to the engine harness.

1. Locate the ladder bracket on the rear of the engine, near the firewall on the driver's side.
2. Cut and remove the tie strap that secures the harness to the ladder bracket.
3. Remove the 18 mm bolt securing the ladder bracket to the block and remove the bracket.
4. Inspect the condition of the harness and refer to [34-066 - Harness Damage and Repair Quick Guide](#) for guidance on how to proceed if the harness is damaged.
 - If the harness requires replacement, refer to Web ECat to obtain the correct harness part number.
5. Secure the harness as needed to protect from potential rubs.
