TECHNICAL SERVICE BULLETIN

2.0L EcoBoost - Rattle Noise And Cracked Flexplate

19-2236
06 August 2019

Ford 2015-2018 Edge

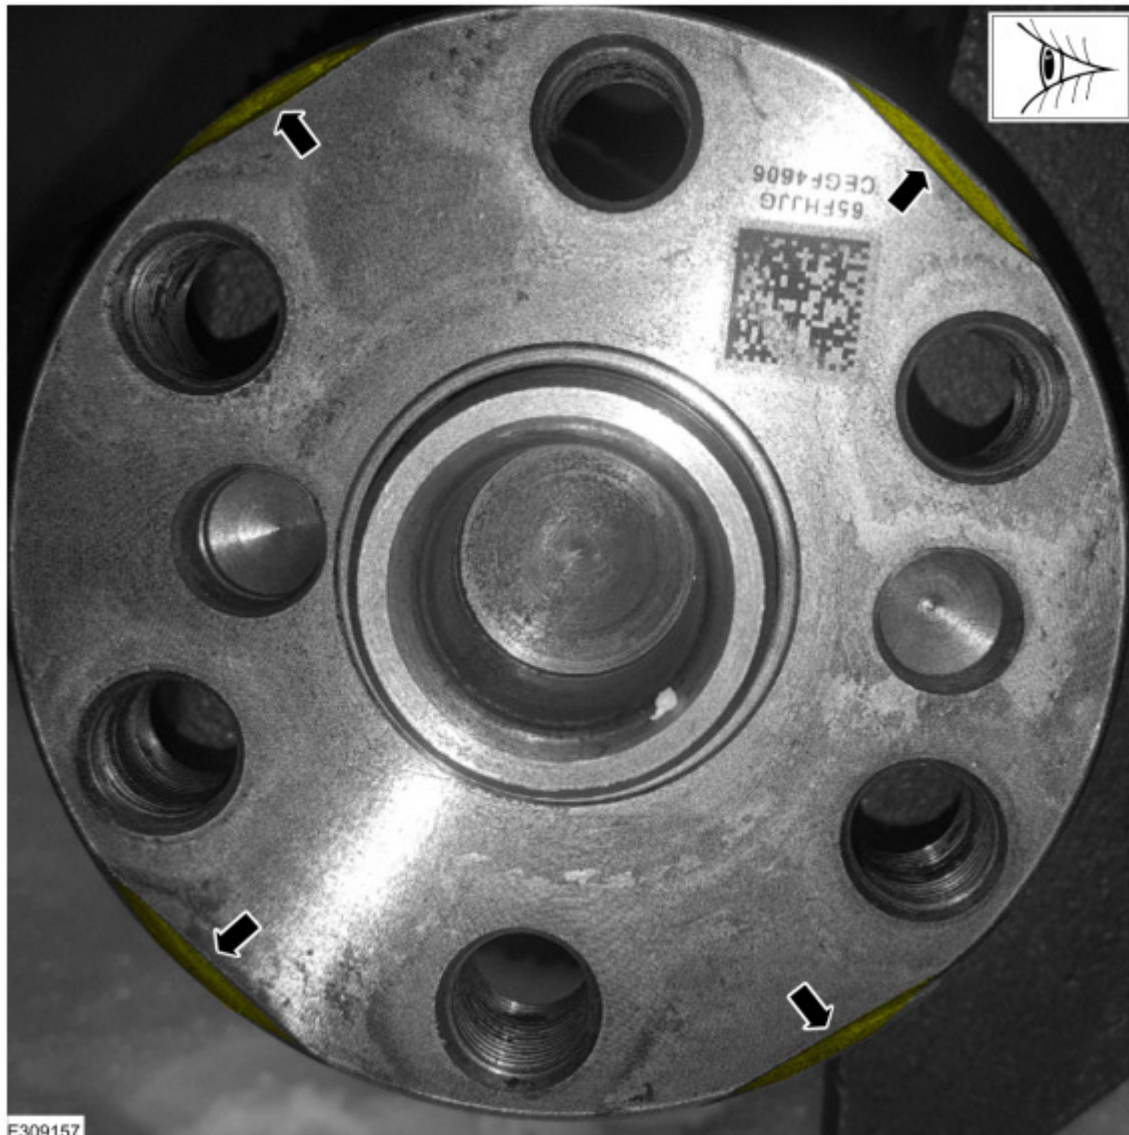
Figure 1

4. Remove the flexplate and inspect the crankshaft mounting face for damage. Are indentations present on the edges of the crankshaft? (Figure 1)
 - (1). Yes - replace the torque converter, flexplate, flexplate bolts, and transmission front pump. Refer to WSM, Section 307-01A. If dowel pins are damaged or missing, replace as needed. Proceed to Step 5.

- (2). No - replace the torque converter, flexplate, flexplate bolts, and transmission front pump. Refer to WSM, Section 307-01A. If dowel pins are damaged or missing, replace as needed. Proceed to Step 46.
