# Hendrickson HaulMaxx Rear Suspension Transverse Torque Rod Tower Bracket Replacement

# 32-054

Century Class Conventional  
Argosy COE  
Cargo

Freightliner  
Service Bulletin

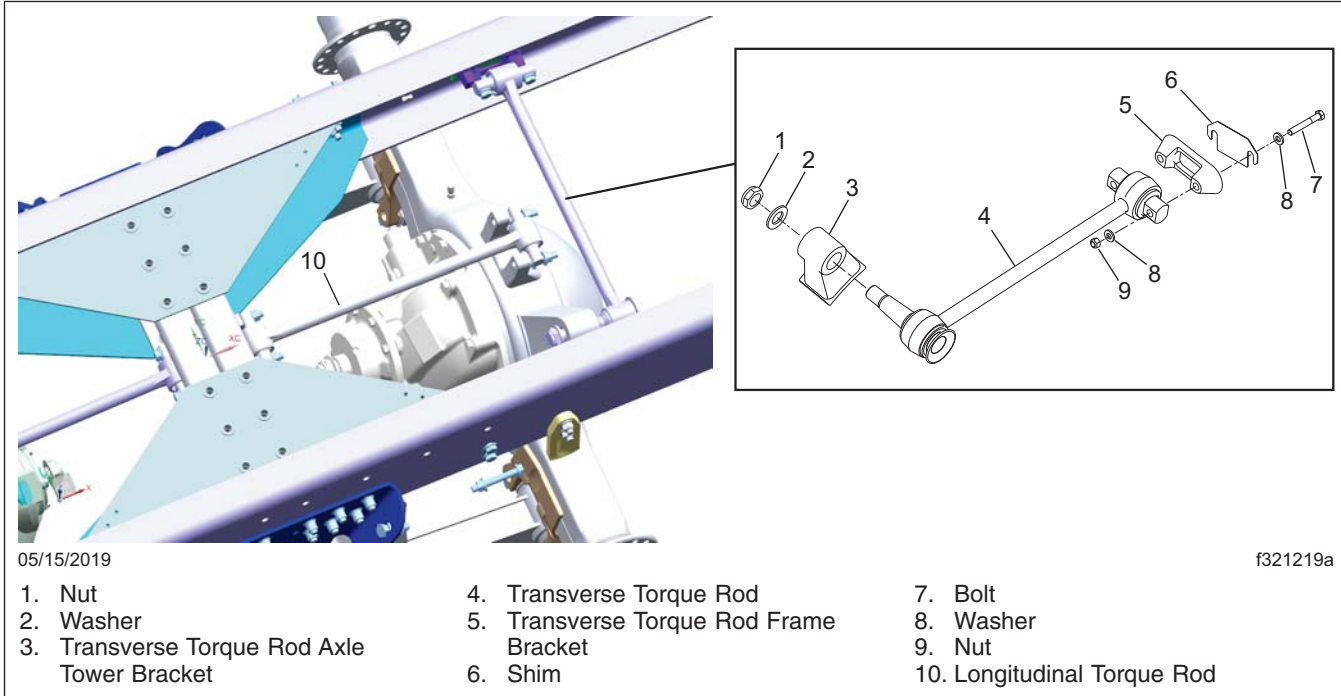
**Fig. 1, Rearmost Axle Assembly**

Some vocational vehicles may have an incorrect transverse torque rod tower bracket installed on the rear drive axles at the factory. This can result in cracking at the transverse rod tower where it is welded to the axle housing, premature wearing of the transverse torque rod tapered pin and bushings, and damage to the transverse torque rod frame bracket.

3. Remove the three mounting fasteners from the transverse torque rod and discard the rod and fasteners. Save the shims. See Fig. 1.

5. Use a disc grinder to grind out the weld and remove the tower bracket. Discard the tower bracket.
6. Remove any weld residue, ridges, or ripples from the surface of the housing. All areas must be flat with the housing wall and bracket. Do not gouge or leave sharp edges on any surface.
7. Remove the paint in a 3-inch radius from the area to be welded.
8. Clean the area using a wire brush and a cleaning solvent that will remove dirt and grease.
